**Investigation into the collision
between the Australian bulk ship
RIVER EMBLEY
and the Royal Australian Navy patrol boat
HMAS FREMANTLE
off Heath Reef, in the Great Barrier Reef
at about 2209 on 13 March 1997**

Report 112

COMMONWEALTH DEPARTMENT OF
**TRANSPORT AND
REGIONAL DEVELOPMENT**

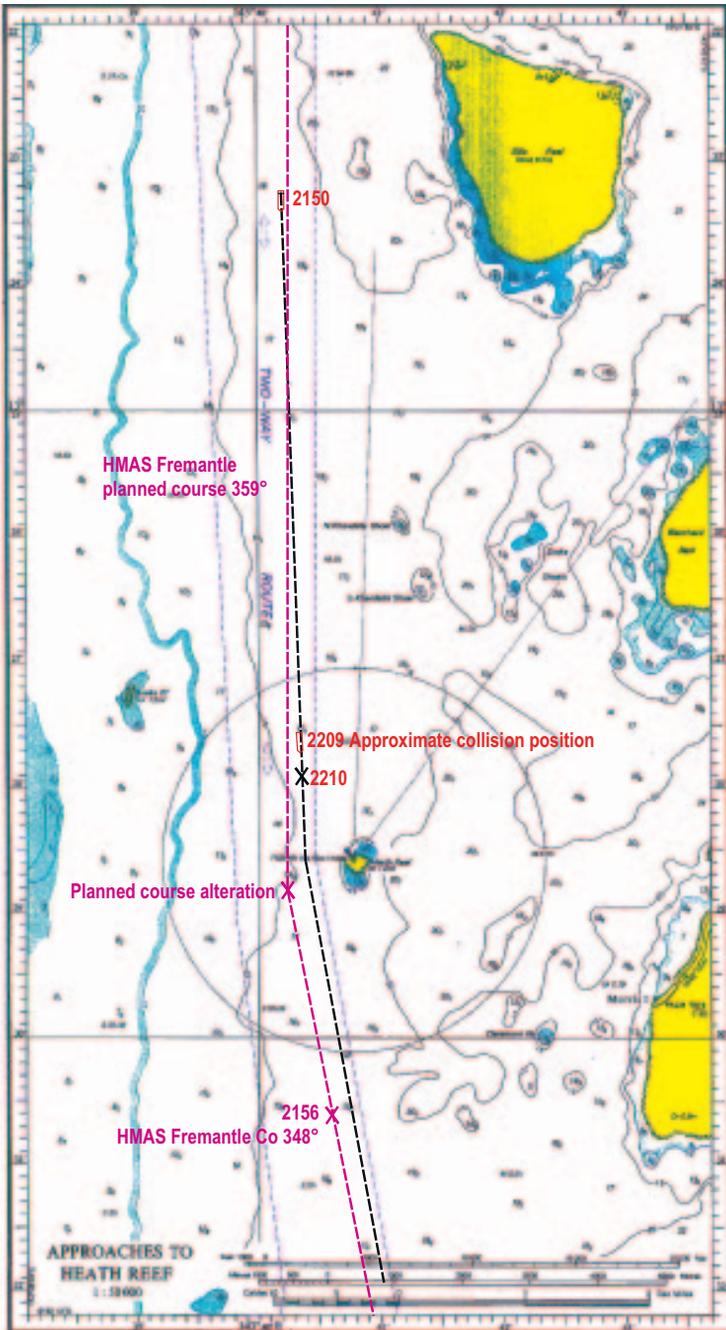
Plotted course of River Embley & HMAS Fremantle

The two vessel's collided with the initial contact between Fremantle's port bow and the starboard bow of River Embley in way of frame 285. The patrol boat's stern then swung rapidly so that its port quarter came into heavy contact with the bulk carrier's starboard side in way of frame 224 on the deep frame/bulkhead between number 2 and 3 ballast tank.

The collision occurred at about 2209. The evidence is that River Embley maintained course and speed until a few seconds before the collision occurred. Also, Fremantle having crossed River Embley's line of advance from port to starboard, attempted to recross the bulk carrier's bow to affect a port to port crossing. Fremantle struck River Embley at an angle, put by those on the River Embley as between 60° and 45° but may have been about 20°.

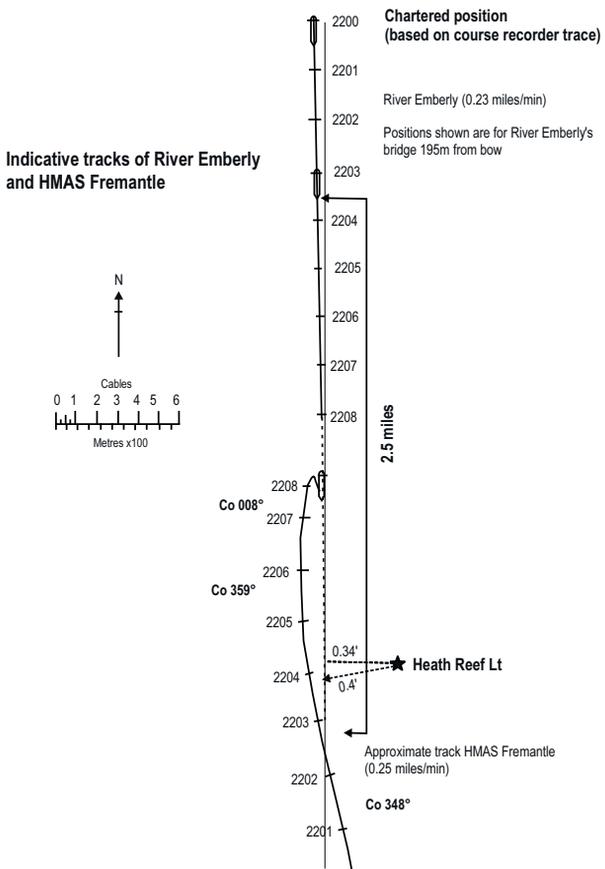
Indicative tracks of River Embley and HMAS Fremantle

In the area of Heath Reef, when two deep draught vessels meet in the area of restricted depth, the pilots exchange information and agree a plan on VHF radio. This may involve a change in speed or, more normally, the north bound vessel will go to the east of Heath Reef.
