INVESTIGATION REPORT  
9701421

Bell Helicopter VH-CKP  
Tartrus Station, Qld  
2 May 1997

INVESTIGATION REPORT

9701421

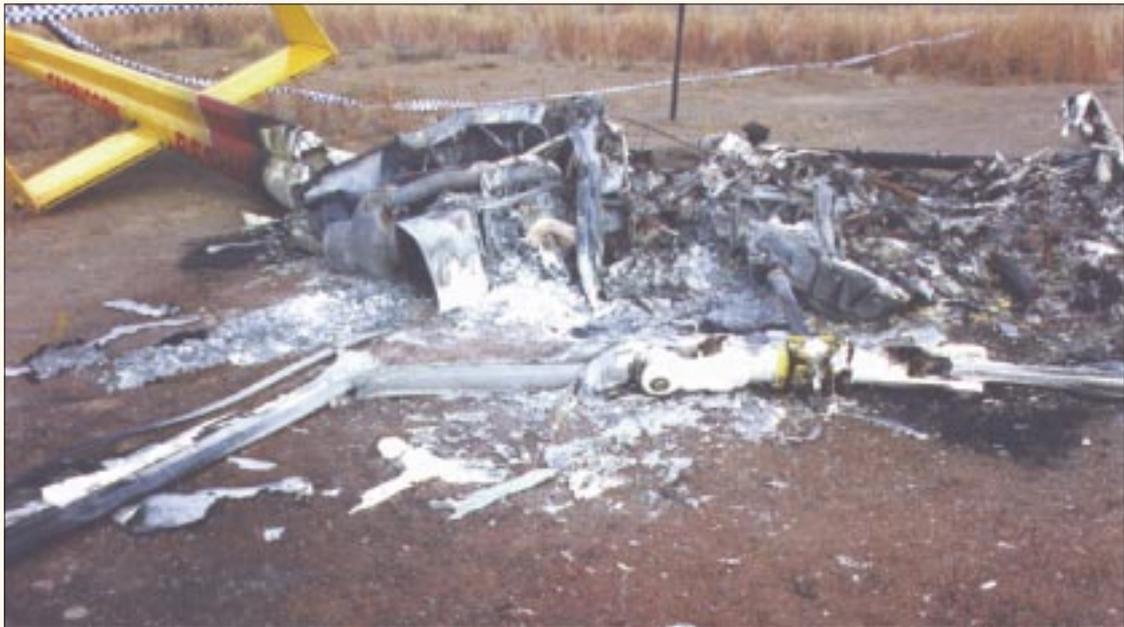
**Figure 1:** The wreckage of VH-CKP.

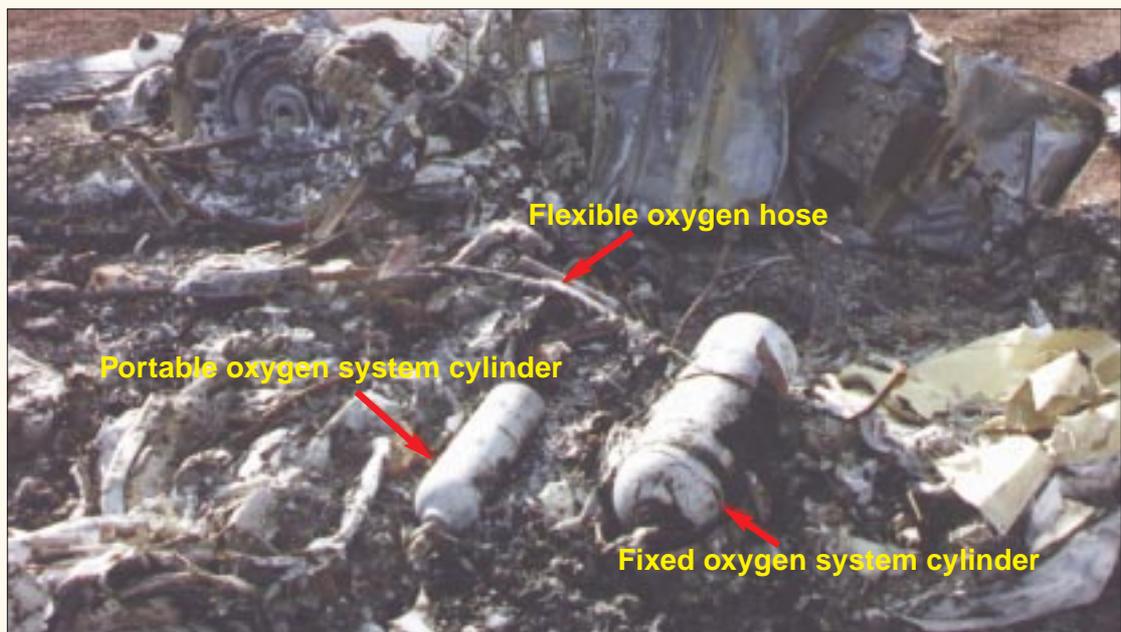
**Figure 2:** The two oxygen system cylinders and the remains of the flexible oxygen hose.

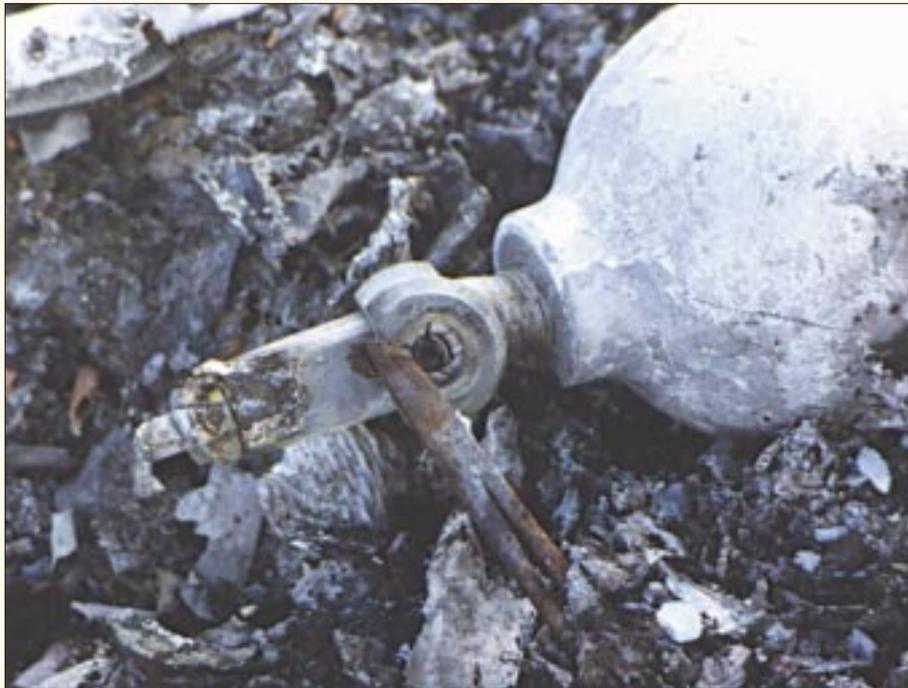
The control wheel end of the valve showed evidence of having been burnt in a stream of oxygen (figs. 5 & 6). Marks on the surface between the regulator attachment and the burnt areas indicated that gas had been flowing from the base of the regulator attachment and impinging on the burnt area (fig. 6). Figure 5, which shows the cylinder and valve in the wreckage of the helicopter, also shows a pair of what appear to be forceps (identified later as a needle holder) which had been burnt by impinging oxygen (probably an austenitic stainless steel, which would begin to melt at about 1,400°C and burn in oxygen at in excess of 2,000°C [2]). These needle holders were adjacent to the area where the gas had been venting from the cylinder valve. The combustion products from the needle holders appear to have been impinging on the burnt area of the valve, which had led to the burning of the brass of the valve body [3]. As the position of the needle holder relative to the cylinder valve was correct for the apparent damage observed, it would appear that the damage to the needle holder and the end of the cylinder valve occurred after the helicopter had been substantially damaged. In other

**Figure 5:** The end of the portable oxygen cylinder and the valve. Note that the regulator is missing, and that a high-temperature fire has damaged the end of the valve.

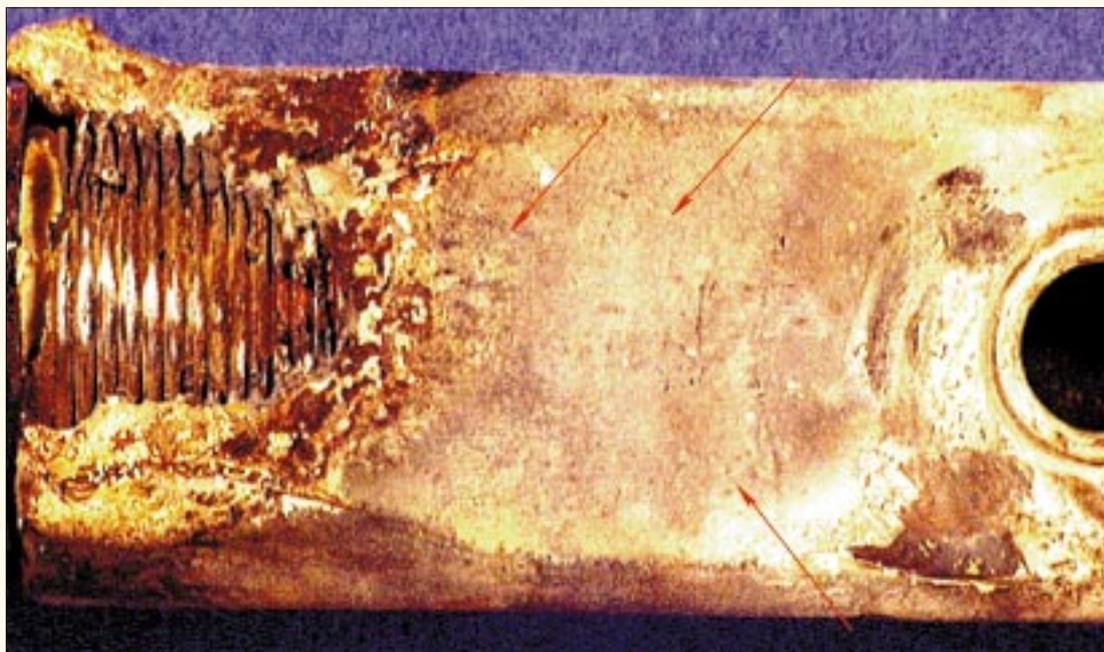
**Figure 6:** The faint indications of the gas flow as shown (some arrowed) on the portable oxygen system cylinder valve surface.

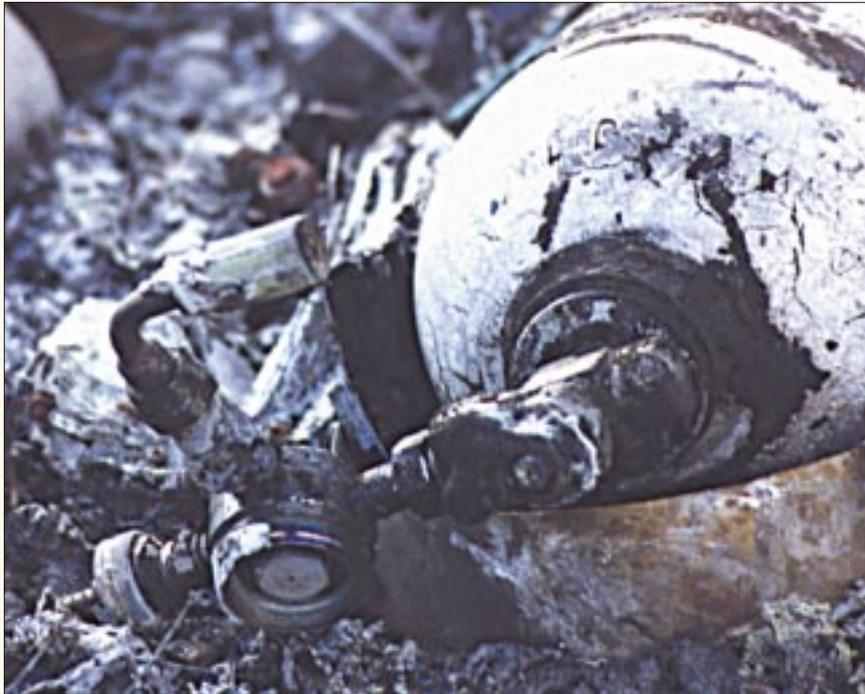
The regulator was found still attached to the cylinder valve, as shown in fig. 7. The bonnet (containing regulating pressure control spring) had melted (probably between 380°C and 420°C, the melting range for common zinc die cast alloys). All polymeric parts had burnt. A schematic of the regulator construction is shown in fig. 4.

**Figure 7:** The fixed oxygen system cylinder and regulator as found in the wreckage of the helicopter. Note the elbow and the end fitting of the flexible line are still attached to the regulator.

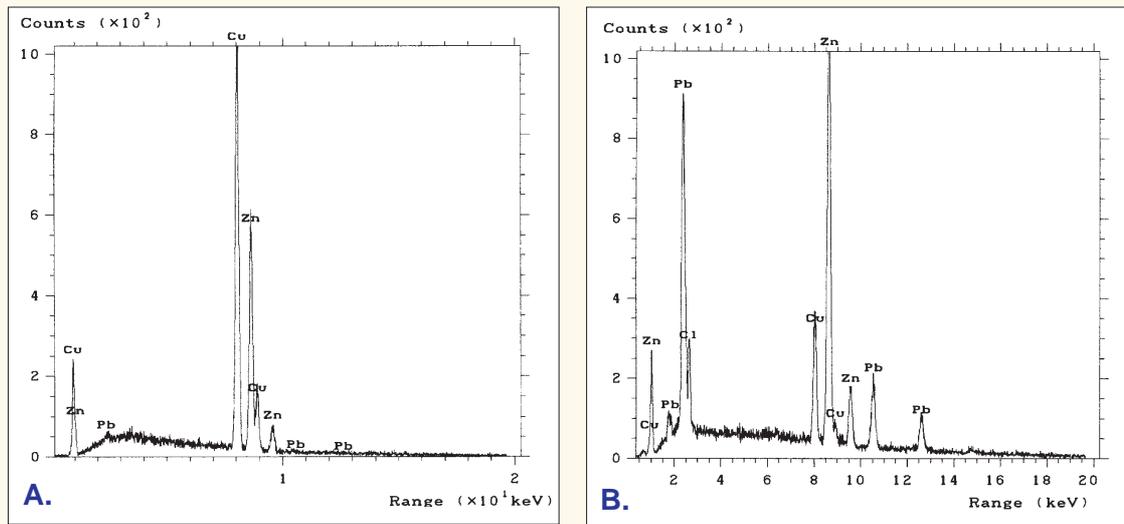
**Figure 8:** Two spectra taken from the fittings attached to the regulator. Spectrum A is of the alloy of the bull-nose connector which would appear to be a leaded brass and spectrum B the dark crystalline material coating the inner surface of this part.

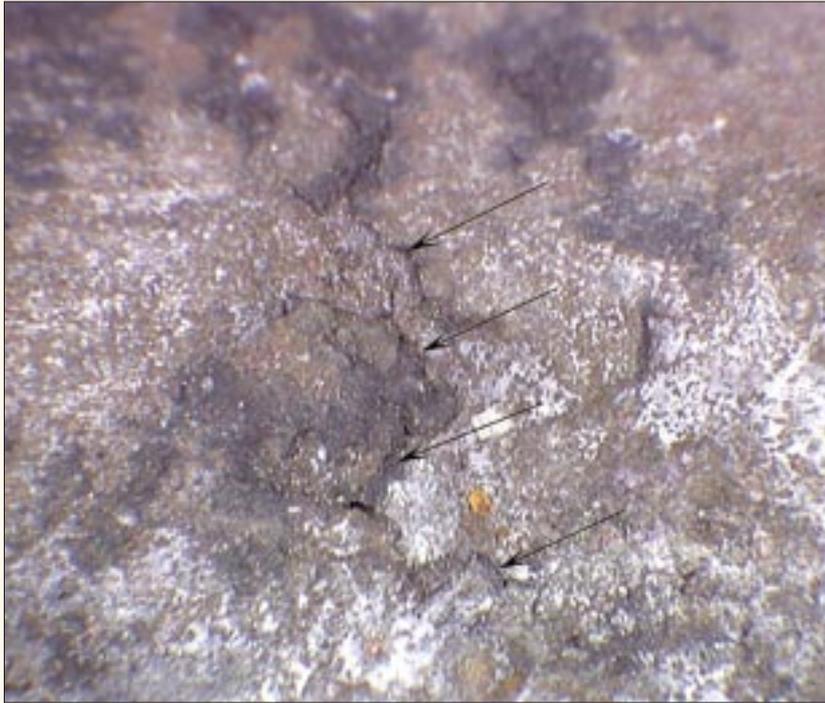
4. The male-to-male adaptor used to connect the flexible hose to the regulator of the fixed system appeared to be of poor quality, and this may have contributed to the ignition of the hose. The fissures in the inner surface of the adaptor would have made thorough cleaning of this part difficult.

Inspection of the two brass fittings that connected the flexible hose to the regulator showed that, apart from the deposits noted above, the internal surface of the male-to-male adaptor had large fissures in it. Examination of these fissures and the microstructure of the fitting indicated that they had probably formed during a hot forming operation (hot-tears). The fitting appeared to have been produced by extrusion and/or near-net-shape forging, followed by machining. The fissures contained considerable amounts of relatively loose oxidised material, along with some evidence of corrosion product (figs. 9 & 10). This oxide was observed down to the internal tips of the fissures. In comparison, the external surface of the fitting was relatively un-oxidised.

**Figure 9:** Some of the large fissures in the inner surface of the male-to-male adaptor.

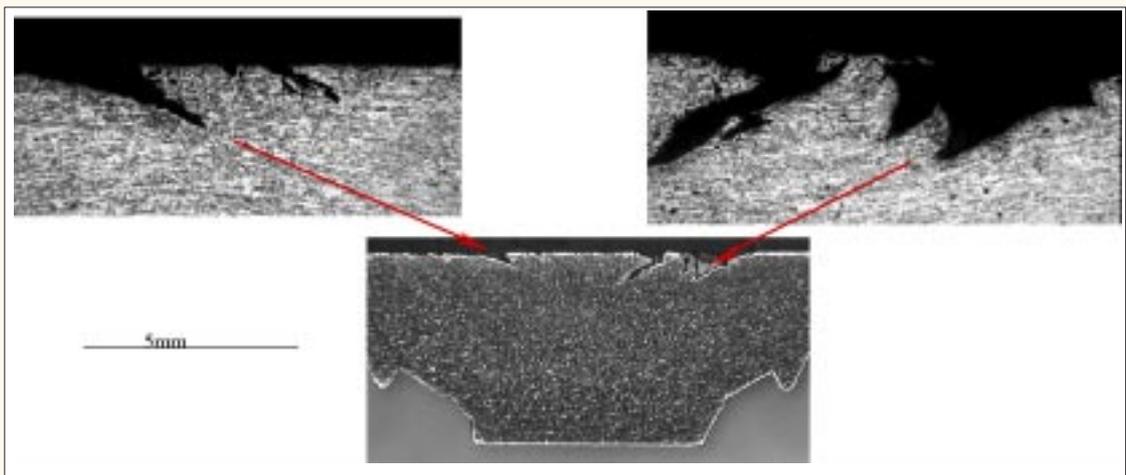
**Figure 10:** A cross-section through the male-to-male adaptor showing some of the large fissures in the inner surface.

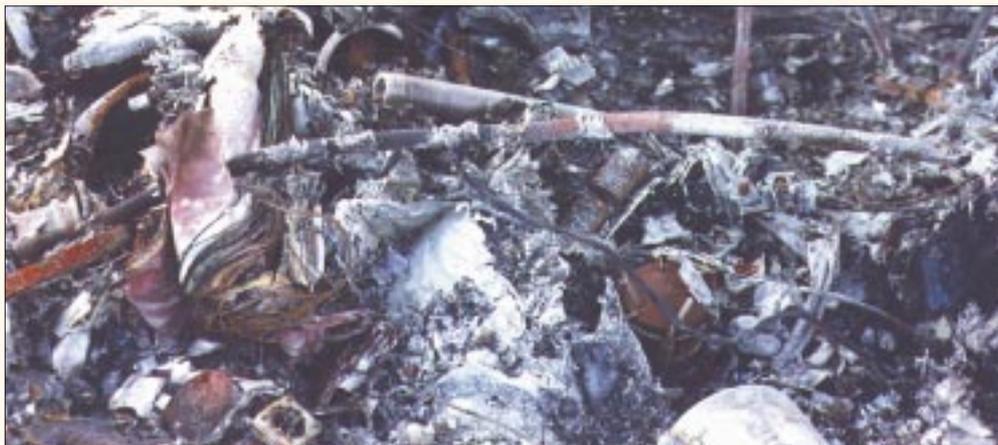
The hose, as received, had been extensively burnt in the fire. All traces of the original polymer parts were missing. A large section of the hose could not be found in the wreckage, although some of the wire braiding was found in the overalls and neck of the person who had just (at the time of the reported explosion) turned on the oxygen cylinder. Of the 1.5-m hose length (estimated), approximately 850 mm was recovered (figs. 11 & 12). The recovered section ran from the gauge end of the hose and ended in a failure that showed clear evidence of melting and some combustion of the wire braiding. (The melting temperature of steel is approximately 1,500°C.) The regulator end of the hose, still attached to the regulator, consisted only of the swaged fitting and bend and a small amount of the braiding encased within the swaged ferrule. The area where the hose had exited the ferrule, exposing the ‘hose tail’, showed indications of melting and burning of the ends of the ‘hose tail’ (melting point for stainless steel is about 1,400°C), the braiding and the end of the ferrule (fig. 13). All of this damage was consistent with an oxygen fire having occurred within this hose.

**Figure 11:** The hose as found in the wreckage of the aircraft. Note that one of the oxygen cylinders is just visible at the bottom of the view. The gauge end of the hose is to the left in this view.

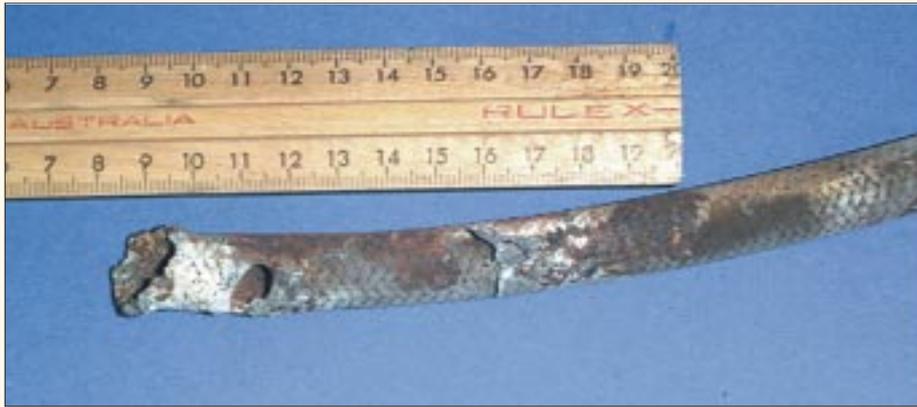
**Figure 12:** The end of the hose, which had damage consistent with a high-temperature fire (greater than 1,500°C). Note the secondary hole along with the melting steel braid.

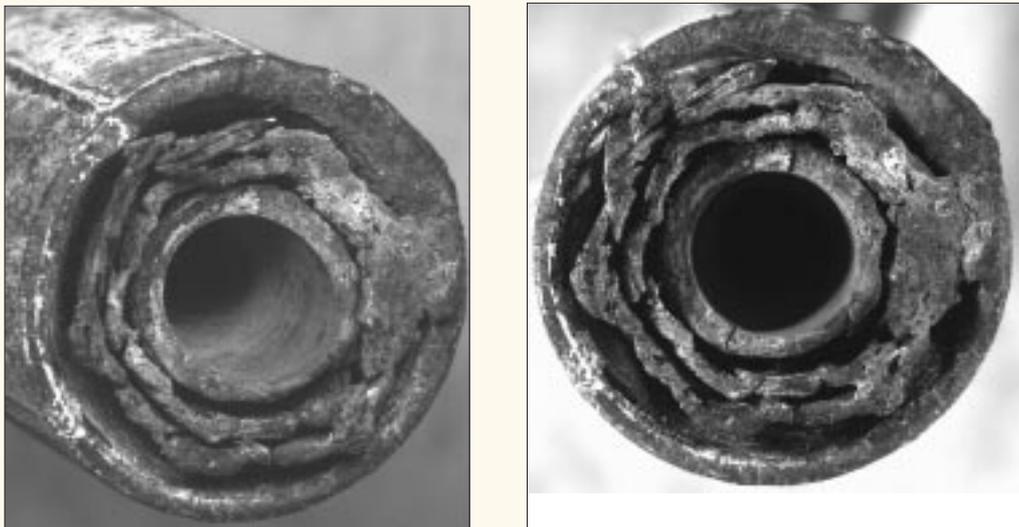
**Figure 13:** Two views of the end of the hose fitting at the regulator end of the hose. Melting and burning of the hose tail, braiding, and the end of the ferrule can be seen.

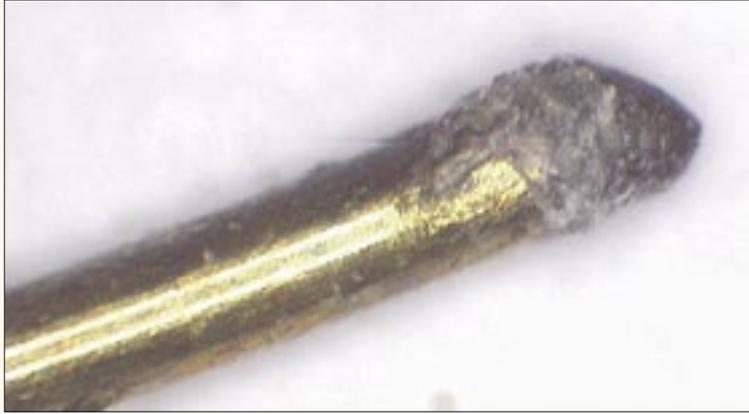
One of the pieces of wire found in the neck of the person who had just turned on the oxygen system was examined. An end of this wire shown in fig. 14 appeared to be melted. The wire was found, when compared to a similar hose from the same manufacture, to be typical of the type of wire used to make the flexible oxygen hose braiding: this included the light-gold appearance of the surface of the wire.

**Figure 14:** The end of a piece of wire found in the neck of the person who had just turned on the fixed oxygen system at the time of the ignition. This end of the wire appears to show evidence of slight melting. The wire was found to be typical of the type of wire used to make the flexible oxygen hose braiding.

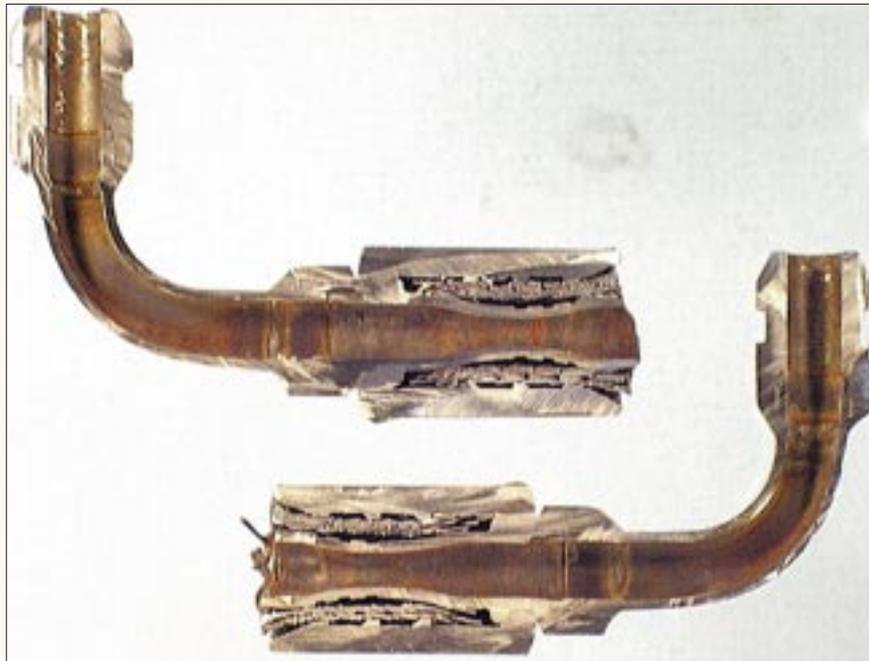
Sectioning the end fittings revealed that the ‘hose tails’ had been partially crushed as a result of the swaging process. At the regulator end of the hose, this crushing had resulted in the 7.1 mm ID ‘hose tail’ being reduced in ID to about 4 mm, in a smooth venturi-like manner (fig. 15). Discussions with the manufacturer indicated that this was not unexpected, the level of crush being an indicator of the effectiveness of the swaging process. Measurements of the final swaged diameter of the ferrules (20.5 mm for the regulator end and 20.8 mm for the gauge end) indicated that they were within the manufacturer’s limits for the type of swaging machine used. An examination of an end fitting from the hose supplied for comparison purposes found that this hose tail was not notably crushed, although in this case the ferrule had been swaged on with a six-jaw chuck.

**Figure 15:** A section through the regulator end of the hose tail showing the reduction in the internal diameter caused by crushing the ‘hose tail’ during the swaging operation.

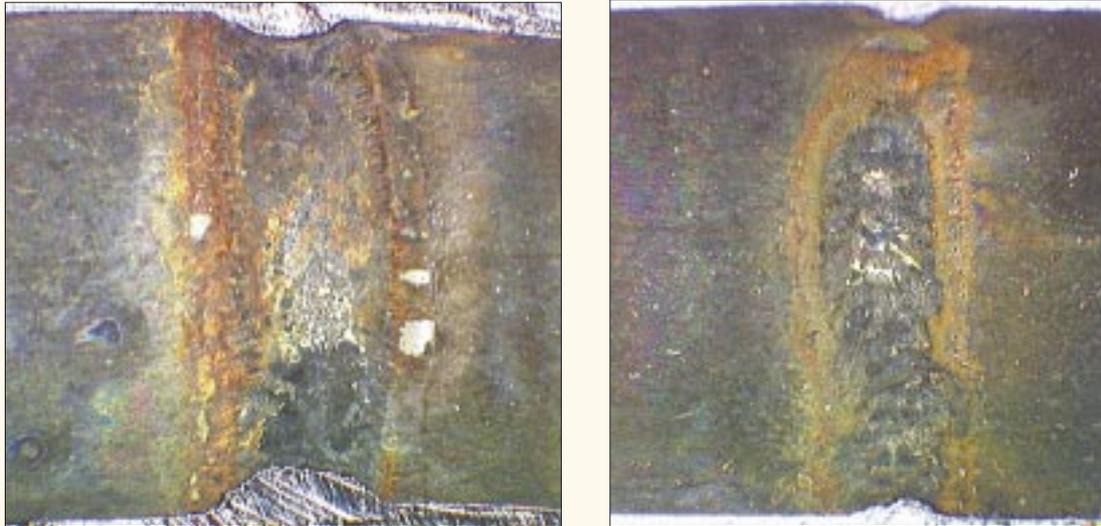
The internal surfaces of the hose end fitting, regulator end, and the elbow were coated with a thick layer of oxide. This oxide was considerably thicker on the inner surfaces of the welds that connected the elbow to its fittings. The thickness of the coating in these areas strongly suggested that they were oxidised prior to the fire as a result of a lack of gas shielding during the welding operation. Several chips (fig. 16) of the oxide from the welded regions had become dislodged, entering the gas stream. It is not known if these chips became dislodged before, during or after the fire.

**Figure 16:** The inner weld surfaces of the elbow showing the thick oxide build-up in these regions. Note that several small regions of the oxide have become detached (cleaner areas).
