ATSB TRANSPORT SAFETY INVESTIGATION REPORT

Aviation Occurrence Investigation – AO-2008-007

Hard landing – Darwin Airport, NT

VH-NXE

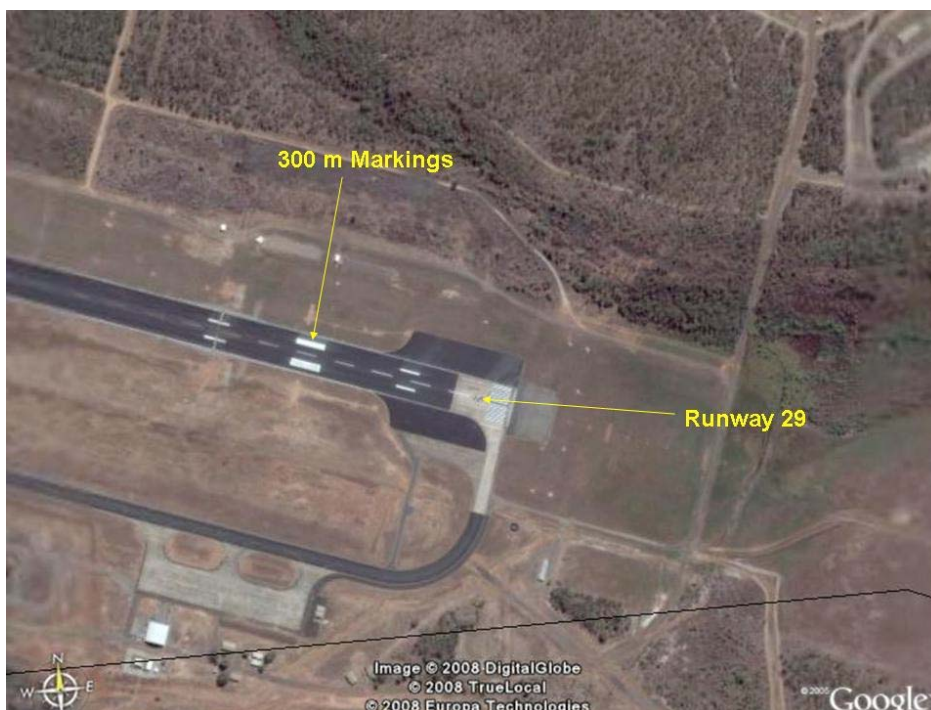
Figure 2: Darwin Runway 29 touchdown markings and environs

At 2114:50, the aircraft touched down with a rate of descent of about 1,000 ft/min, which resulted in a hard impact with the runway prior to the 300 m runway markings (Figure 2). The aircraft then bounced before settling onto the runway. The crew completed the landing rollout and taxied the aircraft to the terminal.

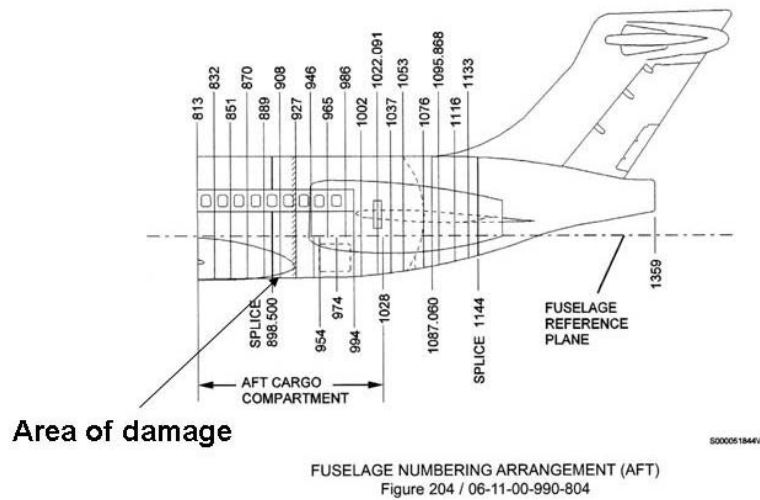
Figure 3: Aircraft dimensions showing area of damage

Damage to the aircraft included several creases to the skin on the fuselage above the wing area and underneath the fuselage behind the wing (Figures 3 and 4). Several longerons⁵ in the rear cargo area were damaged. The left main landing gear and the outer left main tyre were also damaged.

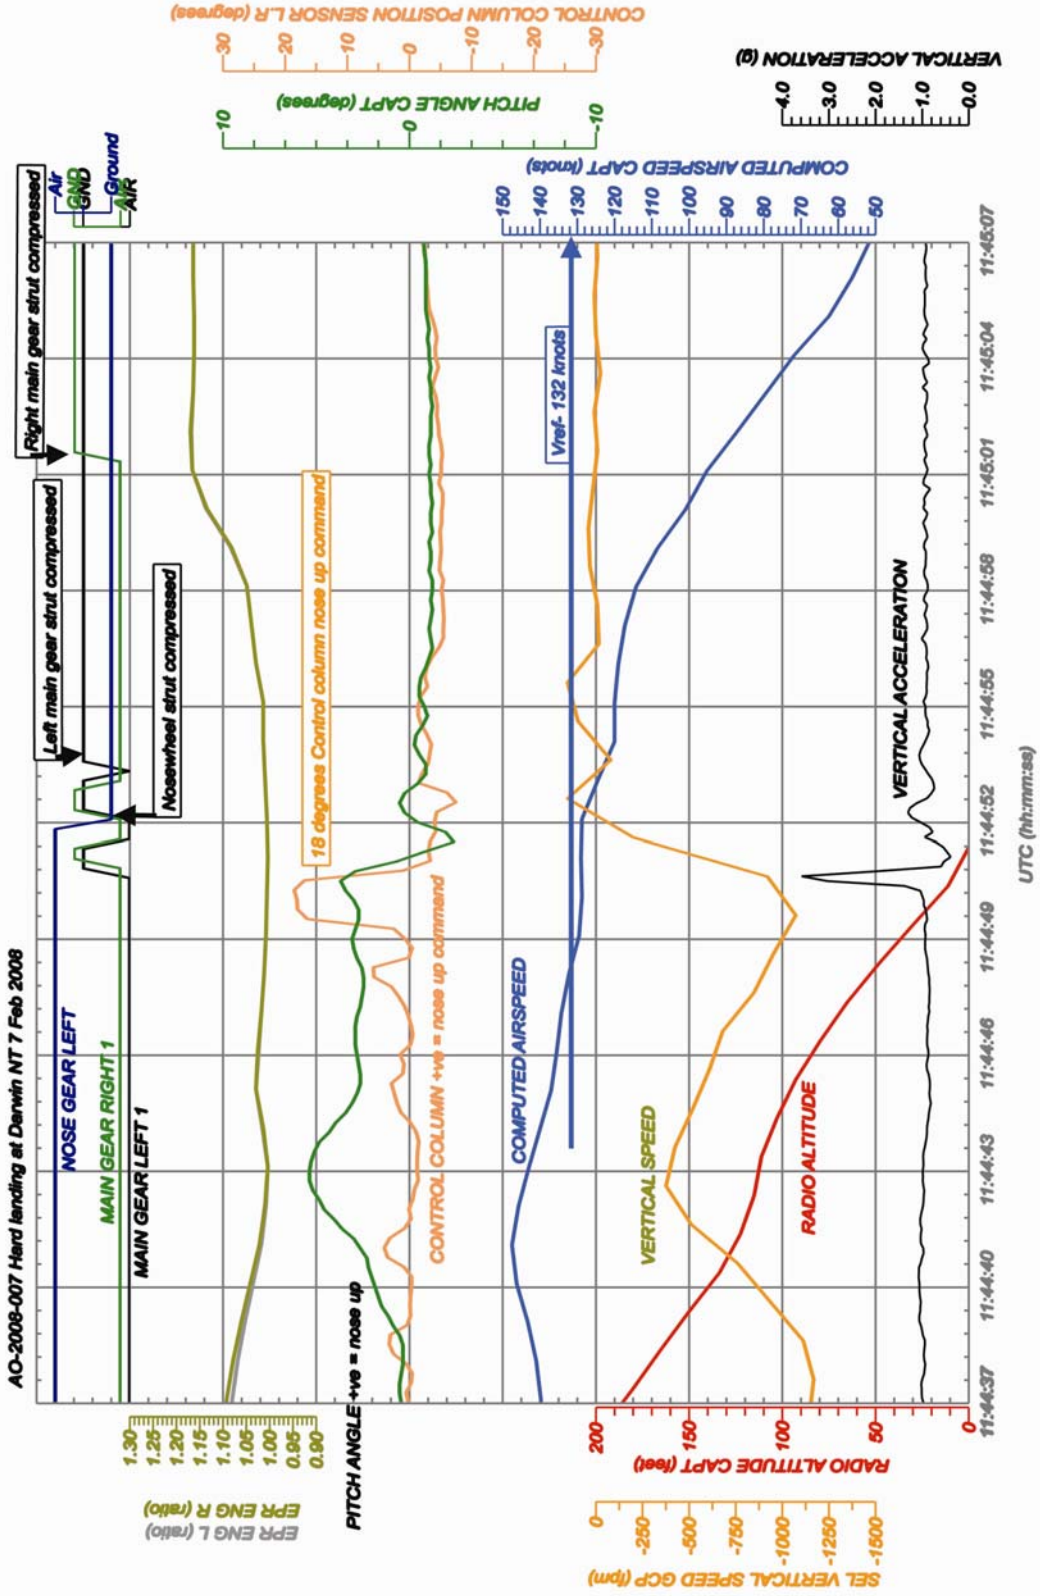
APPENDIX A : FLIGHT RECORDER DATA

The FDR information at Appendix A displays the aircraft's flight path parameters from a radio altitude of 180 ft to after touchdown.

At approximately 30 ft radio altitude, the FDR recorded a rate of descent of approximately 1,000 ft/min at the same time as an abrupt control column nose up command was applied. The copilot recalled hearing the synthesised calls of radio altitude from the aircraft's radar altimeter.
