**ATSB TRANSPORT SAFETY INVESTIGATION REPORT**

Aviation Occurrence Report – 200505683

**Loss of Pressurisation  
15 km north-west of Jindabyne, NSW  
9 November 2005  
VH-VBI  
Boeing Company 737-7Q8**

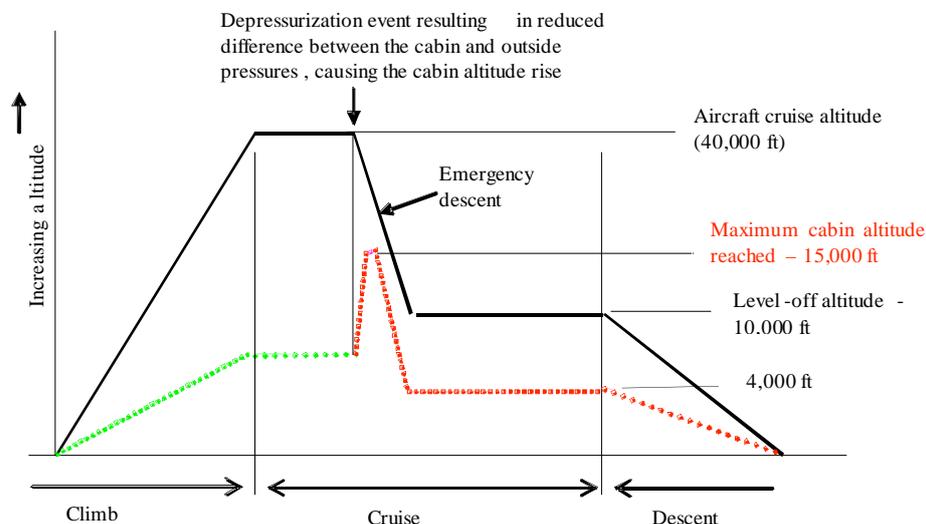
**Figure 2: Cabin and outside pressures during the depressurisation event**

difference in the cabin and outside pressures for the 737 during the occurrence is depicted below (figure 2).

The operator forwarded both valves to their manufacturer in the US for testing and examination. The tests confirmed that both valves were out of adjustment and operated at less pressure than required. The manufacturer confirmed that the amount of maladjustment would cause the cabin altitude to climb above 10,000 ft as experienced during the event. The manufacturer advised that both valve serial numbers were in the range of some other units manufactured in early 2002 that had experienced contaminations in their control mechanisms, causing a calibration shift. No contamination was found within the control mechanisms of either valve. The manufacturer could not confirm that contamination was the cause of the valve maladjustment or provide any other explanation for the calibration shift. The manufacturer advised that the contamination problem had been addressed and that no problems had been observed since that time.

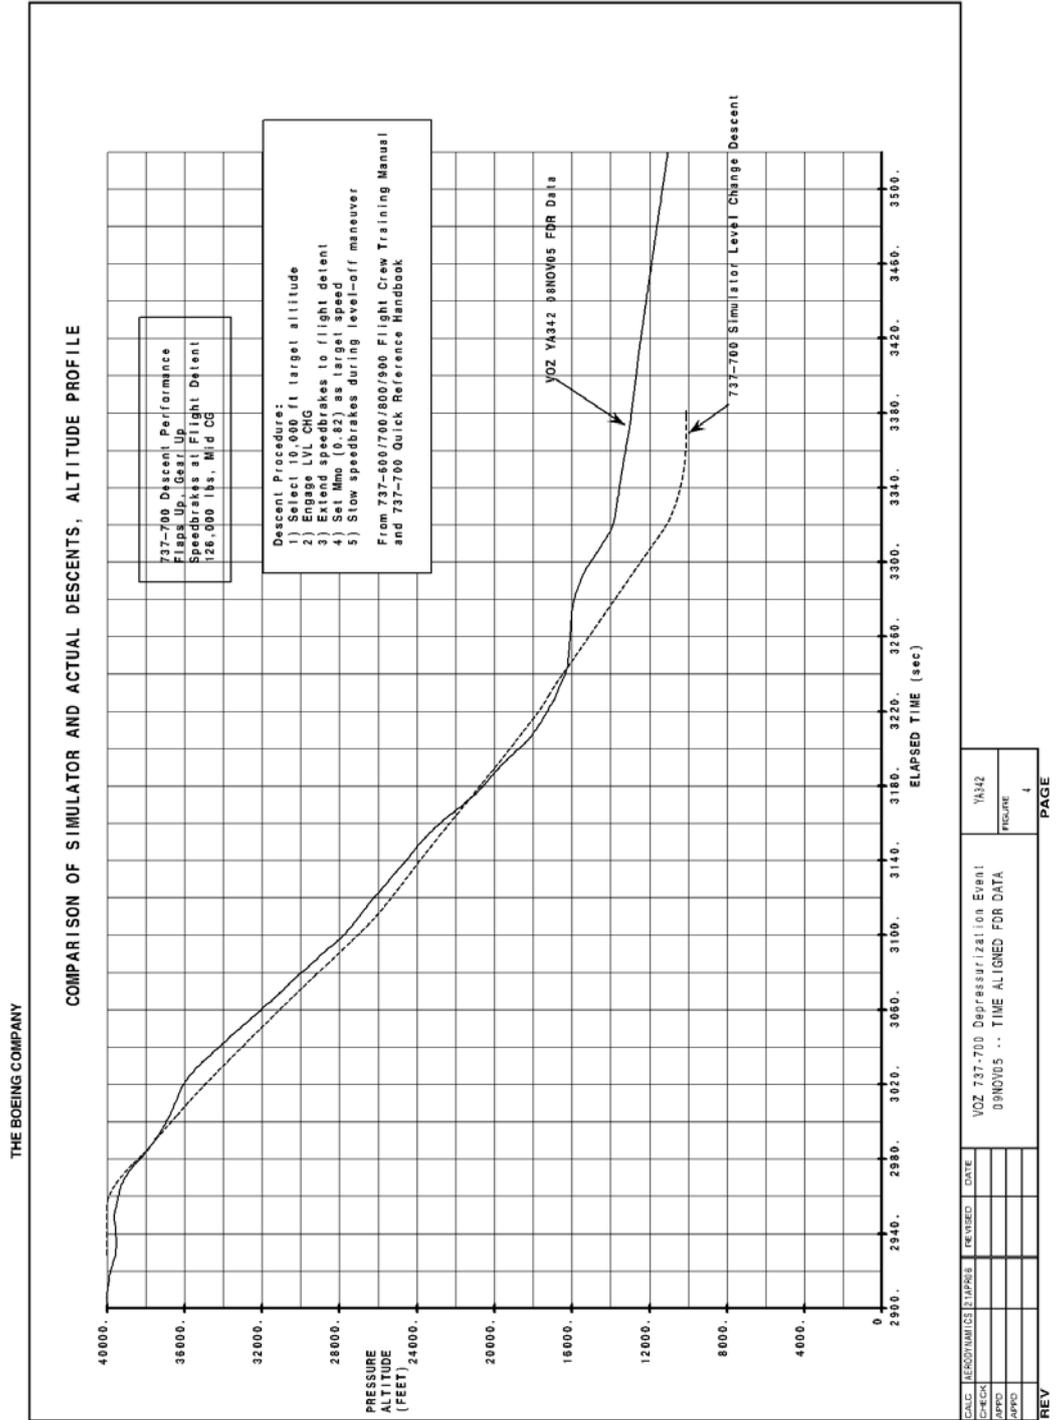
## Manufacturer simulator comparisons

The simulator data was derived by following the procedure outlined above. The comparison of the simulator and actual descent profiles indicated that FL380 was reached at about the same time. From that point the simulator descent reached lower levels approximately 10 seconds before the actual descent until FL210. At that level the actual profile went below the simulator profile until FL160 when the pilot elected to reduce the rate of descent. From this point on, the two profiles diverged. The simulator profile reached 10,000 ft approximately 7 minutes after the descent was commenced. This was 4 minutes earlier than during the actual descent (see Appendix B).
