ATSB TRANSPORT SAFETY INVESTIGATION REPORT
 Rail Occurrence Investigation No. 2007/002
 Final

Level Crossing Accident – Chapple Street, Kalgoorlie (WA)

14 May 2007

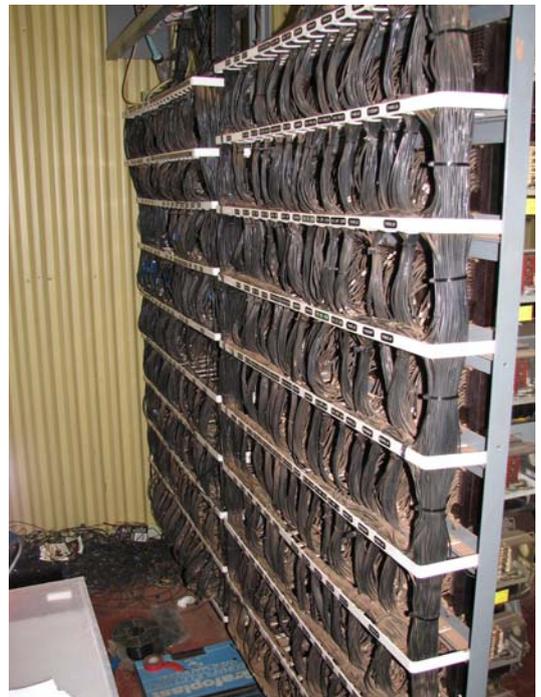
Figure 2: Chapple Street relay room, wiring rack

The examination of this material and an inspection of the Chapple Street location/relay room established that a temporary wiring strap had unintentionally been left in situ while making wiring alterations. The wiring strap had by-passed the normal function of the level crossing circuit which caused the boom gates to remain in the vertical position and prevented the flashing lights and bells from operating for the passage of train 2478.

The wiring strap used to by-pass the operation of the Chapple Street level crossing was a distinct colour (orange) as mandated in WNR procedures and should have been clearly visible against the black wiring of the relay rack. WNR procedures specifically recognise the risk associated with using temporary wiring straps and mandate the need to account for and remove them at the completion of the works.

Both the engineer and technician were well aware of this requirement yet in their haste to prevent road traffic delays¹⁰ failed to record the use of the strap as required.

As a result of this action they overlooked the use of wiring strap at the conclusion of the day's work. Had they recorded the use of the wiring strap (and counted/accounted for them as per the procedures) it is probable that the oversight would not have occurred.
