Australian Transport Safety Bureau

INVESTIGATION REPORT

BO/200000492

# **One-engine inoperative training – failure to achieve predicted performance**

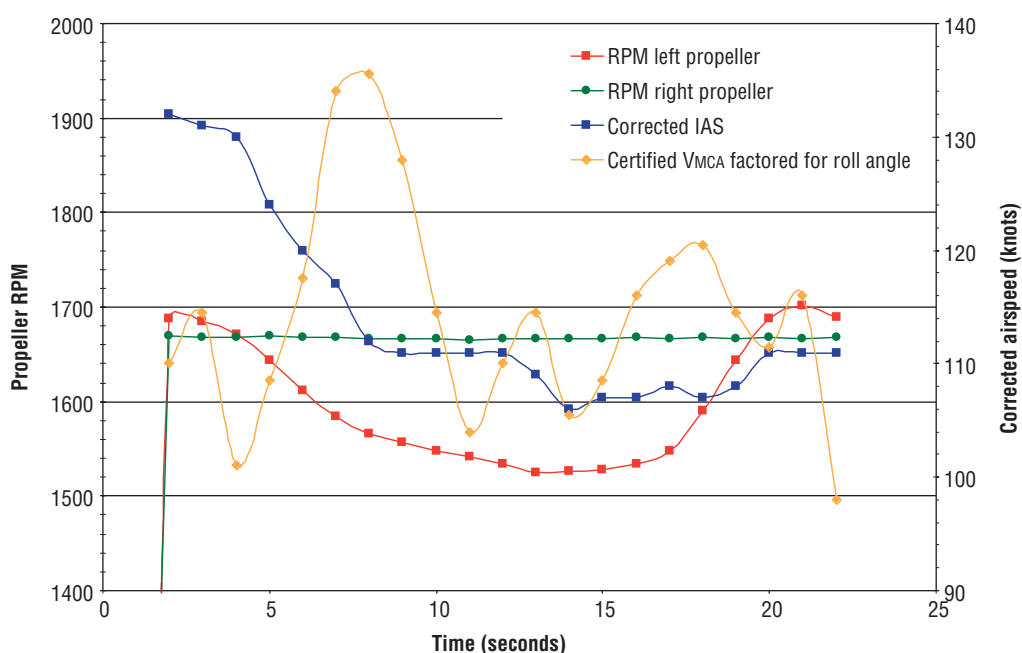
**Chart 1:**  
**VH-NTL relationship between propeller RPM and airspeed**

During the sequence, the left propeller RPM reduced by about 160 RPM. The lowest propeller RPM was coincident with the lowest recorded airspeed. The handling pilot regained normal control 21 seconds after takeoff when the left engine torque was increased to 232 ft-lbs and the propeller had returned to the governing range. The relationship between the left propeller RPM and airspeed is shown in Chart 1 below.

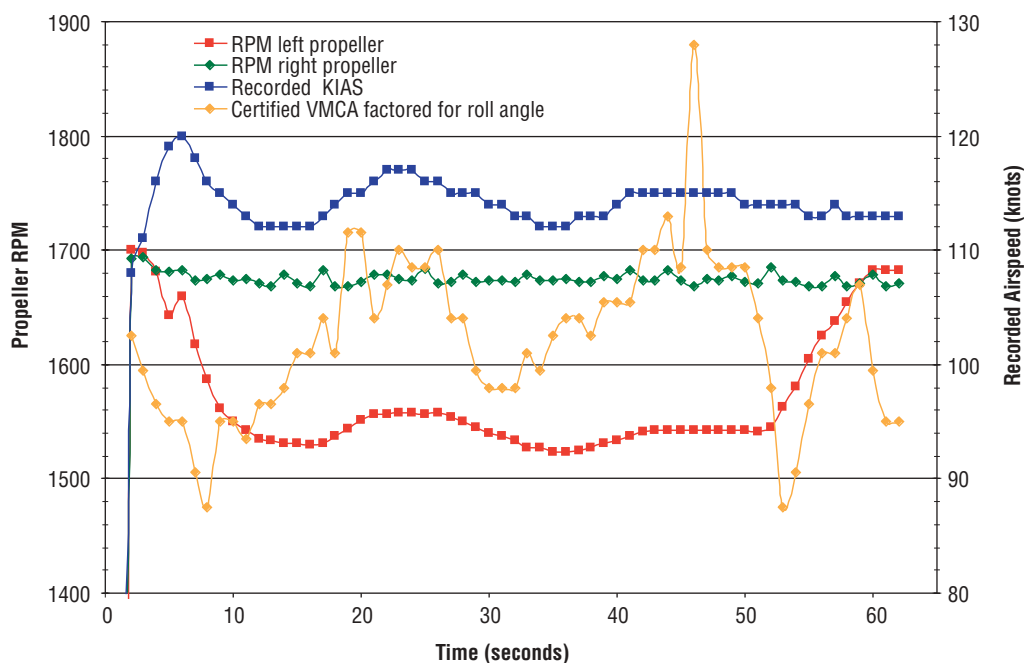
**Chart 2:**  
**VH-FOZ relationship between propeller RPM and airspeed**

During the test flight sequence the highest recorded value for the left propeller was 1,700 RPM, and the lowest recorded value was 1,524 RPM. The lowest propeller RPM was coincident with the lowest recorded airspeed of 112 KIAS. The relationship between the left propeller RPM and airspeed is shown in Chart 2 below.

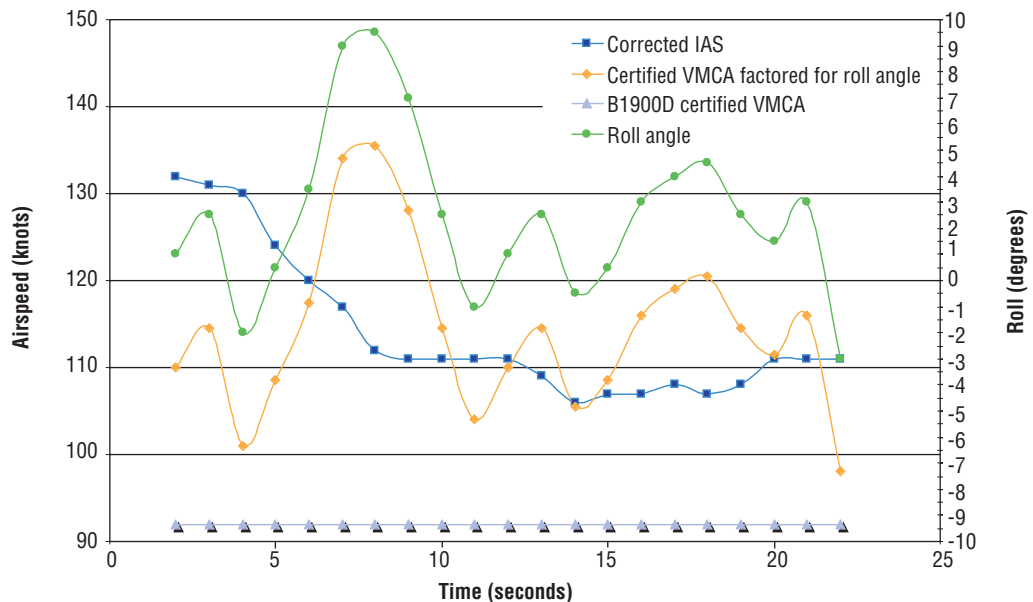
**Chart 3:**  
**Relationship between roll angle and  $V_{MCA}$**

The relationship between roll angle and certified  $V_{MCA}$  for the occurrence take-off sequence is shown in Chart 3 below. The speed at which the aircraft was operating was below the certified  $V_{MCA}$  factored for bank angle of less than five degrees at certain stages during that sequence.

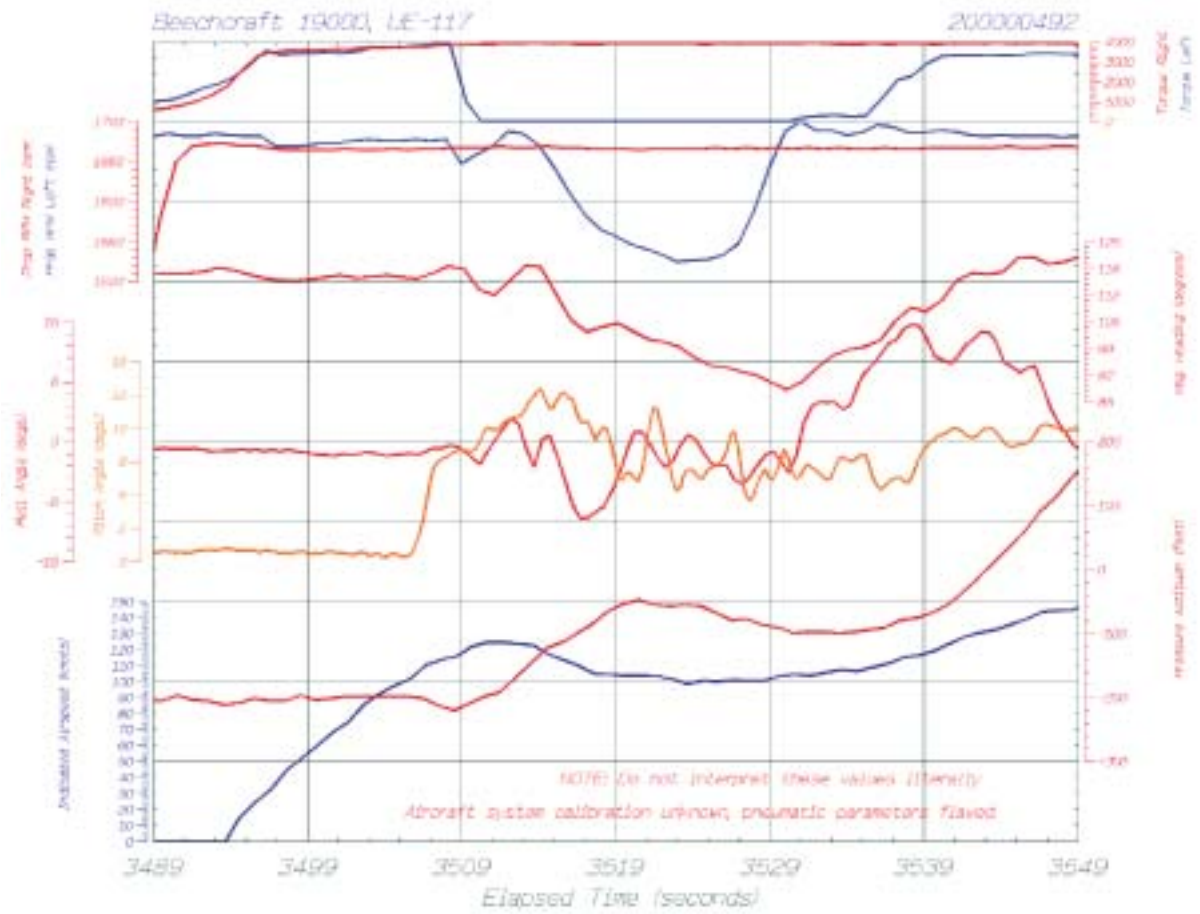
## Attachement A – Take-off sequence SSFDR data plots for VH-NTL

In the 21 seconds following the simulated failure of the left engine, the aircraft heading decreased from 112 degrees magnetic to 088 degrees. The heading change was in excess of the operator's permitted one-engine inoperative heading flight tolerance. However, the rate of heading change was not constant. In the three seconds following simulated failure of the left engine, the aircraft heading increased from 112 degrees magnetic to 119 degrees. This equated to a yaw rate of 2.3 degrees per second towards the operative engine. In that same period, the aircraft nose-up pitch increased from 10.3 degrees to 12.3 degrees. In the next 18 seconds, the aircraft heading decreased from 119 degrees magnetic to 090 degrees, equating to a yaw rate of 1.6 degrees per second towards the inoperative engine. In the same period, the aircraft nose-up pitch decreased from 12.3 degrees to seven degrees, however, the change in pitch attitude was not constant.

The pitch plot showed that significant variation in nose-up pitch occurred during the take-off sequence. In the five seconds following the simulated failure of the left engine, aircraft nose-up pitch was increased from 10.3 degrees to 12.5 degrees. During the next four seconds it reduced to 6.5 degrees, then increased to 10.8 degrees in the next two seconds. Pitch variations continued throughout the sequence until power was restored on the left engine and control of the aircraft regained.

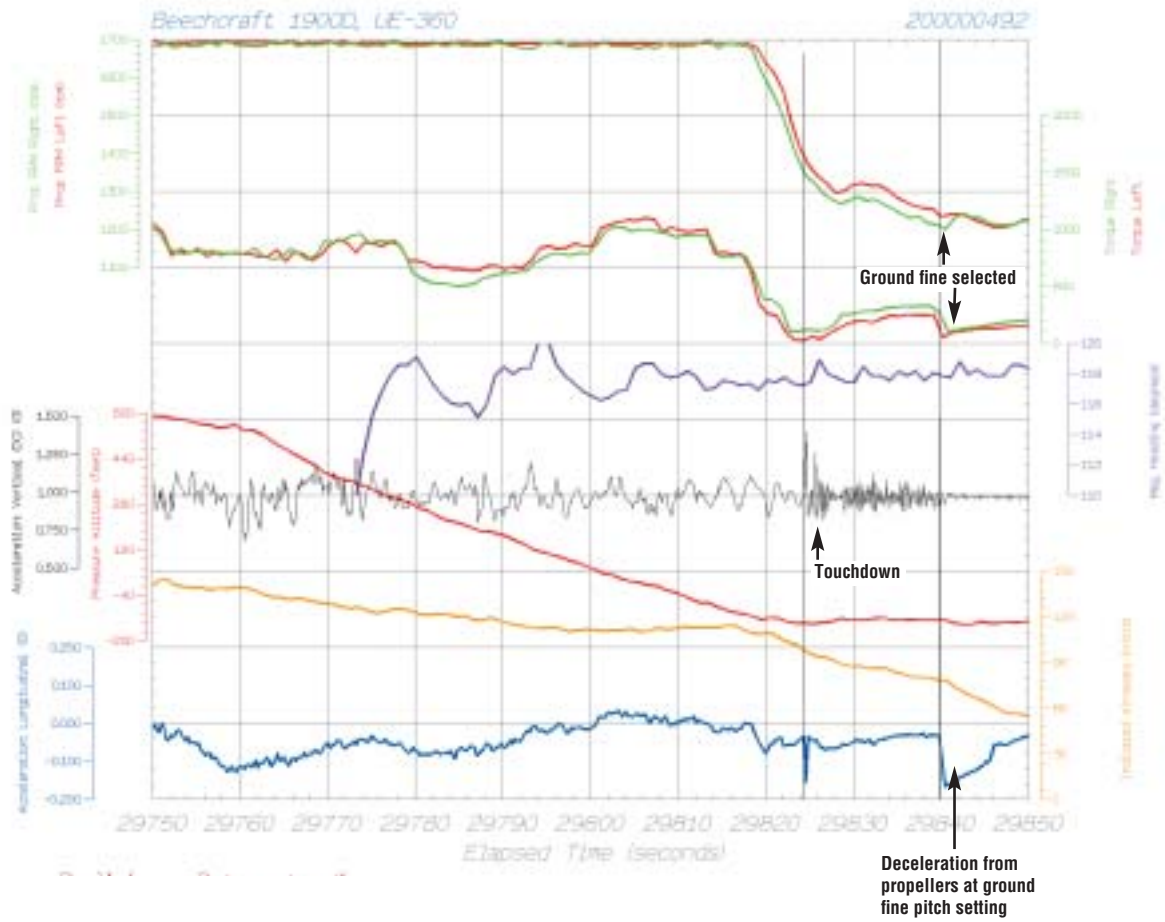
# Attachment G – Test flight landing sequence for VH-FOZ

Attachment G shows the SSFDR data plots of the test flight landing sequence. Touchdown occurred at about timeframe 29824, and is evidenced by the oscillation of the vertical acceleration parameter. Ground fine pitch was selected at about timeframe 29840, and is evidenced by transient variations in the propeller RPM and engine torque parameters. The transition of both propellers from ground idle to ground fine is evidenced by the rapid reduction in longitudinal acceleration at timeframe 29840.
