**ATSB TRANSPORT SAFETY REPORT**  
Aviation Occurrence Investigation  
AO-2008-064  
Final

**Stickshaker activation**  
**Boeing 717-200, VH-NXE**  
**Alice Springs, NT**  
**18 September 2008**

Stickshaker activation – Boeing 717-200, VH-NXE, Alice Springs, NT, 18 September 2008

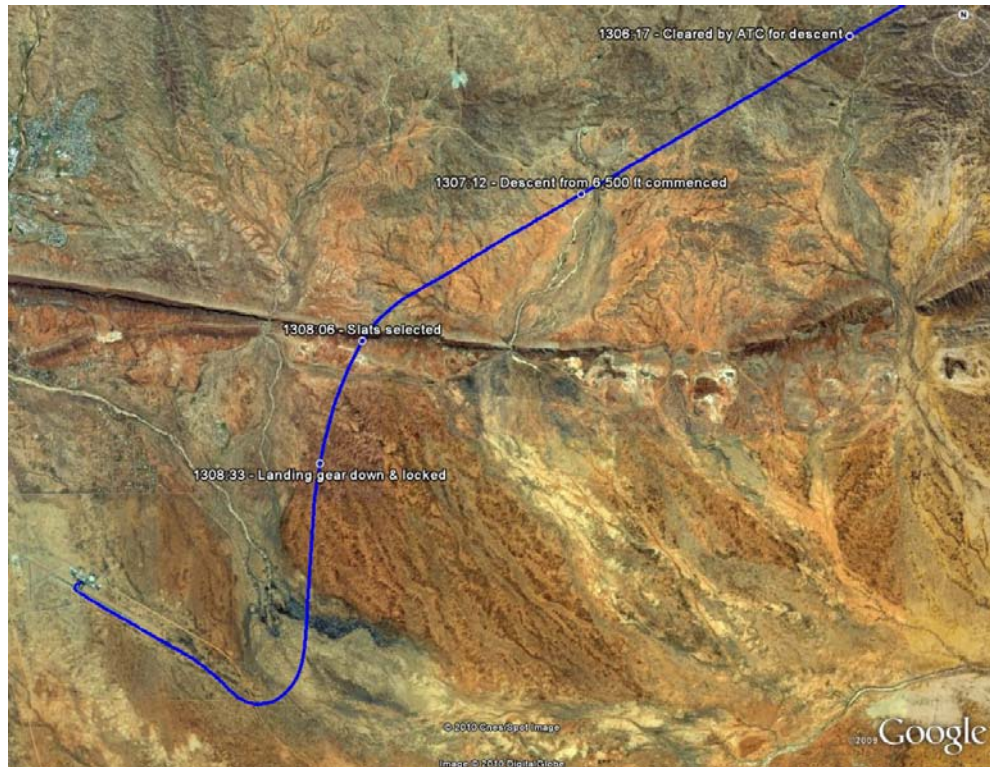
**Figure 1: Initial approach track**

The PIC recounted that due to being high on profile, he disconnected the autothrottle<sup>7</sup> and reduced engine thrust. The recorded N1<sup>8</sup> correspondingly reduced from 66% to 28% and the aircraft's spoilers<sup>9</sup> were deployed for 45 seconds. The PIC's recollection was that at some point, PROF<sup>10</sup> was selected on the FCP, which should have reengaged the autothrottle.

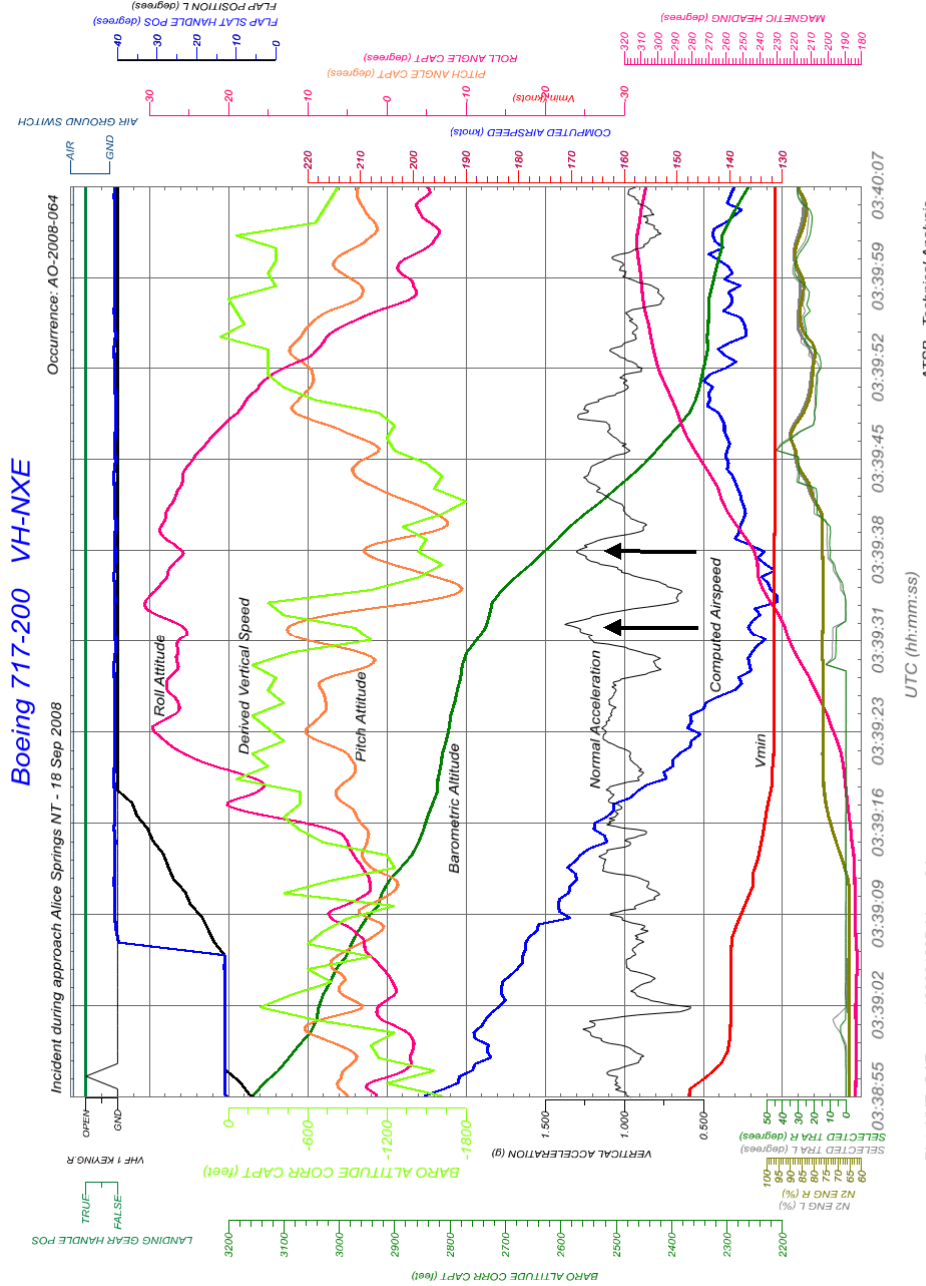
# APPENDIX A: DATA PLOT

Analysis of the recorded data showed that at 1309:32, the stickshaker activated as the aircraft was passing 950 ft AAL on a heading of 223° magnetic (M) with a recorded bank angle of 28° and airspeed of 135 kts. Following the stickshaker activation, the recorded pitch angle decreased from an average 6° to -4° with no immediate recorded throttle movement and no increase in the N1 value, which was then about 36%. At 1309:35, the airspeed had reduced to a recorded value of 131 kts with a bank angle of 30°.

The flight crew reported that shortly after the first stickshaker activation, the stickshaker momentarily activated again. Correspondingly, the data showed that at 1309:38, the stickshaker activated again as the aircraft was passing 850 ft AAL with a recorded bank angle of 27° and airspeed of 134 kts. The recorded pitch angle was 0° and the rate of descent was 1,800 ft/min. The nose was lowered again and the recorded airspeed increased to vary between 140 and 145 kts. Shortly after, the recorded throttle position increased and N1 reached a high of about 76%.
