ATSB TRANSPORT SAFETY INVESTIGATION REPORT

Technical Analysis 23/2006

High Pressure Turbine Blade Fracture

CFM56-3C1

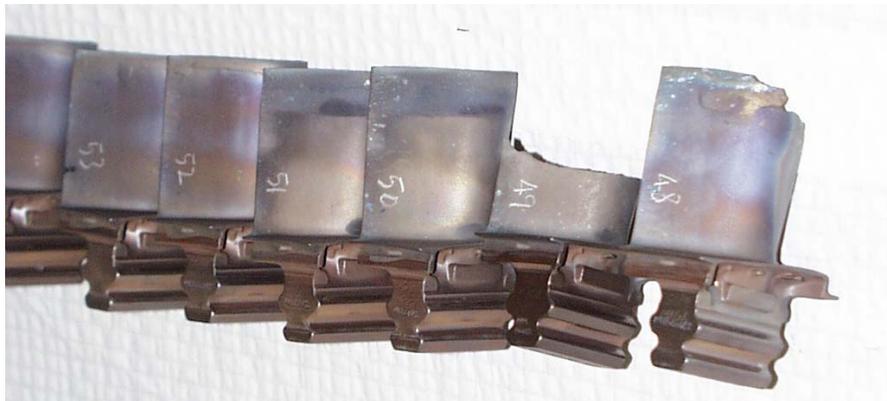
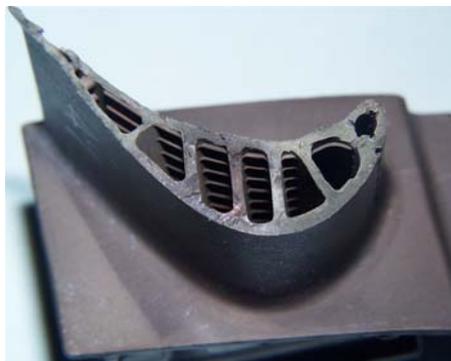
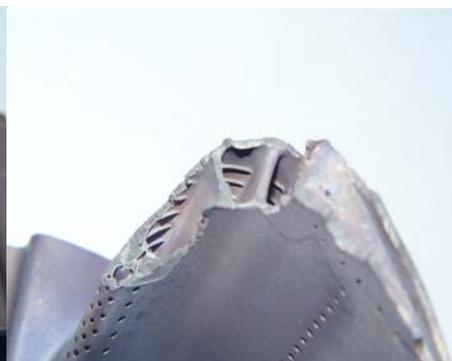
Figure 1: The damaged blades among the HPT blade set removed from engine 725274 (Operator photographs)

Blade 49 (s/n GSH81)

Blade 48 (s/n 331R5)

Examination of the blades revealed that blade s/n GSH81 (no. 49) fractured through the blade airfoil section as a result of fatigue crack growth. Fatigue cracking initiated from a planar defect in the fourth internal rib (ribs numbered from the leading edge), see figures 2 and 3. The loss of material from the leading edge of the adjacent blade (blade s/n 331R5, no. 48) was clearly a secondary event.

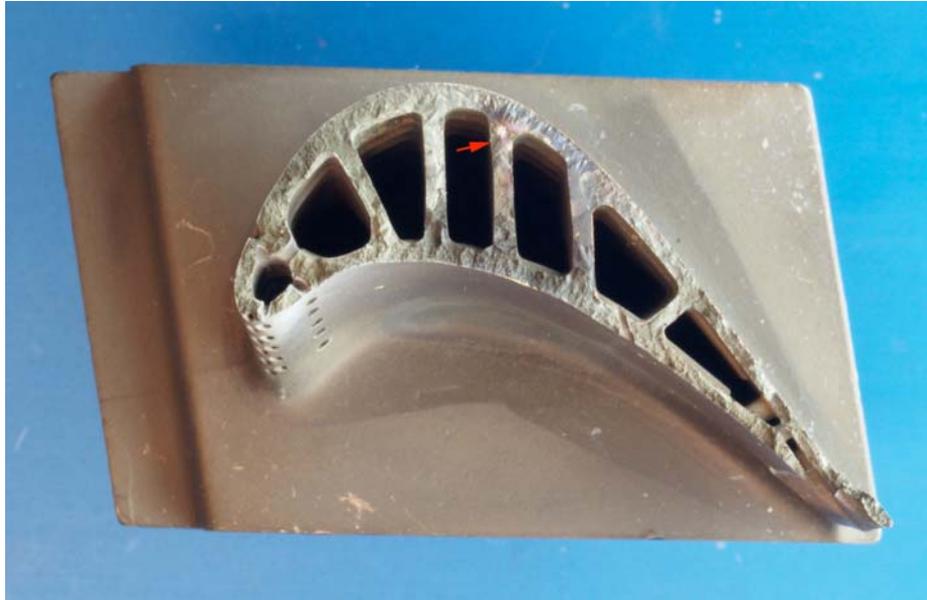
Figure 2: Blade GSH81 fracture

The site of fatigue initiation is arrowed

The fracture of high pressure turbine (HPT) blade p/n 1475M35P01, s/n GSH81, occurred as a result of intergranular oxidation at the surface of the fourth internal rib and subsequent fatigue crack propagation.

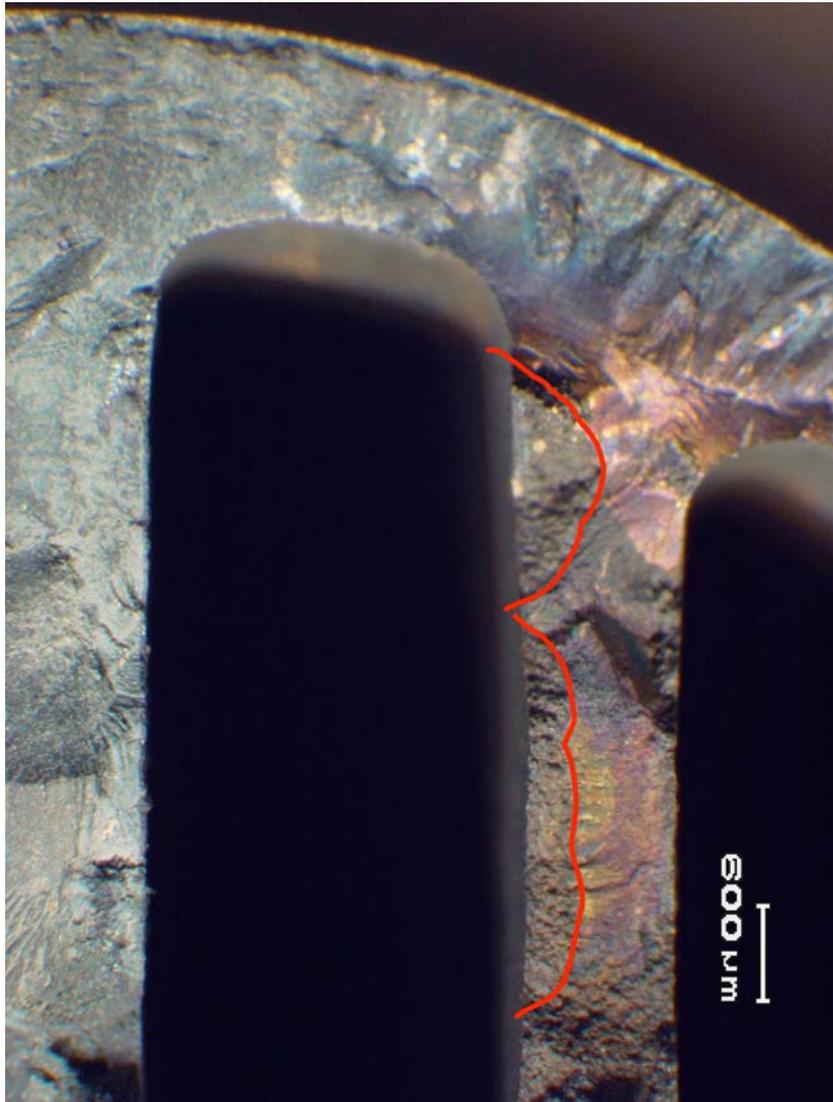
Figure 3: Photomicrograph of the planar defect at the site of fatigue crack initiation

The extent of the planar defect extending from the face of the fourth internal rib is delineated, approximately, by the red line.

Destructive examination of blade s/n GSH81 was conducted by GE. Metallographic sectioning and examination of the region associated with the planar defect provided evidence that the mechanism of defect formation was intergranular oxidation.

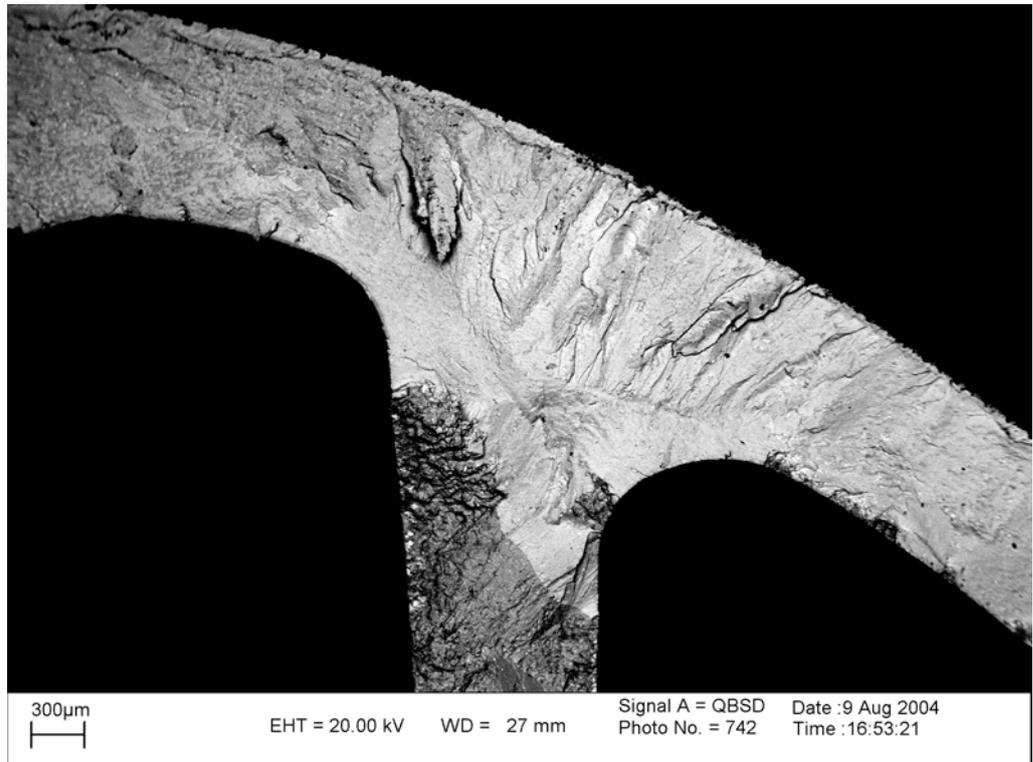
Figure 4: Scanning electron micrograph showing the differences in the fracture surface morphology between the planar defect and the fatigue crack surface

Scanning electron microscopy revealed that the ‘planar defect’ exhibited a more heavily oxidised surface when compared to the region of fatigue crack growth, see figures 4 and 5.

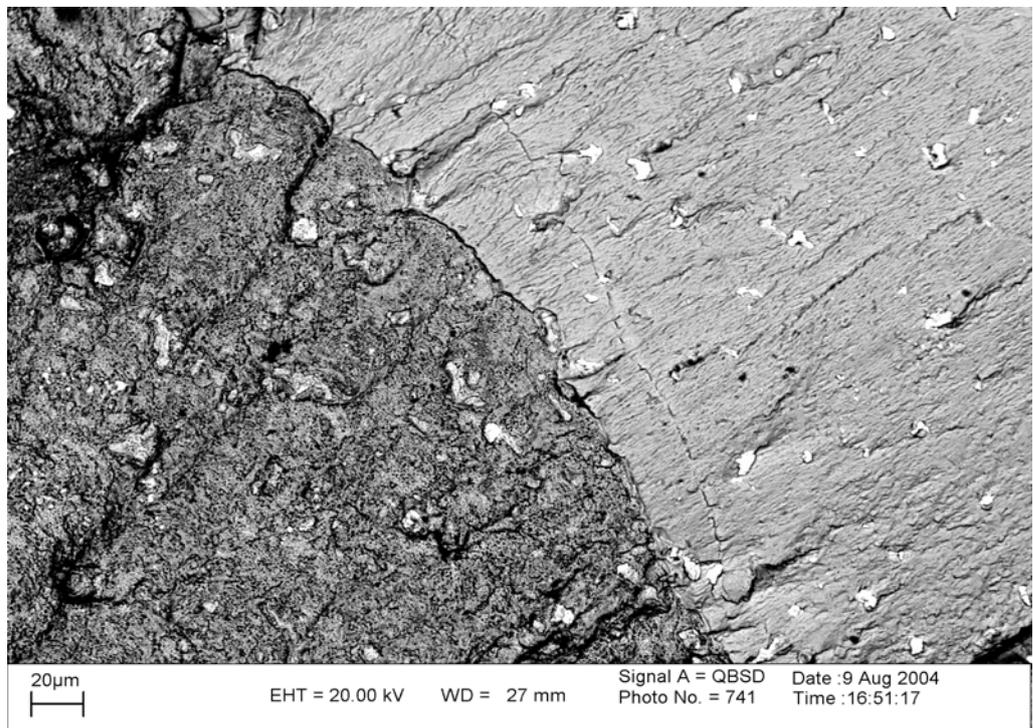
Figure 5: Detailed view of the boundary between the planar defect and fatigue cracking

The region of fatigue crack propagation is to the right
