ATSB TRANSPORT SAFETY REPORT

AVIATION OCCURRENCE INVESTIGATION AO-2009-026

Fuel starvation event, VH-JTI

Coomera, Queensland

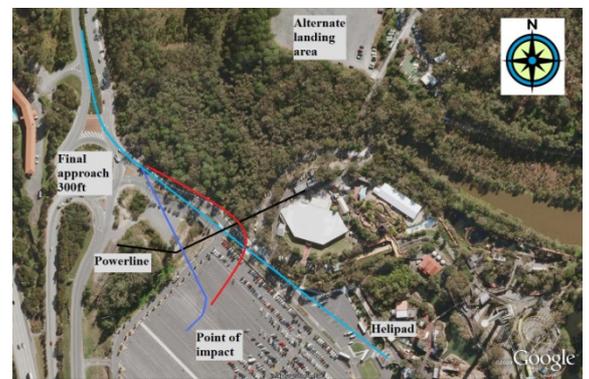
The pilot recalled deciding that a forced landing (autorotation)³ at the entertainment facility helipad would not be possible and elected to use the adjacent car park instead because of its open space (Figure 2). During the autorotation, the pilot had to alter his flightpath to avoid a powerline. The pilot stated that this required a higher collective⁴ setting than would normally be used in autorotation, contributing to the main rotor speed reducing to about 74%. In consequence, he was unable to reduce the helicopter's rate of descent sufficiently before touchdown and the helicopter impacted the ground heavily.

Figure 2: Overview of the landing area showing the normal (in sky blue) and intended approach (in red), and actual autorotation (in darker blue) flightpaths

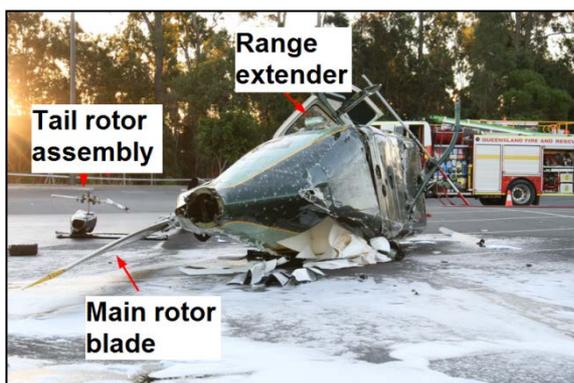
Figure 3: Wreckage site

There was substantial damage to the underside of the helicopter's fuselage, cockpit plexiglass, skid-landing gear, transmission deck, tail boom, and tail rotor gearbox (Figure 3).

The fuel tank was punctured by the skid-landing gear rear crosstube, which was driven up through the fuselage by vertical deceleration forces. The main rotor blades were slightly damaged. Examination of the wreckage confirmed that all of the damage was the result of impact forces.

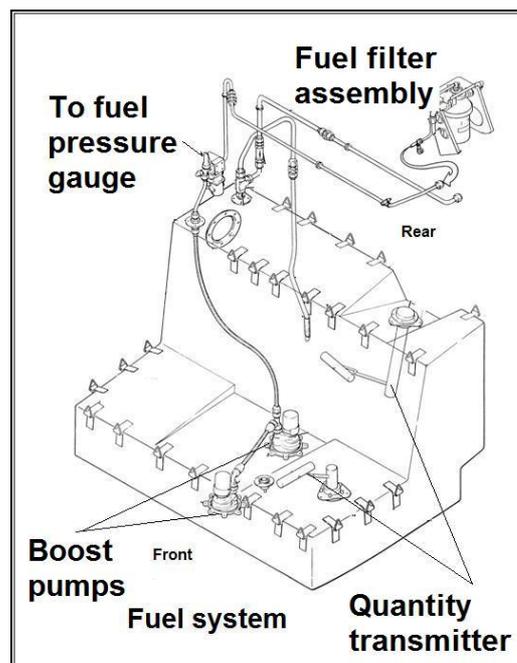
Figure 4: Fuel system

contents in the upper (vertical) section of the tank, while the lower float sensor measured the fuel in the lower (horizontal) section of the tank (Figure 4). The fuel quantity gauge displayed the sum of these two fuel quantity measurements.

Fuel was pumped to the engine by two submerged electric fuel boost pumps that were fitted to the bottom of the fuel tank, one behind the other as shown in Figure 4. The boost pumps supplied fuel to the engine-driven fuel pump under positive pressure. If either electric fuel boost pump failed, or if a pump's intake became uncovered, a pressure sensor on the combined pump outlet would detect the resulting loss of fuel pressure, causing the FUEL PUMP warning light to illuminate on the annunciator panel in the cockpit.

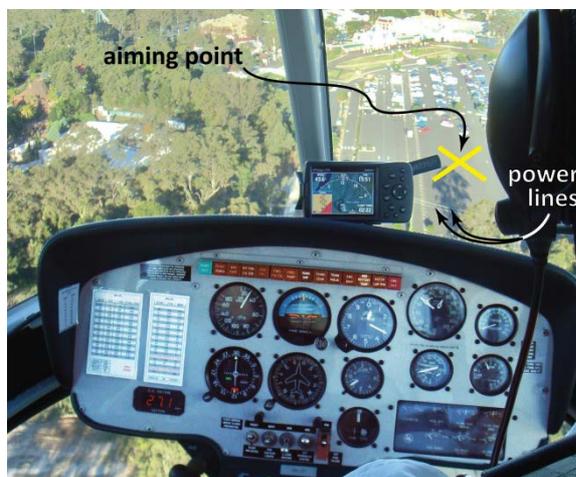
Figure 5: Forward view from the rear seat at 300 ft during the autorotation

The passenger who was located in the centre rear seat took a number of photographs during the flight. One of those photographs, which was taken when the helicopter was at 600 ft AGL on descent to the helipad, showed the fuel gauge reading about 9 USG (34 L). Another, which was taken about 30 seconds later at 300 AGL and just after the engine lost power, showed the helicopter's instrument panel, the powerlines, and the pilot's intended forced landing area (Figure 5). The instrument readings at that time are listed in Table 3.

Time	15:51
Global Positioning System (GPS) heading	121 °M
GPS speed	43.6 kts
Airspeed	30 kts
Altitude	300 ft
Power turbine speed	47 %
Rotor RPM (Nr)	74 %
Engine torque	0 psi
Rate of descent	800 ft/min
Compressor turbine speed (N1)	26 %
Compressor turbine outlet temperature	220 °C
Fuel quantity	9 USG (34 L)
