AVIATION SAFETY INVESTIGATION REPORT  
200203449

## Flying training accident at Moorabbin

Cessna 172R, VH-CNW  
Cessna 172R, VH-EUH  
29 July 2002

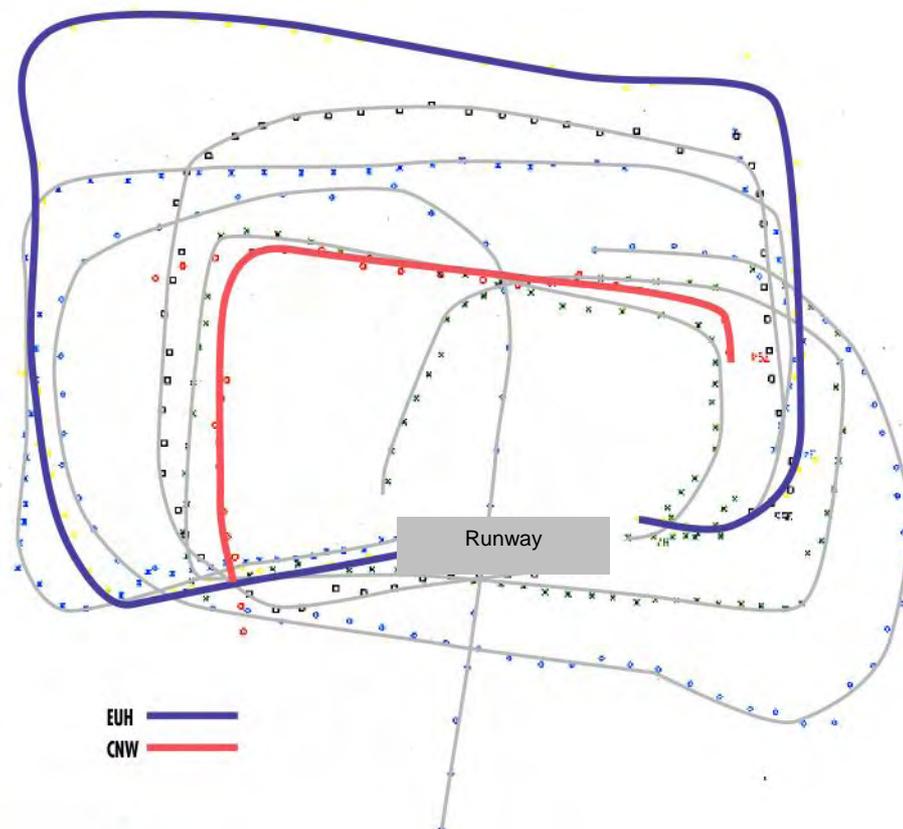
Radar data indicated that the pilots of EUH conducted a wider circuit than the pilot of CNW. The EUH circuit would have taken approximately 7 minutes to complete, whereas the pilot of CNW conducted a circuit that would have taken approximately 4.5 minutes to complete. Both circuit dimensions were within the range of circuit dimensions that were being conducted by other pilots at the time. Figure 2 shows the circuit patterns of the two accident aircraft, and the circuit patterns of the other aircraft that were operating in the circuit at the time of the accident.

**Figure 2: Radar plot of aircraft in the Moorabbin circuit between 1830 and 1845 on 29 July 2002 (the radar tracks of some aircraft not considered significant to the sequence of events are not depicted).**

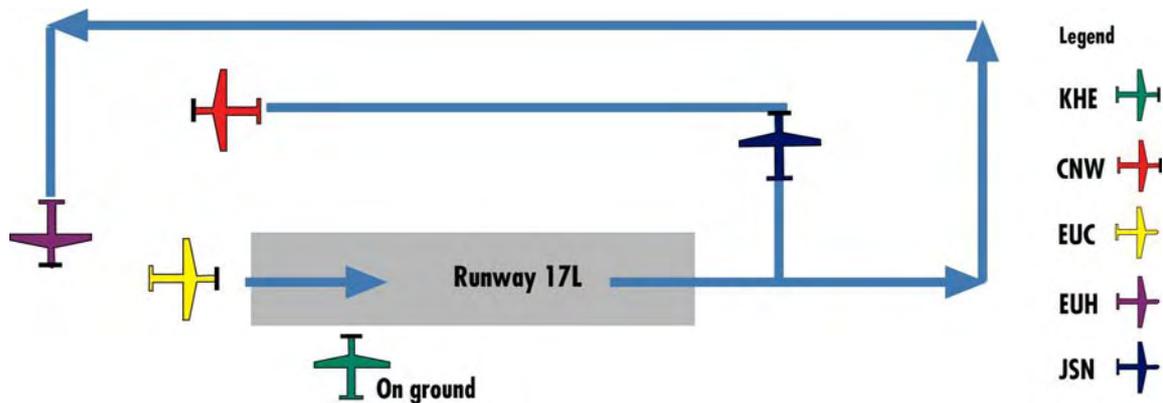
**Figure 4**  
**Depiction of aircraft locations before CNW turned onto base leg.**

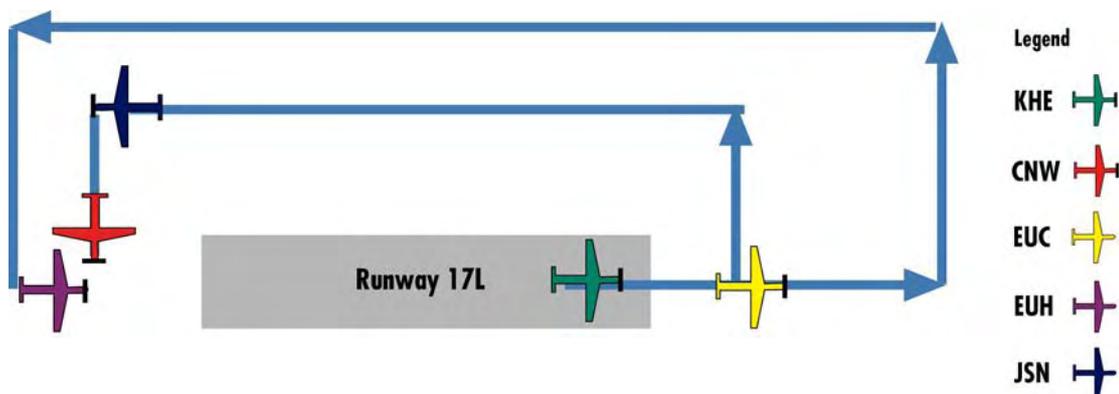
The pilot of CNW commenced the turn onto the final approach approximately 50 seconds later. At about that time EUC was airborne and on the upwind leg following the touch-and-go landing, and another Cessna 172, VH-KHE, was on the runway and had commenced a take-off roll. Those locations are shown in figure 5.

**Figure 5: Depiction of aircraft locations before CNW turned onto final approach.**

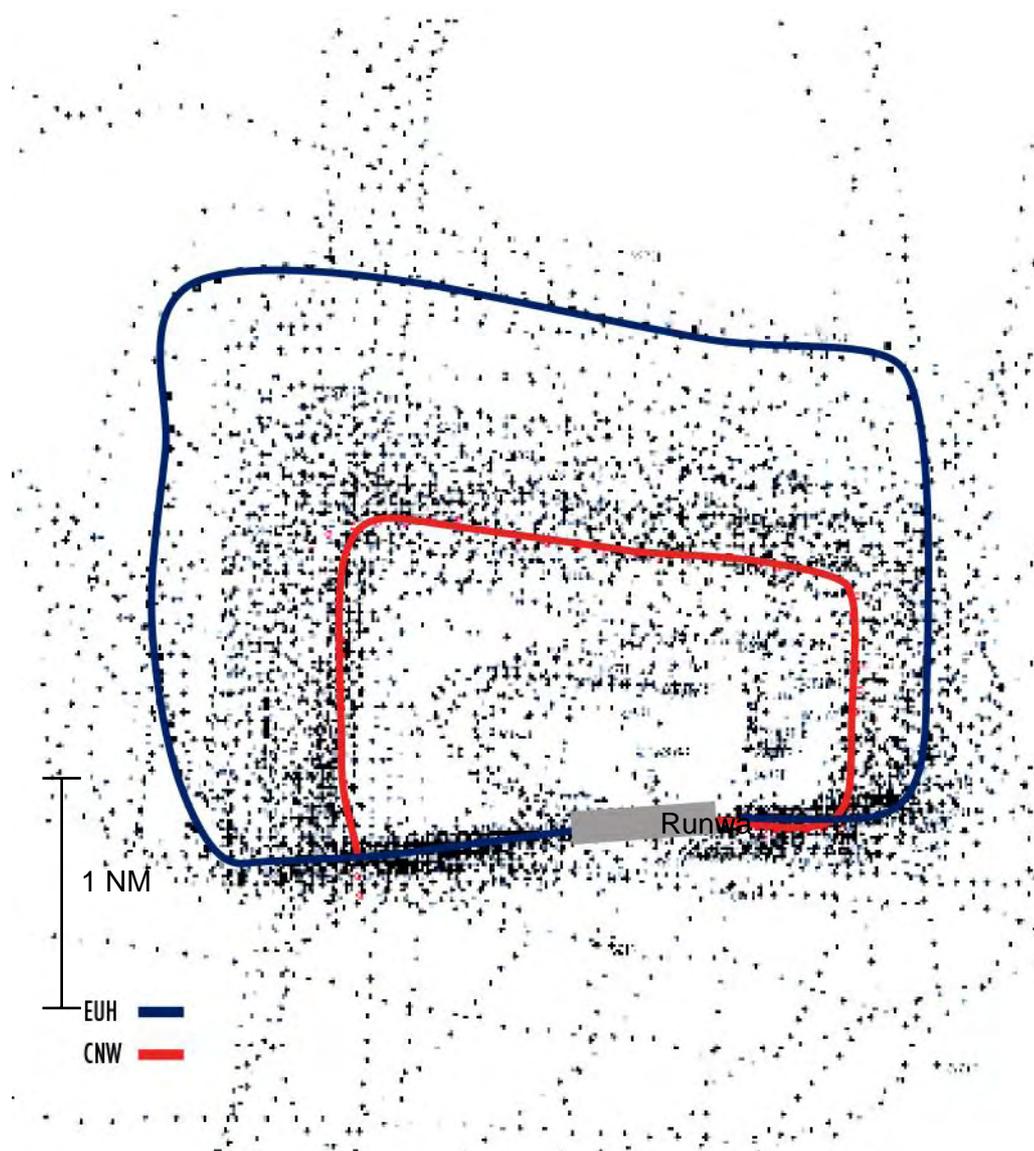
Figure 7 is an extract from the radar data of the Moorabbin circuit area over a 2.5 hour period during the afternoon of 29 July 2002, with the tracks of the two accident aircraft leading to the collision (CNW in red and EUH in blue) superimposed. It shows that there were a variety of circuit dimensions flown throughout that period. It also shows that the dimensions of the circuit flown by the pilot of CNW were relatively small, and the dimensions of the circuit flown by the instructor and student pilot of EUH were relatively large by comparison. They were however, both within the range of the circuit dimensions that had been flown during that period. The dimensions of the circuit pattern flown by the instructor and student pilot on board EUH were similar to what was described by the Chief Pilot of the flying school, as the normal circuit size flown by instructors from that flying school.

**Figure 7: Composite radar plot of the circuit area for Moorabbin runway 17L, between 1300-1500 and 1815-1845 on 29 July 2002, with the accident aircrafts' circuits superimposed.**

The dimensions of the circuit flown by the pilot of CNW at Moorabbin before the accident had a downwind leg approximately 1 NM abeam of the runway, and the crosswind and base legs were approximately 2.2 NM apart.

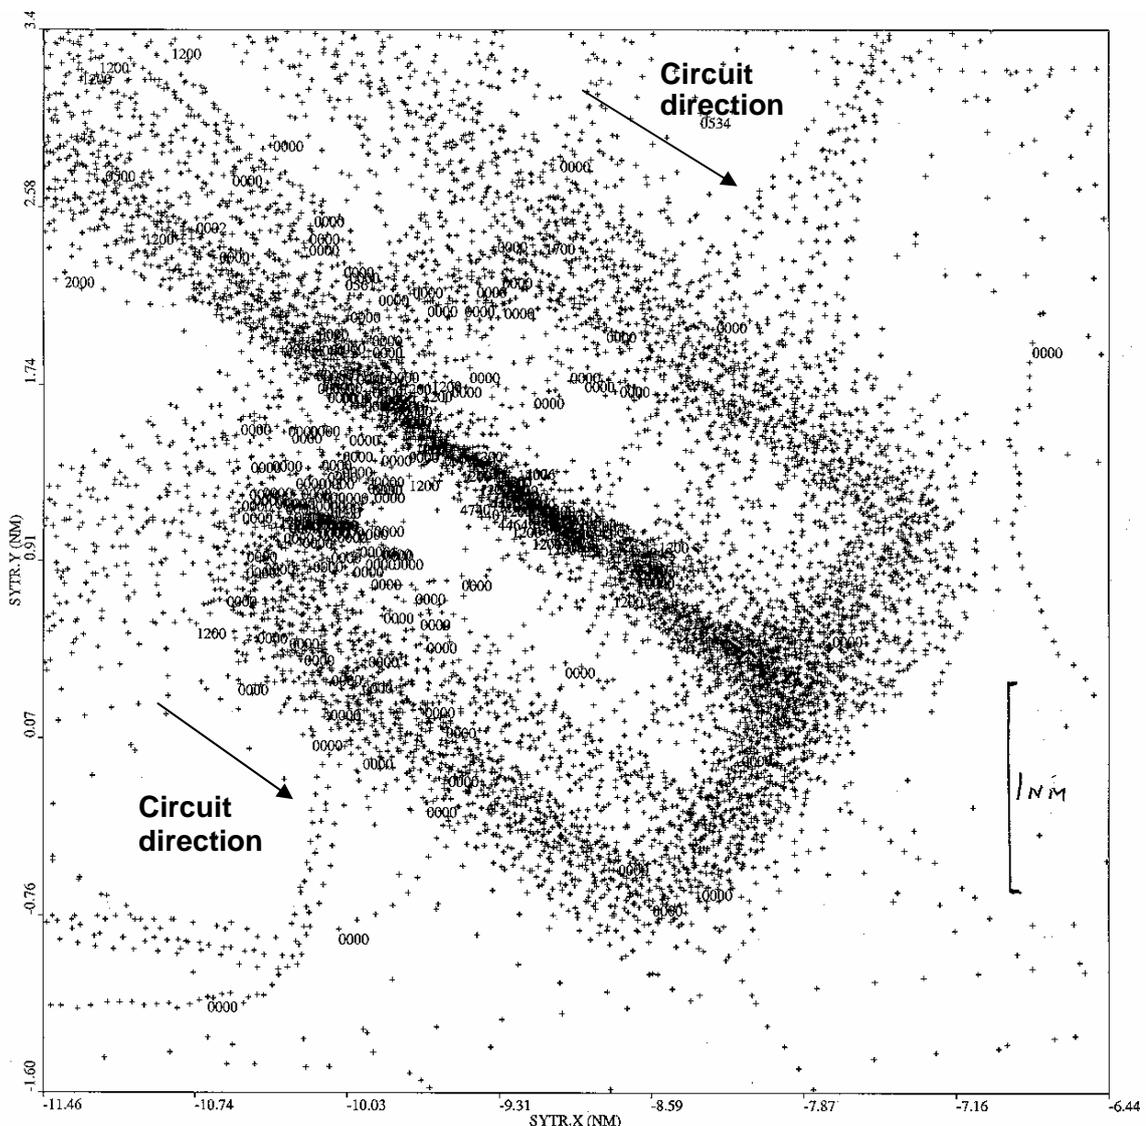
The pilot of CNW had conducted most of her night training at Bankstown airport, before transferring to Moorabbin to continue her flying training. For comparison, Figure 8 shows a radar plot of Bankstown airport aircraft tracks covering a four hour period. It shows that the average circuit had a downwind leg approximately 1 NM abeam of the runway, and that the crosswind and base legs were approximately 2.2 NM apart.

**Figure 8: Radar plot of the Bankstown circuit area between 1000 and 1400 on 17 July 2002.**

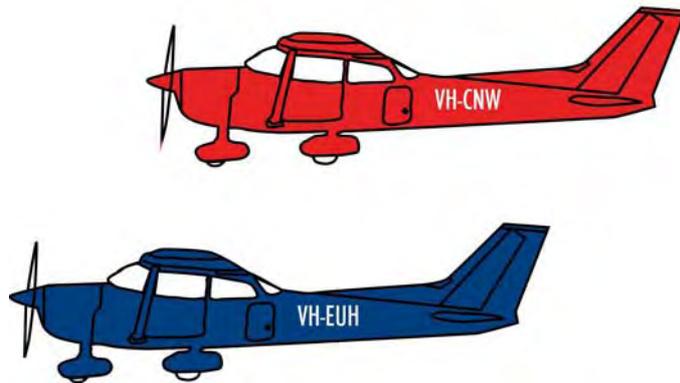
A pilot's normal field of view from within the cockpit of a C172 is partially obscured by the aircraft's wings and fuselage. Figure 9 shows the approximate relative locations of CNW and EUH, in elevation, from witness reports, when the two aircraft were on final approach.

**Figure 9: The relative locations of CNW and EUH on final approach based on witness reports.**

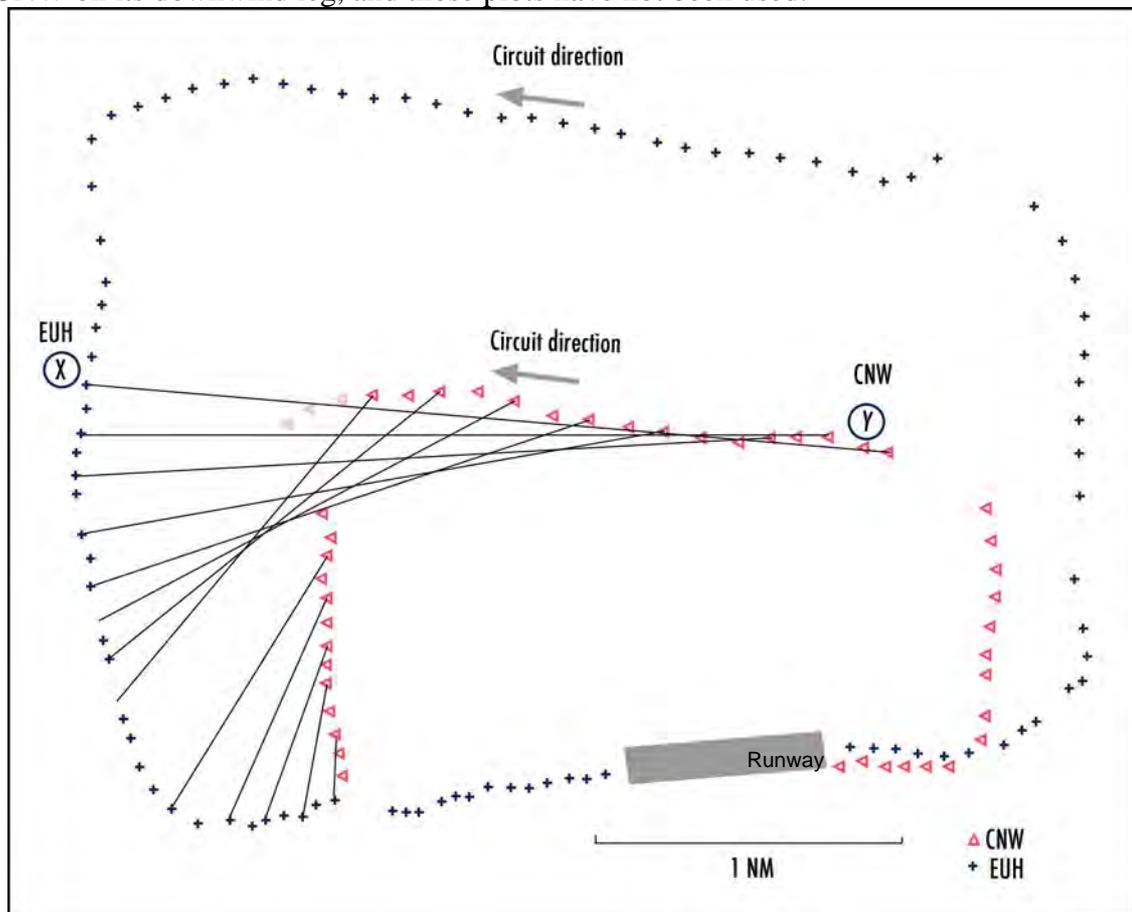
Figure 10 depicts the radar track plots from the accident aircraft during their circuit leading up to the accident. The black lines are relative bearings between EUH and CNW. They depict the bearing and distance between the two aircraft at specific times during the

circuit leading up to the accident. Point 'X' is the approximate location of EUH at the time the pilot reportedly saw CNW. Point 'Y' is the location of CNW at that time. Based on ground speed analysis, there is doubt about the accuracy of the last three plots for CNW on its downwind leg, and those plots have not been used.

**Figure 10: Radar plot of the circuit area, showing the relative bearings between the two accident aircraft before the accident.**
