OUTLINE OF INCIDENT

Shortly before noon on Thursday 14 August 1986 the Netherlands Antilles flag heavy lift cargo ship 'GABRIELLA' capsized and sank alongside No. 2 Products Berth in Port Kembla harbour New South Wales.

On 14 August 1986 John Michael Quinlan, Principal Marine Surveyor for New South Wales in the Federal Department of Transport, was appointed under Section 377A of the Navigation Act 1912 to make a Preliminary Investigation into the circumstances of the capsizing of the Netherlands Antilles registered ship 'GABRIELLA' (call sign PJTQ) in Port Kembla harbour on 14 August 1986.

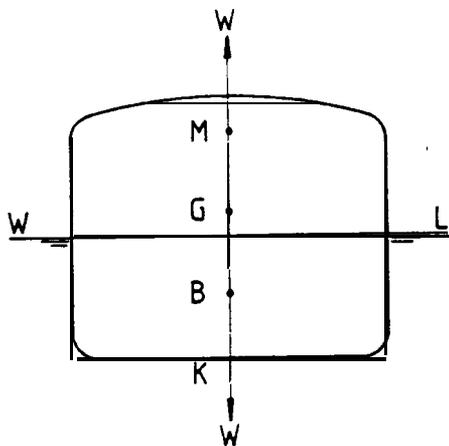
FIG. A

Figure A represents a ship floating upright in still water. The centres of gravity and buoyancy are at G and B respectively.

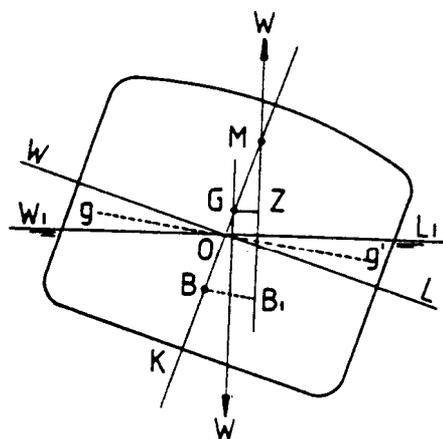
FIG. B

If the ship is inclined by an external force to a small angle as shown in Figure B the centre of gravity will remain at G and the weight of the ship (W) can be considered to act vertically downwards through this point. The centre of buoyancy shifts from B to B1.

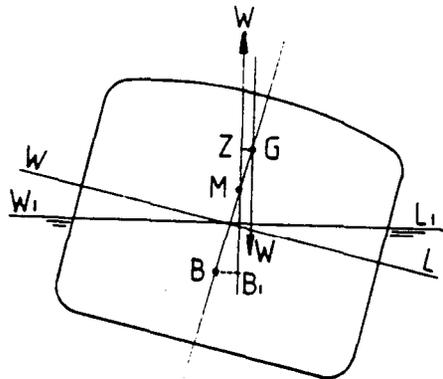
FIG C

A ship is in stable equilibrium if, when inclined, it tends to return to the initial position. For this to occur the centre of gravity must be below the metacentre. Figure A shows a ship in the upright position having a positive GM. Figure B shows the same ship inclined to a small angle. The centre of buoyancy moves from B to B₁ to take up the new centre of gravity of the underwater volume, and the force of buoyancy is considered to act vertically upwards through B₁ and the metacentre M. If moments are taken about G there is a moment to return the ship to the upright. This moment is referred to as the Moment of Statical Stability and is equal to the product of the force (W) and the length of the lever GZ.

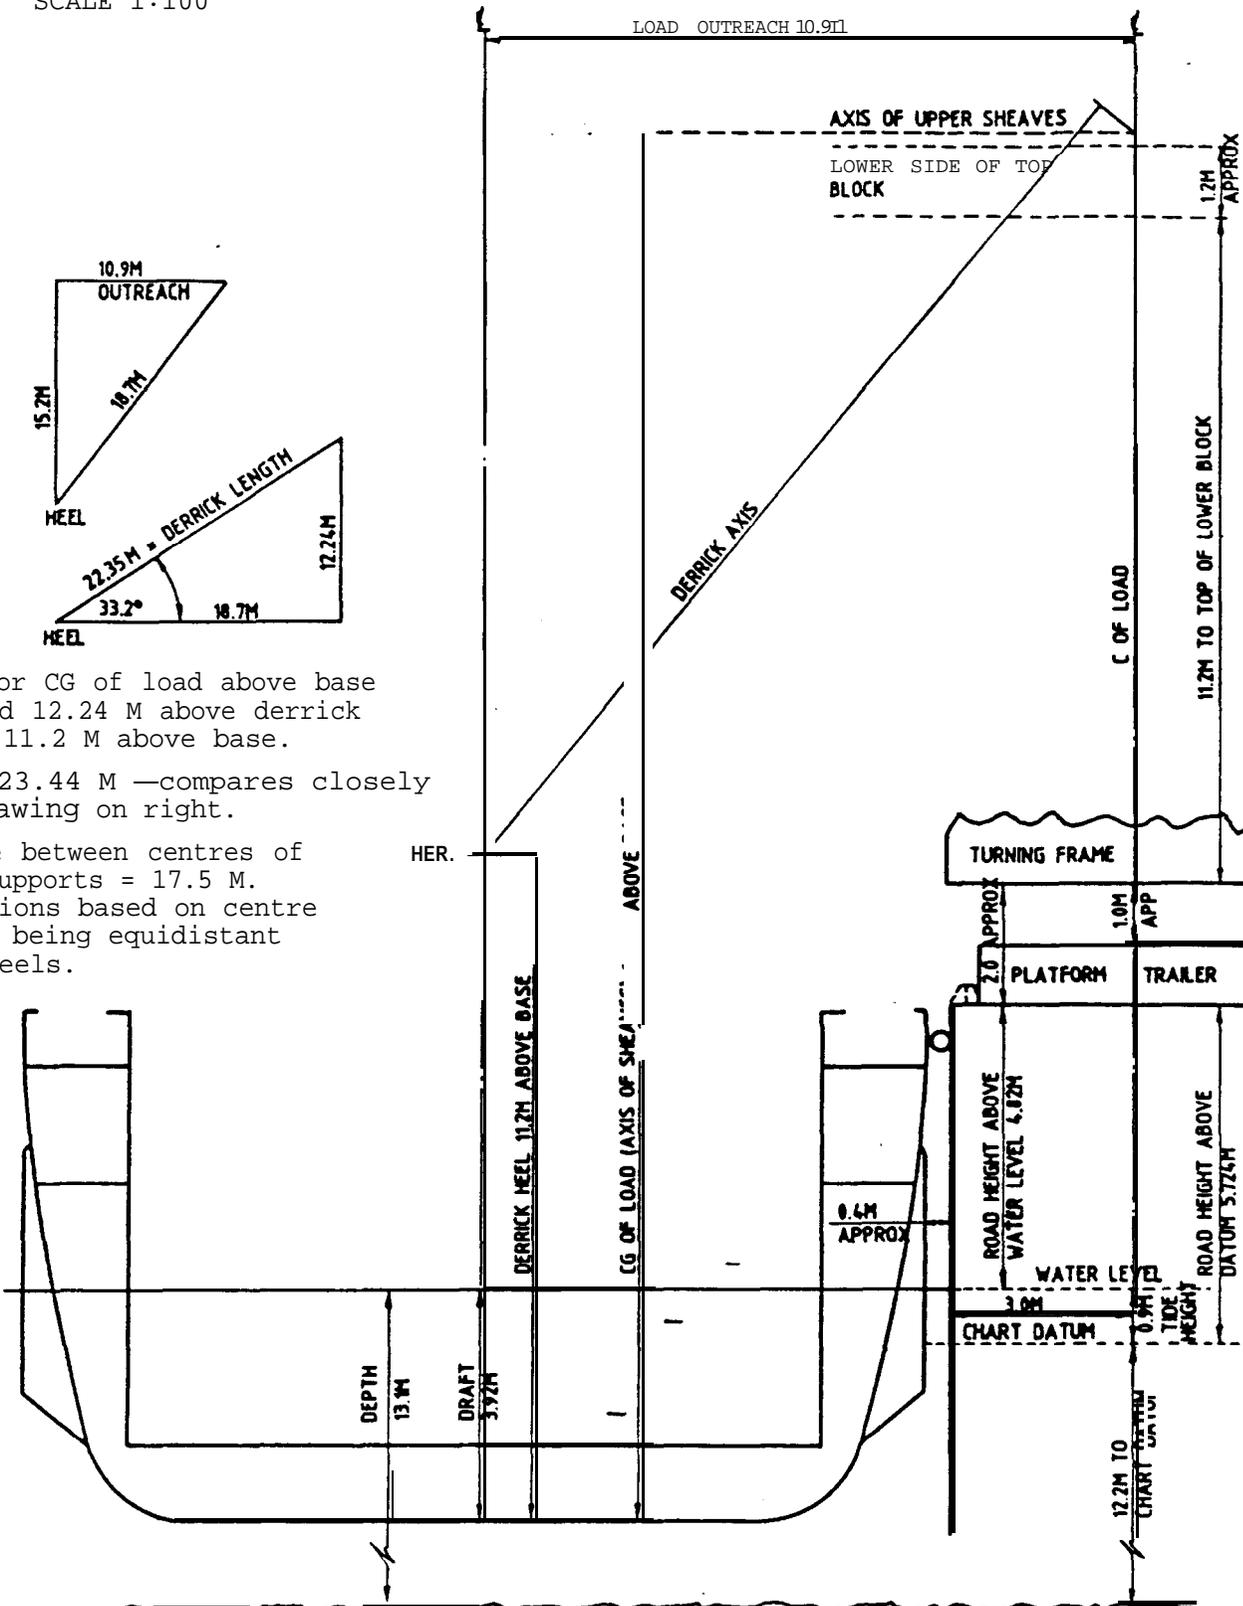
CONDITION IMMEDIATELY BEFORE ACCIDENT

Calculations for CG of load above base show it located 12.24 M above derrick heel which is 11.2 M above base.

∴ KG of load 23.44 M —compares closely with scale drawing on right.

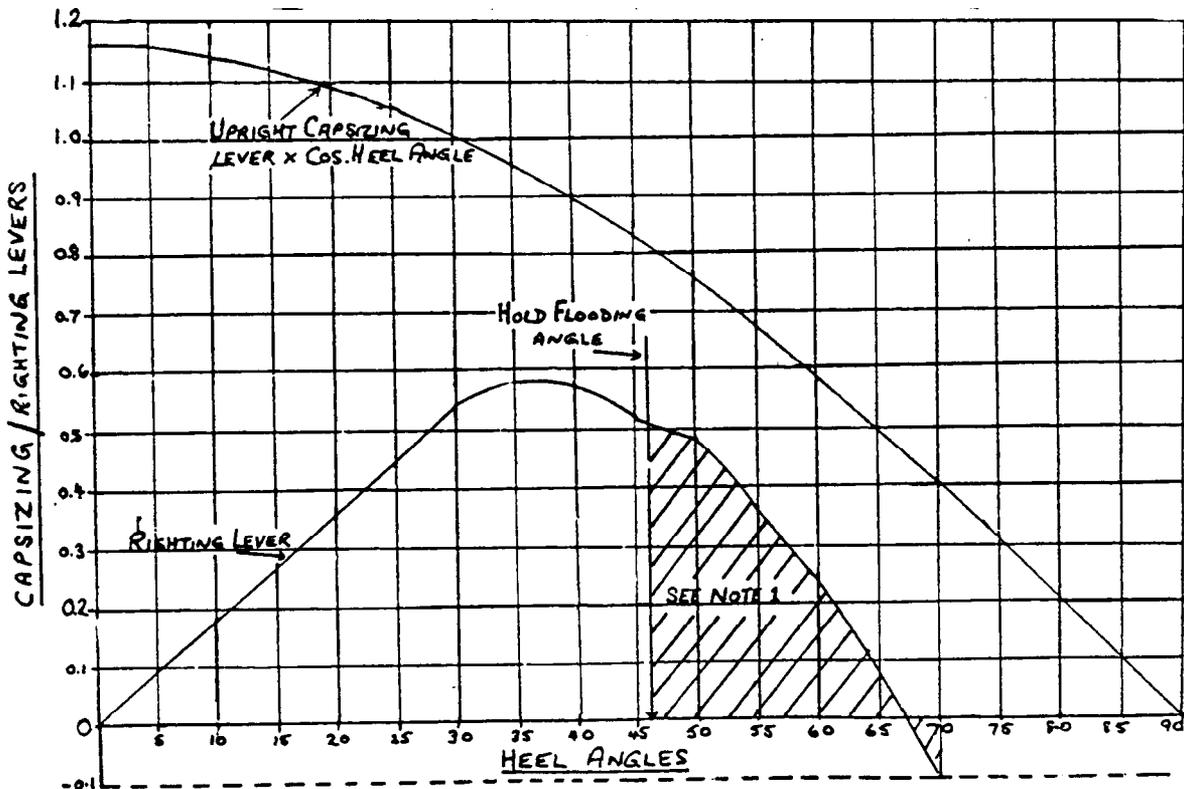
CURVES OF CAPSIZING & RIGHTING LEVERS

NOTE 2 There are no KN curves in the ship's data for 35° 45° 55° & 65°. GZ values at these angles have been extracted from GZ curves in the data for angles of heel 0° to 60°.
