Bureau of Air Safety Investigation

INVESTIGATION REPORT

9304023

**De Havilland DH-104 Series 5 Dove VH-DHD
1 km south-west of Essendon, Victoria
3 December 1993**

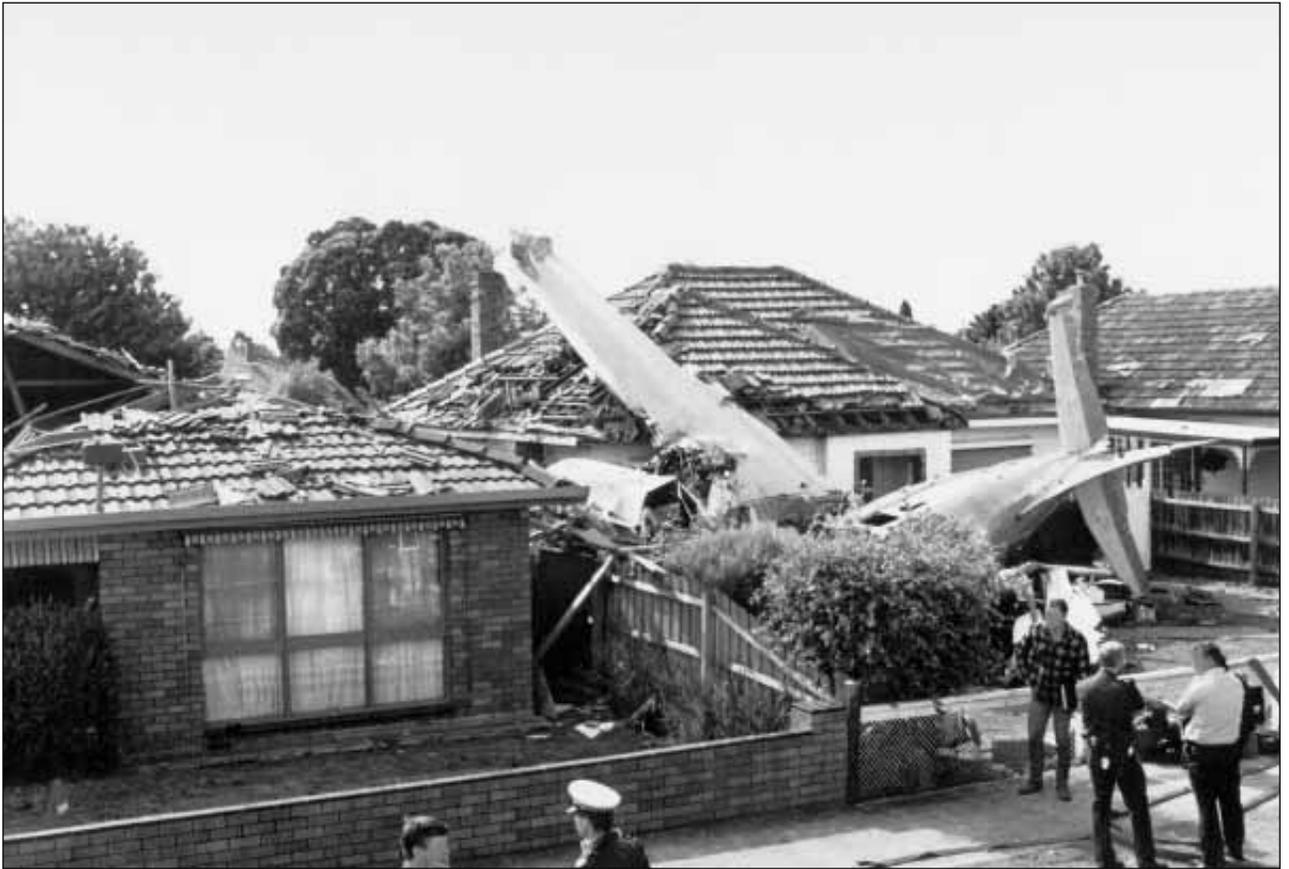
VH-DHD following crash into houses near Essendon Airport 3 December 1993.

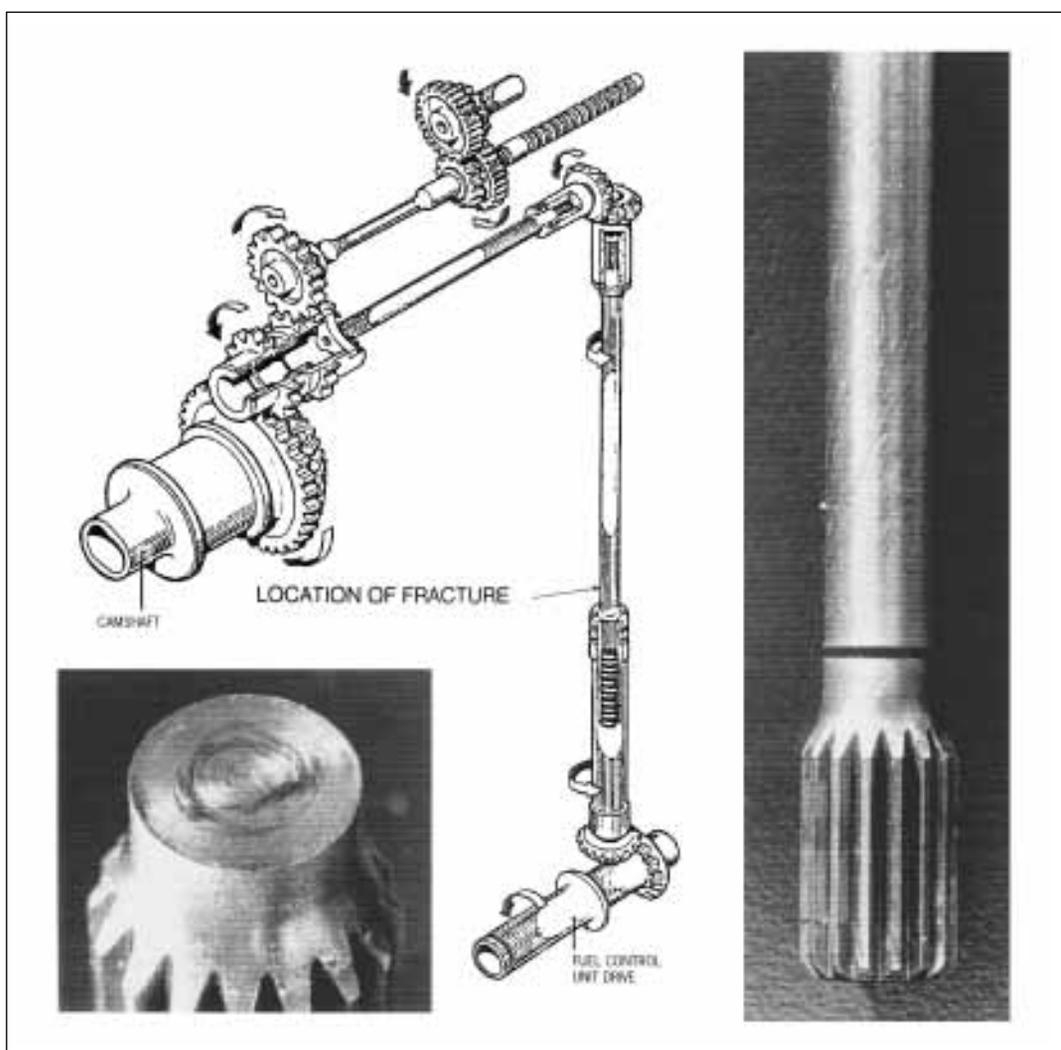
Examination of the fuel control unit vertical drive shaft fracture showed it to be consistent with torsional overload. The fracture had occurred on the plane of maximum shear stress. (see fig. 2). No pre-existing condition of the shaft which might have contributed to the failure of the shaft was found.

Figure 2. Views of the fractured vertical drive shaft showing the location of the fracture and the fracture surface. The schematic shows the relationship of the drive shaft with the engine camshaft and fuel control unit drive.

Examination of the right fuel control unit revealed that the driving spindle of the integral geared fuel pump had seized in its surrounding bush. The seizure resulted in torsional overload of the vertical drive shaft causing it to fracture. The vertical drive shaft, being only 7 mm in diameter, was the weakest component in the fuel control unit drive.

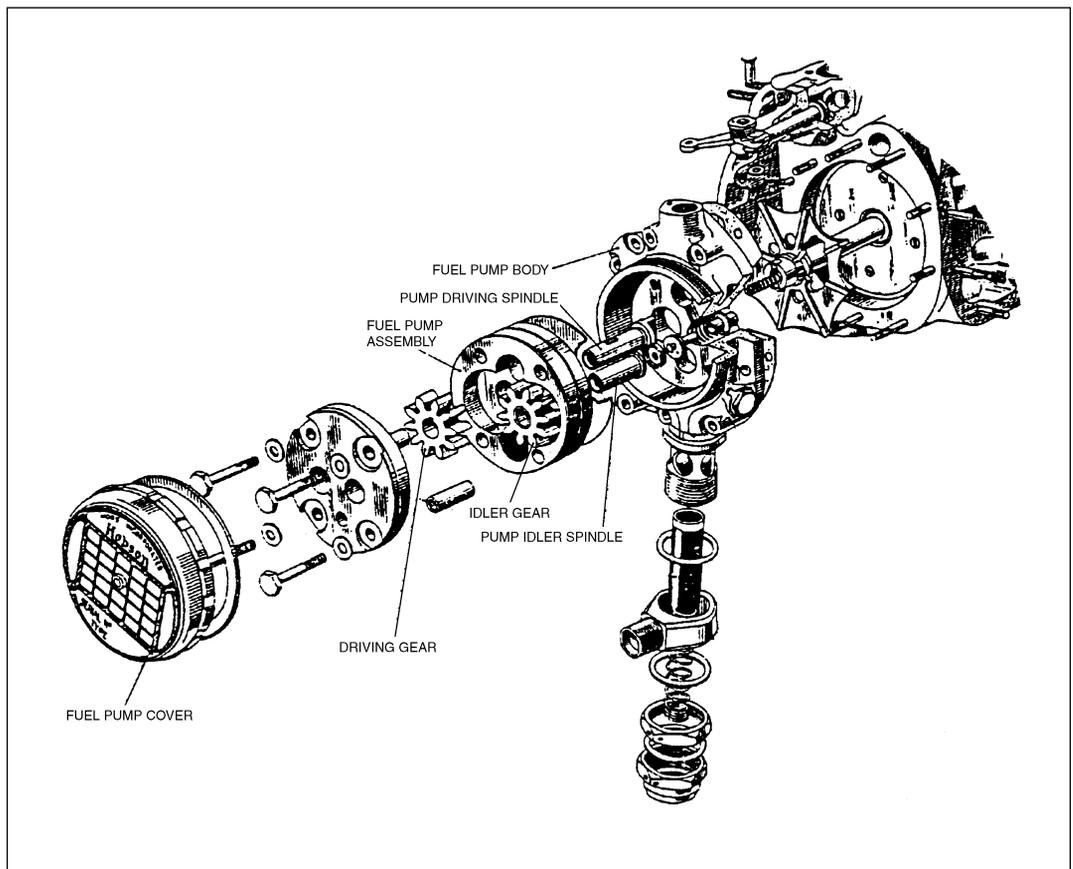
The pump drive spindle is fitted into a flanged bronze bush in the fuel pump assembly. The spindle and bush thrust faces form a thrust bearing. Metallographic examination of the bush revealed the material to be typical of leaded bronze. Heat generated between the thrust faces caused lead to melt and exude from the bronze alloy bush. The bush and spindle ultimately seized.

The moving components in the pump are lubricated by fuel. Two radial V-grooves are machined into the bush thrust face to introduce fuel between the thrust faces. During normal operation a small quantity of fuel flows through holes in the spindle, and through the grooves in the bush, into the clearance between the spindle and bush thrust faces, providing lubrication. The degree of wear between the thrust faces had resulted in the V-grooves of the bush virtually disappearing. A trace of the grooves was revealed only under high magnification.

Figure 3. Schematic showing an exploded view of the fuel pump contained within the fuel control unit.

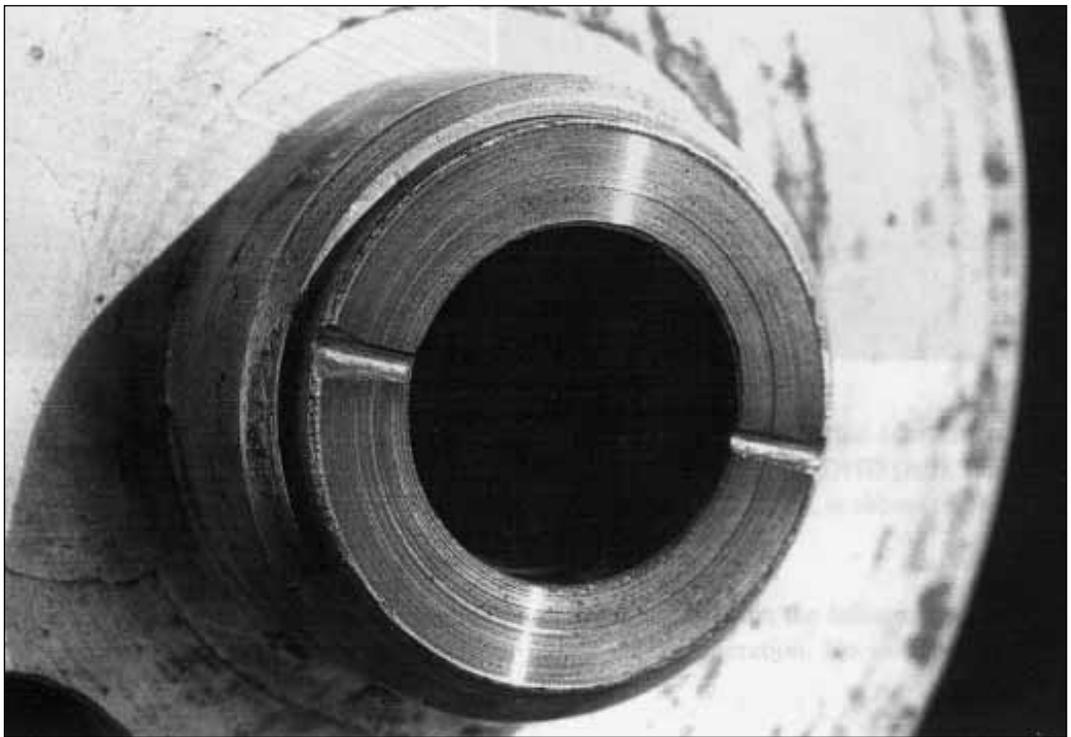
For comparison, the left engine fuel control unit was also disassembled and inspected. The bush and spindle thrust faces from the left engine fuel control unit fuel pump were examined. The bush face contained clearly defined and adequately deep V-grooves.

Figure 4. The thrust face of the bush fitted to the FCU fuel pump, left-hand engine.

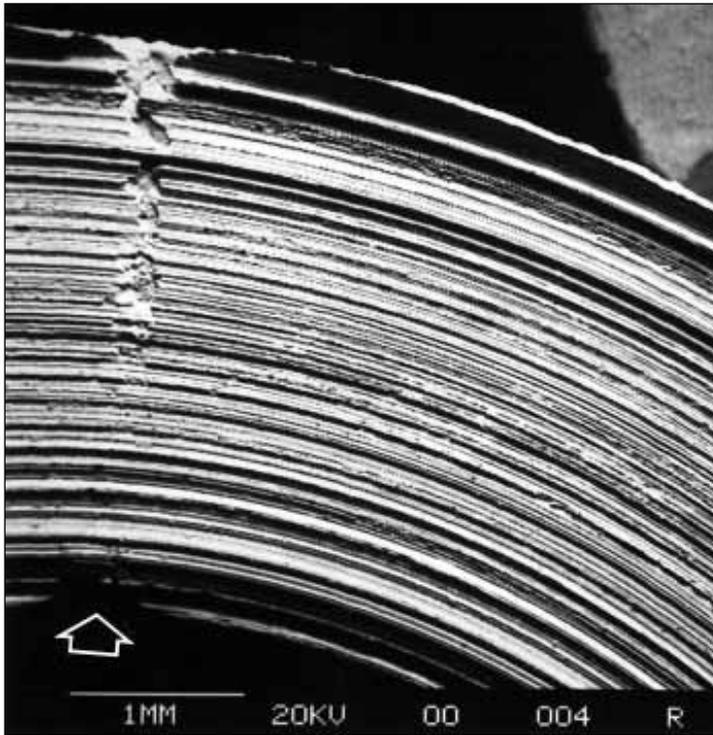
Both the bush and spindle thrust faces contained deep circumferential wear marks. Deposits of iron oxides were present on the spindle face. All fuel passages were free of any blockage.

The marks on the thrust faces from the right engine fuel control unit appeared to have been the result of dry metal-to-metal contact. The thrust faces from the left engine fuel control unit showed some circumferential wear marks consistent with abrasive particles having been present between the surfaces at some time. These particles were probably introduced in the fuel. The contractor who had previously repaired the fuel control unit reported that it is normal for those received for repair to have wear marks on the thrust faces.

Figure 5. Scanning electron micrograph showing the remnant of the radial lubrication groove on the thrust surface of the fuel pump bush, right-hand engine.

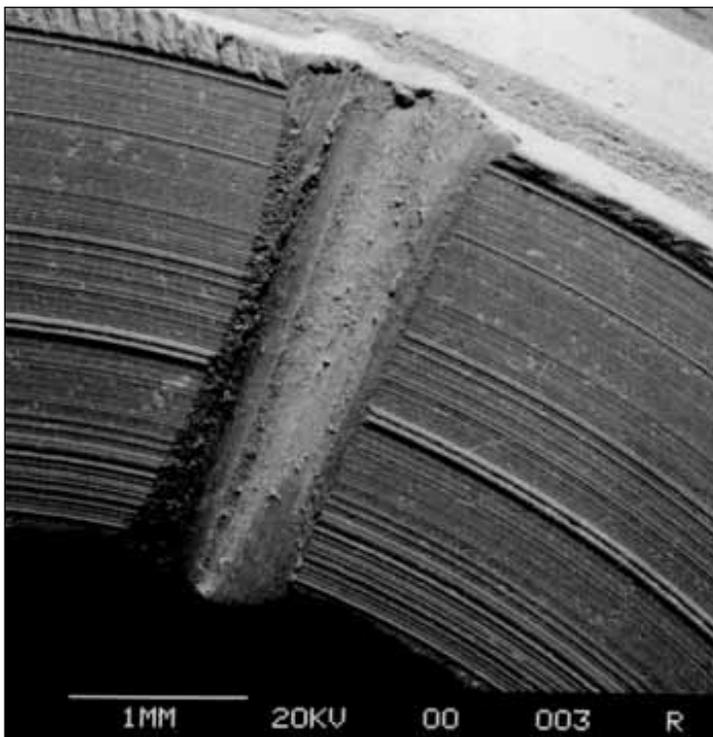
Figure 6. Scanning electron micrograph showing the surface of the bush from the left-hand engine
