Collision with terrain, VH-RDU

Double Mountain, Queensland

8 September 2011

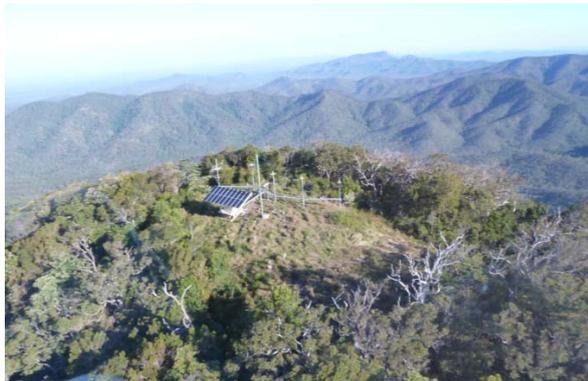
Figure 2: View of the HLS, looking south-east

The HLS was situated atop the western peak of Double Mountain and under the control of the Department of Defence. It had an elevation of 2,421 ft and was surrounded by trees on three sides and a mast and antenna array on the other (Figure 2). A number of trees encroached the approaches to the HLS and the landing surface was uneven and covered by long grass. Numerous tree stumps protruded above ground level.

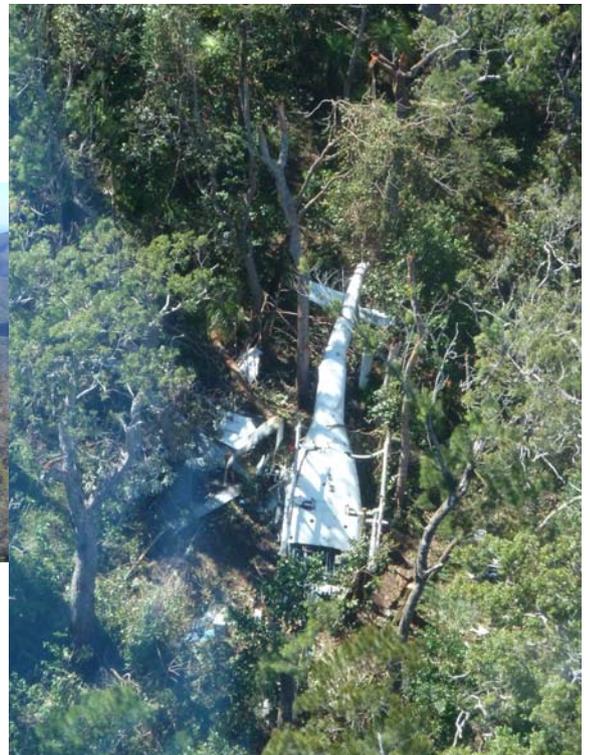
Figure 3: Aerial view of the wreckage

The wreckage of the helicopter was located on a steep slope about 50 m west of the HLS, in dense forest (Figure 3). It was oriented on a magnetic bearing of 250°. During the impact sequence, the helicopter descended through the trees at a very steep angle, breaking off a number of substantial tree branches before impacting the ground.

Blade cuts on the tree branches were consistent with marks on the leading edges of the main rotor blades and of the remaining tailrotor blade. The first blade strikes were on branches at a height of about 23 m on a tree that was about 9 m back along the swath through the trees.
