# Collision with terrain, VH-HFH Cessnock Aerodrome, New South Wales 4 February 2011

## Abstract

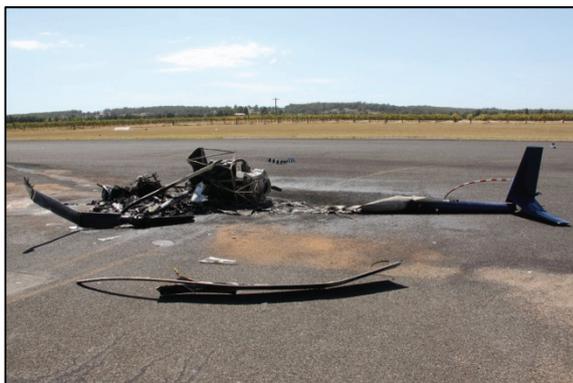
**Figure 2: Aircraft wreckage**

The accident site was located on the runway at Cessnock Aerodrome adjacent to a taxiway intersection (Figure 1). Main rotor contact marks indicated that the helicopter initially contacted the runway while banked to the left at 53° and travelling to the south-west at about 26km/h. The helicopter continued rolling to the left and the fuselage contacted the runway at an angle of about 110°. The helicopter travelled a further 17 m before coming to rest on its left side, orientated north. An intense fire consumed the majority of the helicopter (Figure 2).

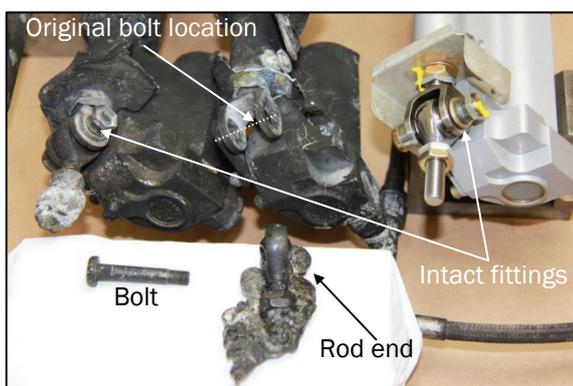
**Figure 3: Left, right and exemplar hydraulic-boost servos**

On-site examination of the wreckage identified that the bolt that retained the lower flight control push-pull tube to the left-front hydraulic-boost servo was missing (Figure 3). The bolt and rod end were subsequently found within the wreckage however; to date, the retaining nuts and associated fixtures have not been located.

The helicopter manufacturer advised that a break in the connection of any of the push-pull tubes, whether above or below the hydraulic-boost servos, will lead to the immediate loss of control of the helicopter. The manufacturer's maintenance manual does not permit the removal or fitment of that bolt other than during the repair or overhaul of the hydraulic-boost servo by the manufacturer.

The Australian Transport Safety Bureau encourages all operators of hydraulic system-equipped R44 helicopters, and organisations performing inspection, testing, maintenance and repair activities on the flight control systems of those helicopters, to note the circumstances detailed in this preliminary report. It is suggested that those operators and maintenance organisations consider inspecting the security of the hydraulic-boost servos on all hydraulic system-equipped R44 helicopters.
