ATSB TRANSPORT SAFETY REPORT  
Aviation Occurrence Investigation A0-2010-089  
Interim-factual

# In-flight uncontained engine failure Overhead Batam Island, Indonesia 4 November 2010 VH-OQA Airbus A380-842

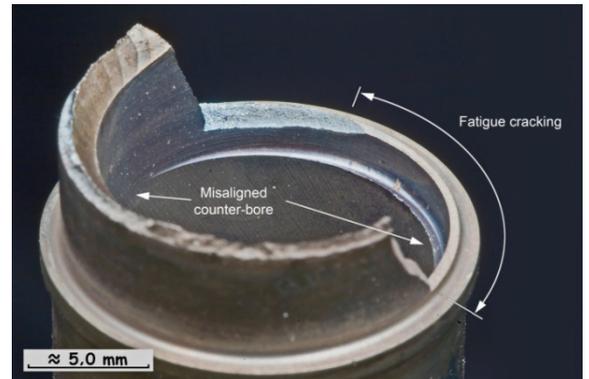
**Figure 1: Updated location of fatigue cracking**

The investigation has found that the intermediate pressure (IP) turbine disc failed as a result of an overspeed condition, liberating sections of the IP turbine disc that then penetrated the engine case and wing structure. The disc failure was initiated by a manufacturing defect in an oil feed pipe that resulted in a wall thickness reduction in an area that is machined to receive a coarse filter. That section of the oil feed pipe sustained a fatigue crack during engine operations that led to an internal engine oil fire that weakened the IP turbine disc. In turn, a circumferential fracture was induced around the disc, allowing it to separate from the IP turbine shaft. The unrestrained disc accelerated to critical burst speed. This led to the No 2 engine failure and subsequent significant penetration damage to the airframe structure and systems.

Since the ATSB's Preliminary Report was issued, analysis of the oil feed pipe fracture surface has progressed and the investigation team has a better understanding of the failure mechanism. Technical reviews to date of the available evidence have established that the location of the fatigue cracking that was depicted in Figure 9 of the Preliminary Report<sup>1</sup> is not the area of interest. The area of fatigue cracking and misaligned counter bore is now understood to be as shown in Figure 1 below.
