# Collision with terrain, VH-POJ

## 40 km N Horsham, Victoria

### 15 August 2011

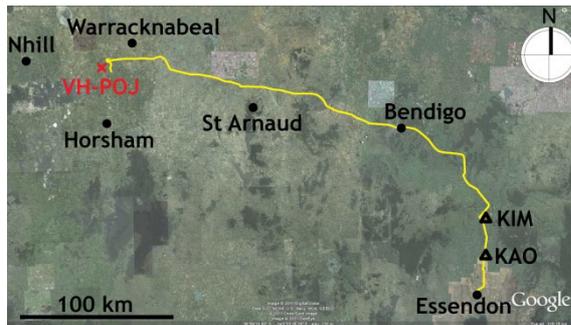
**Figure 1 Accident flight track**

The pilot had planned to fly from Essendon to the VFR waypoints Kalkallo (KAO) and Kilmore (KIM), and then direct to Nhill. He departed Essendon at 1600, however, after passing KIM he flew POJ to Bendigo Airport, landing there at approximately 1649<sup>2</sup> (Figure 1).

While on the ground at Bendigo, the pilot logged on to the National Aeronautical Information Processing System (NAIPS), from which it was possible to access the most up-to-date aviation weather forecasts and reports. One of the passengers telephoned a family member at Nhill for an assessment of the weather there. On the basis of this assessment, the pilot decided to continue the flight and POJ departed Bendigo for Nhill at approximately 1711 (Figure 1).

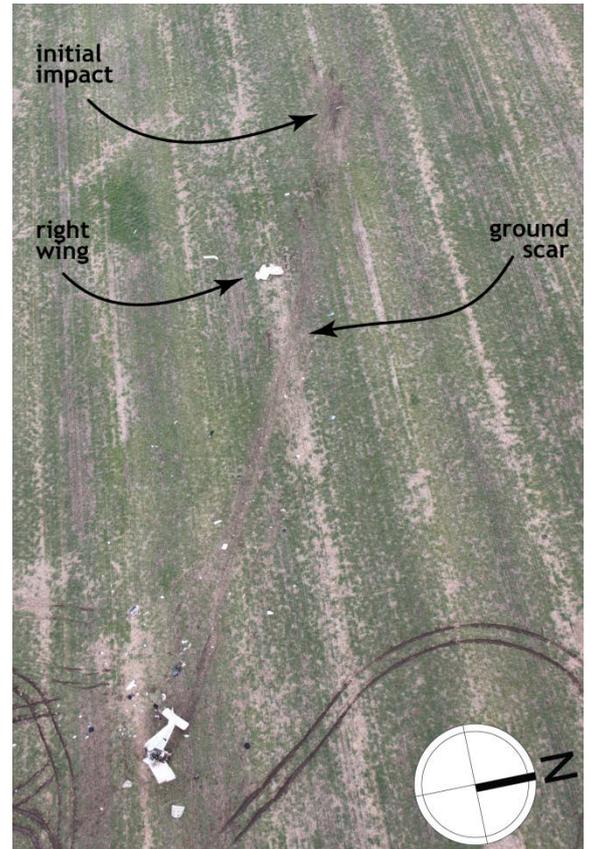
**Figure 2 Aerial view of accident site**

Ground impact marks indicated that the aircraft impacted the ground in a right wing-low attitude. The aircraft's fuselage came to rest about 100 m from the initial ground impact (Figure 2).

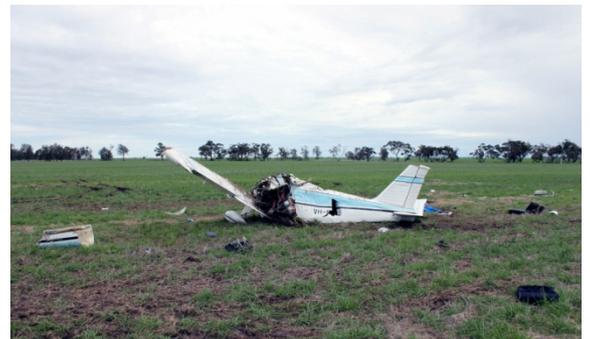
**Figure 3 Aircraft wreckage**

The right wing had separated from the fuselage. The soil in the vicinity of the right wing was contaminated with fuel.

All of the aircraft's primary structure and flight controls were located at the accident site and there was no evidence of fire (Figure 3) or pre-

impact failure. No anomalies of the aircraft's flight control system were identified. The engine exhibited no external signs of pre-impact damage.
