Serious crew member injury on board

Spirit of Tasmania I

17 September 2011

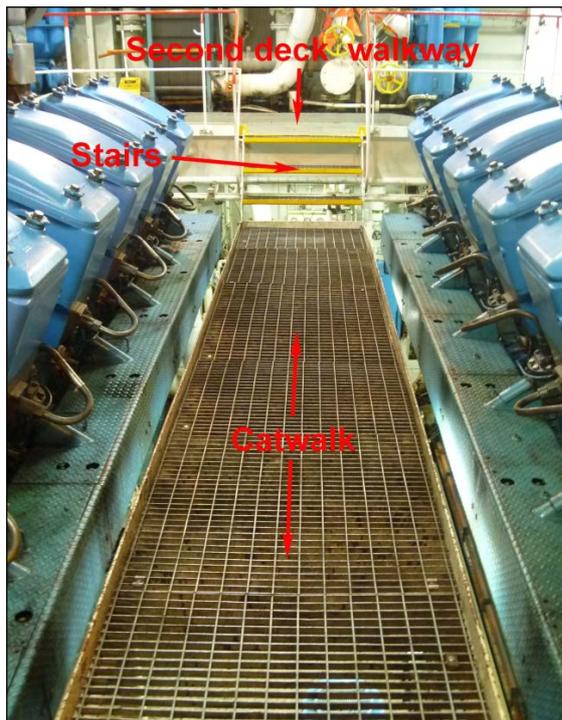
Figure 2: Catwalk between main engines 3 and 4

The IR had carried out this task many times before. He went up to the second deck and moved the fan, which was bolted to a trolley, around the second deck walkway to the forward end of main engines 3 and 4 (Figure 2). He then stepped down onto the catwalk in order to move two sections of the catwalk floor grating (each about 1 m x 1 m in size). He lifted one grating and slid it

- The catwalk gratings have been refitted in their correct positions so that only one grating has to be moved to make an opening for lifting operations.
- All the gratings have been secured to both sides of the catwalk framework, except for one which has been designated for opening. This grating has been fixed in place with hinges on one side to allow ease of access. It has also been painted yellow to distinguish it from the other gratings.
- Permanent retractable safety barriers have been inserted between the forward rails at the top of the catwalk stairs.
- A new procedure has been added to the company's safety management system. This procedure outlines the controls that are necessary when working on, or in the vicinity of, openings in on board structures.

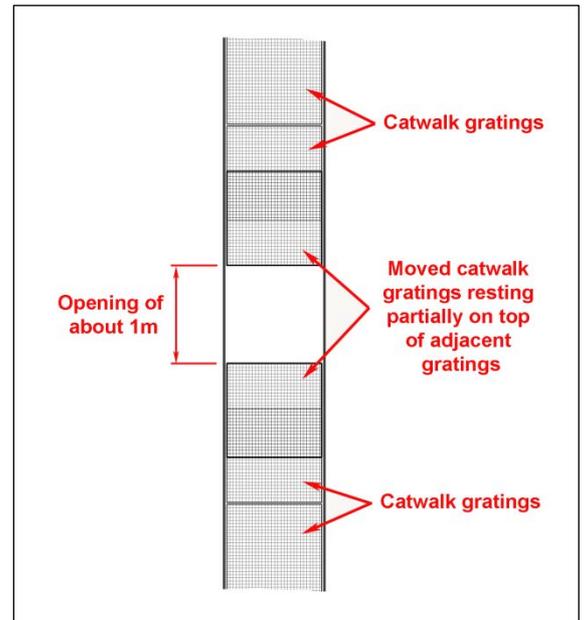
Figure 3: Schematic diagram of catwalk gratings

partially on top of the adjacent grating. He then moved forward and lifted a second grating and slid it forward; again placing it partially on top of an adjacent grating. This exposed an opening of about 1 m between the gratings (Figure 3).

Then, without warning, the electrical engineer fell through the opening in the catwalk, landing on the deck about 2 m below. He did not recall slipping or feeling the gratings move under his feet.

Therefore, it is possible that he stepped into the opening as he pushed the grating back into place.

In this case, if the IR had placed a safety barrier around the catwalk opening, the electrical engineer would not have placed himself in danger. Similarly, if the electrical engineer had thoroughly surveyed the area, he may have determined that two gratings had been moved, not one, and that he risked falling through the opening if he was not careful.
