Collision between grain trains 3234N and 8922N at Yass Junction, New South Wales

9 December 2010

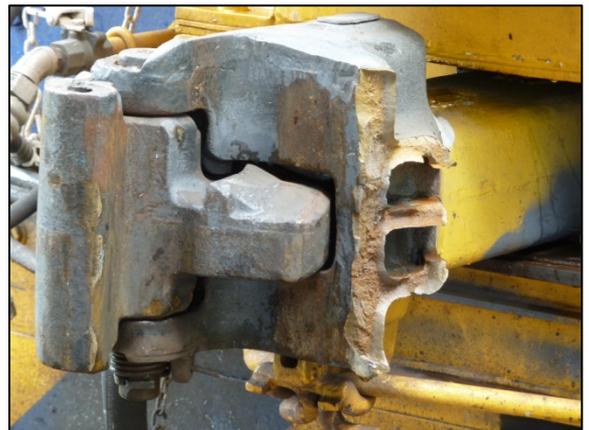
Pacific National operations centre at Parramatta. Both drivers of train 3234N inspected the damage and found that the automatic coupler on the leading locomotive of train 3234N was damaged and the end of train marker from train 8922N was lying on the ground. The crew of train 8922N were contacted but said they were unaware of the collision.

Figure 1: Locomotive 8136 coupler damage.

Pacific National inspected both trains and noted minor damage to leading coupler on locomotive 8136. No other damage was noted.

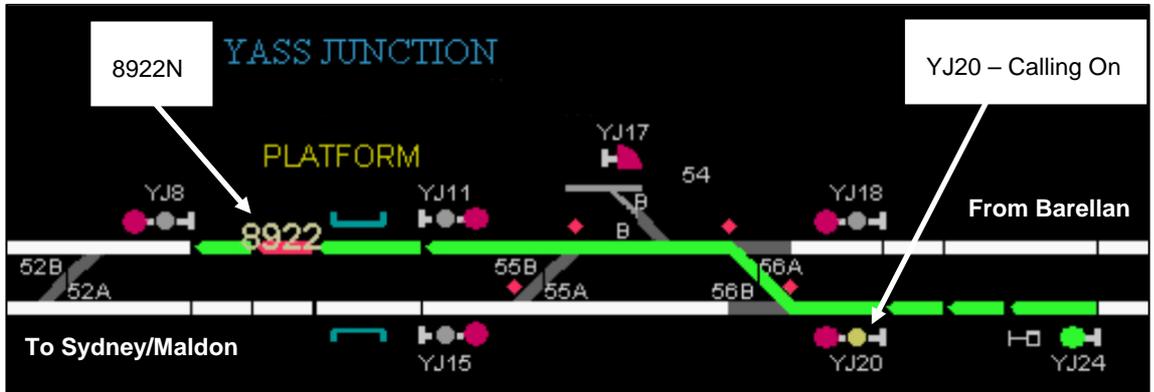
Figure 2: Phoenix extract at 0125:00.

Data obtained from ARTC's Phoenix Control System showed that train 8922N travelled past signal YJ20 at Yass Junction (main line turnout indication) at 0121:57 and over the cross-over (number 56 points) at about 35 km/h before coming to a stand near signal YJ8. In this position there was room for another train of similar length to stop in-clear on the Up Main line behind train 8922N. At 0125:00 (Figure 2) the same route was set and signal YJ20 cleared to a Calling On indication.

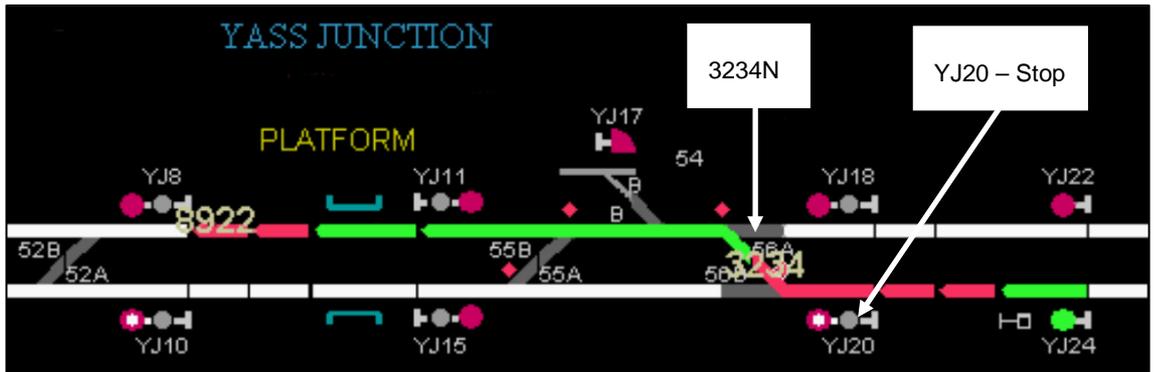
Figure 3: Phoenix extract at 0147:33.

Copyright - ARTC ©. Note - signal YJ24 set to a pre-set clearing mode.

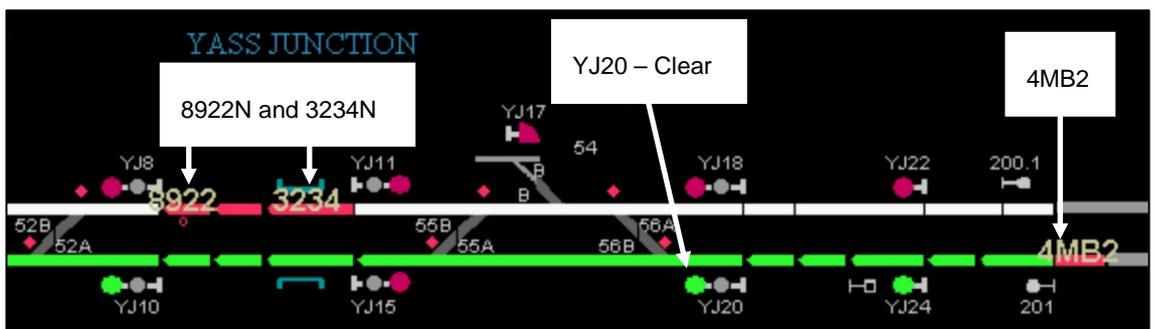
Figure 4: Phoenix extract at 0150:12.

As train 3234N approached Yass Junction, the accept signal (YJ24) was displaying a caution aspect. Train 3234N proceeded past this signal at 0142:29 before stopping short of home signal YJ20. A Calling On shunt signal was displayed on signal YJ20 which indicated to the train crew that while the route was set from the Down Main line to the Up Main line, the route was not clear. There was no verbal communication between the network controller and the crew of train 3234N regarding the status of the line ahead or requirements of the movement. Train 3234N passed signal YJ20 at 0147:33 (Figure 3), about 23 minutes after the route was originally set. Once train 3234N was clear of the cross-over, the route was reset so signal YJ20 could be cleared for the following train 4MB2 (Figure 4) which was to pass the two grain trains stopped on the Down Main line at Yass Junction.

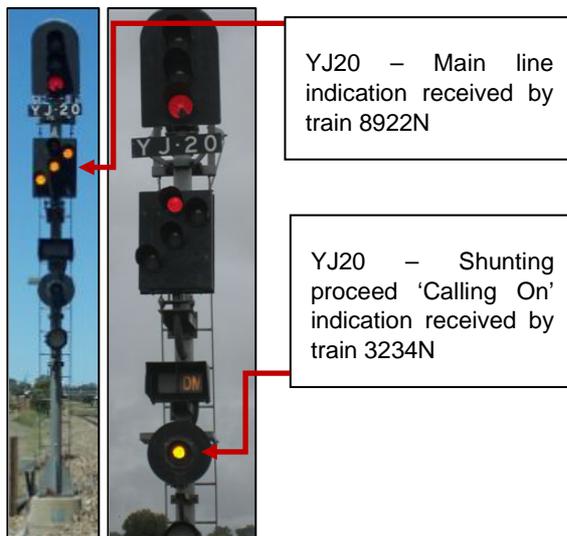
Figure 5: Signal YJ20

- stop
- main line proceed through on Up Main line
- main line proceed through on Down Main line in up direction (turnout with route indicator), Figure 5
- shunting proceed through on Down Main line in up direction (turnout with route indicator), Figure 5.

On the day of the collision, train 8922N received a main line proceed from signal YJ20 to travel over number 56 points and continue on the Down Main line up to signal YJ8 where the train would stand and wait. Train 3234N received a shunting proceed indication from signal YJ20 called a Calling On to travel over number 56 points and continue on the Down Main line and stop short of the preceding train 8922N. The signalling system worked correctly and as designed.

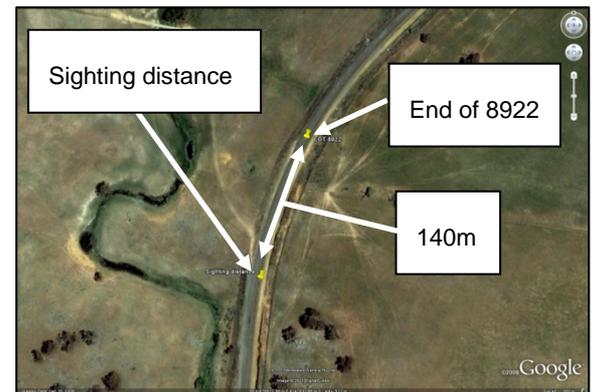
Figure 6: Sighting distance.

At the time of the collision it was dark with moderate rain. Sighting distance was limited by the curvature of the track, embankments, and the effective illumination of the train’s headlight. There is a strong correlation between these factors, the driver’s statement, and the recorded data from the train. Based on measurements in (Figure 6), the actual sighting distance is consistent with the driver’s actions, and the driver reacted almost immediately once he saw the train stopped ahead.

Even though the driver was operating at a speed that he considered appropriate, a ‘restricted speed’ of 32 km/h for the prevailing conditions, it is evident that an even lower approach speed was necessary. Based on the actual deceleration rate of the train, the maximum speed for it to be able to stop short of the train ahead within the available sighting distance with an emergency brake application, was 30 km/h. Using the same deceleration rate and the draft ANRP definition of a restricted speed of 25 km/h, it is likely that train 3234N would have been able to stop before colliding with train 8922N.
