# Smoke Event, VH-PRX, Sydney Airport

## 25 November 2011

### Abstract

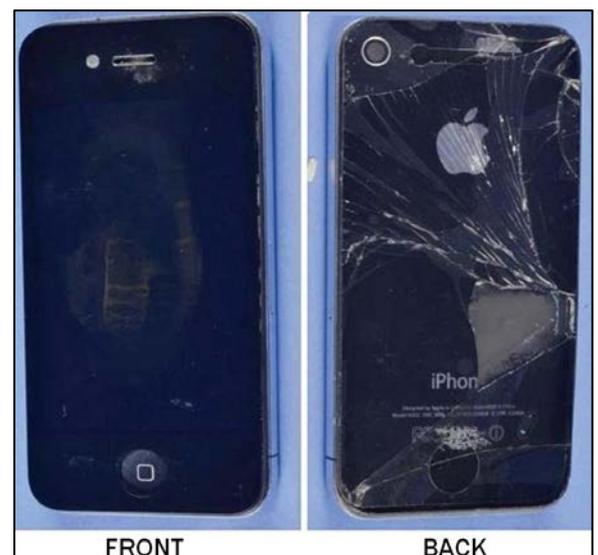
Figure 1: Incident mobile telephone

The mobile telephone owner reported that it was purchased approximately 1 year prior to the incident. The owner also reported that approximately 6 months after purchase, the screen was replaced after it was damaged. The owner could not recall the name of the facility that performed the servicing; however, indicated that it was not an authorised Apple service provider.

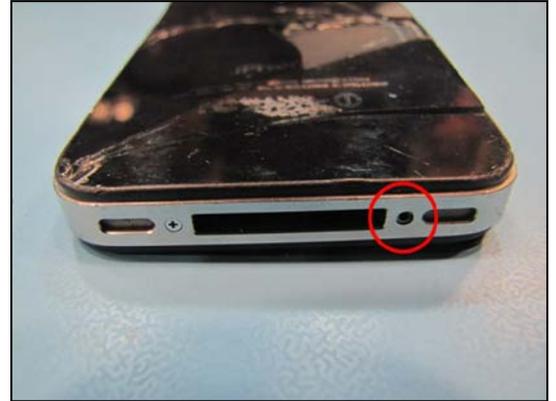
After the incident, the mobile telephone was transported to the ATSB. On receipt, it was noted that one of the screws from next to the 30-pin connector at the base of the telephone was missing (Figure 2). The screw socket thread at this location was visually examined and found to be in good condition.

**Figure 2: Image of 30-pin connector with location from which a screw was missing indicated**

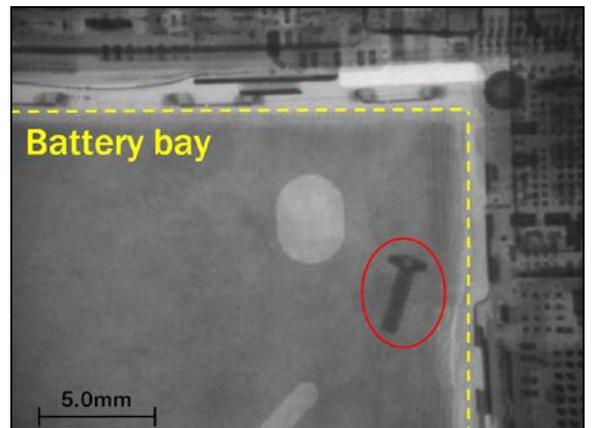
Preliminary x-rays performed on the mobile telephone revealed an isolated screw located in the battery section – away from any apparent fixtures associated with the telephone's construction (Figure 3).

**Figure 3: Preliminary x-ray of mobile telephone section, screw circled**

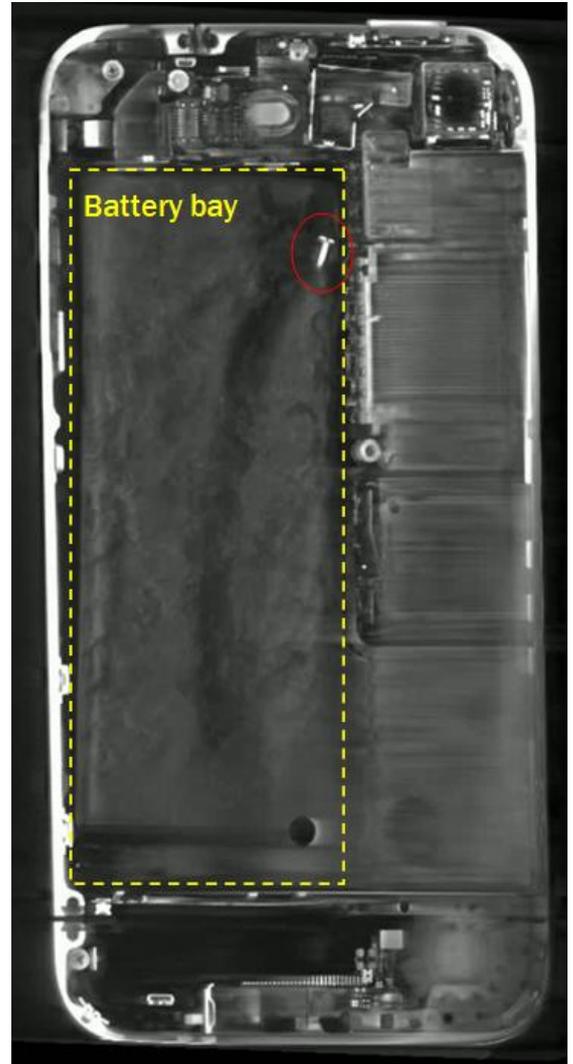
- The incident mobile telephone had sustained a thermal runaway event within its lithium-ion battery
- The screw that was found in the battery area had precipitated the incident and was most likely from the 30-pin connector
- One of the screws used to fasten the main circuit board was missing
- Two screws that retained a flexible cable were installed incorrectly (swapped locations)
- The main circuit board flexible cable adhesive was disturbed
- The two liquid contact indicators<sup>3</sup> were missing
- A metal clip near the battery was deformed

Figure 4: CT scan image of entire mobile telephone, screw circled

The completed examination concluded that the mobile telephone battery failure was most likely the result of the following sequence of events:

- A screw from the 30 pin connector at the base of the telephone (or an identical item), was misplaced in the battery bay during a repair operation.
- Over time, this screw caused mechanical damage to the battery, resulting in an internal short circuit.
- The short circuit lead to the thermal runaway event.

With respect to the mobile telephone battery failure, the ATSB concurred with the findings of the examination facility. The failure was initiated by a screw misplaced in the battery bay during repair.

Mechanical damage caused by the screw and the subsequent internal short circuit resulted in the thermal runaway event.
