Collision with terrain – Guimbal Cabri G2, VH-ZZT

Camden Airport, New South Wales – 13 April 2012

ATSB Transport Safety Report
Aviation Occurrence Investigation
AO-2012-055
Final

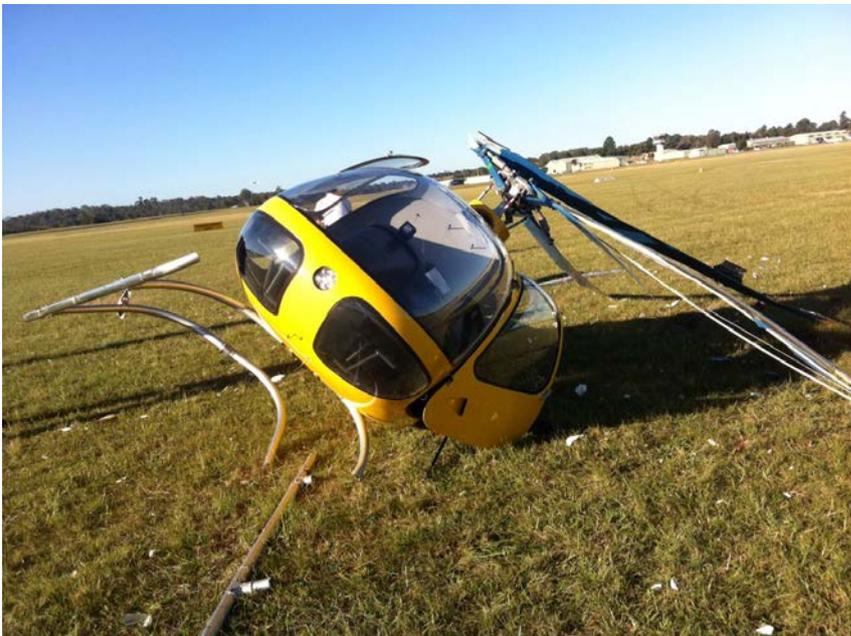
Figure 1: VH-ZZT

The helicopter collided with terrain in a left skid-low, nose-high attitude, and came to rest on its side. Both occupants exited the helicopter. The instructor was not injured, however, the student sustained some minor soft tissue injuries. The helicopter was seriously damaged (Figure 1).
