# Hard landing involving Cabri G2, VH-CDU

Bankstown Airport, 25 October 2012

**ATSB Transport Safety Report**  
Aviation Occurrence Investigation  
AO-2012-140  
Final – 27 February 2013

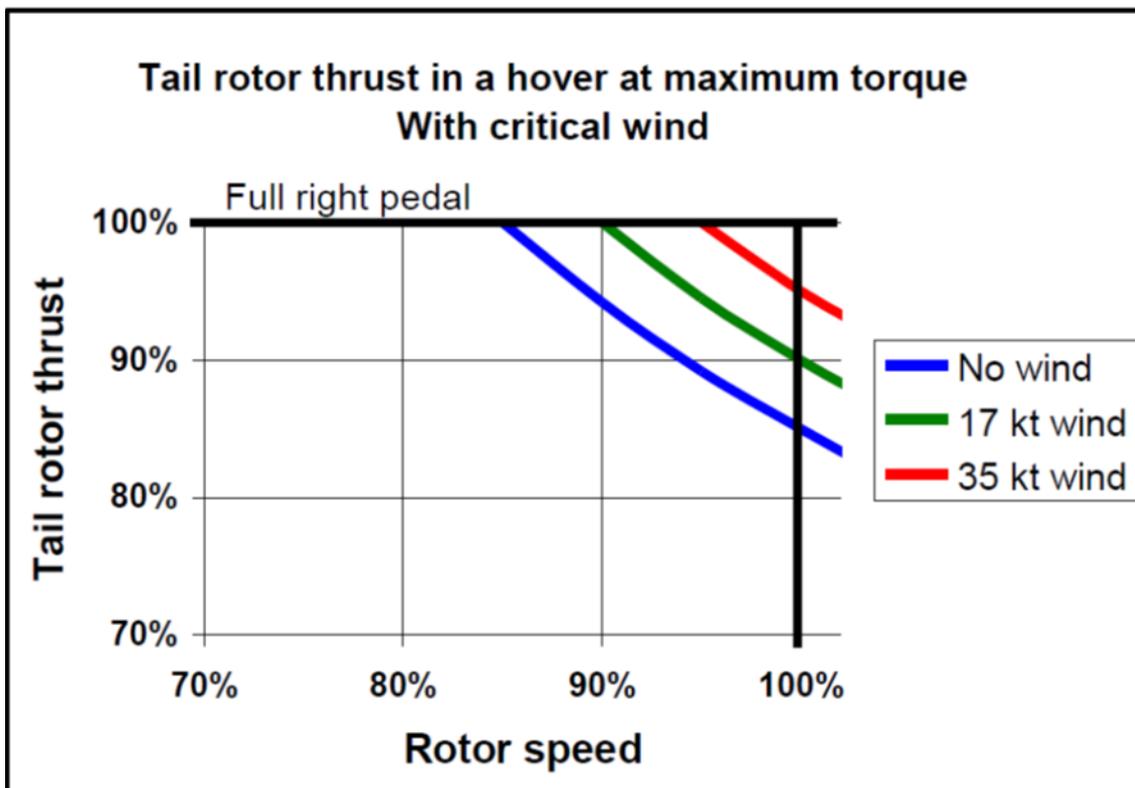
**Figure 1:** Tail rotor thrust margin versus rotor speed at maximum torque

Both the European Aviation Safety Agency (EASA) and the US Federal Aviation Administration (FAA) certification requirements are that the helicopter (in this category) can be controlled in yaw with a 17 knot wind from every direction at the maximum gross weight for the density altitude and at the minimum powered rotor speed (515 RPM or 95% in the Cabri G2). The Cabri G2 exceeds the certification requirements and has demonstrated that yaw can be controlled at a main rotor speed as low as 85 % RPM (450 RPM) in nil wind conditions (Figure 1). Following the incident, the

The electronic RPM governor in the Cabri controls the rotor speed within a maximum variation of +/- 3 %. It is possible to override the governor and lower the main rotor speed below the minimum controllable value of 85 % (Figure 1) while demonstrating low rotor speed in a hover. Increasing the torque in order to recover the rotor RPM in this situation may exceed the anti-torque capability of the shrouded tail rotor.

The Cabri G2's high main rotor inertia will make the yaw departure to the left comparatively quick. Moreover, if the governor is not turned off for the manoeuvre, the governor will react quickly in the event the pilot stops overriding it, contributing to the speed of departure in yaw to the left. The manufacturer commented that practising low main rotor RPM recovery in ground effect or at low altitudes poses an unnecessary risk and is not warranted in the Cabri G2 when a similar manoeuvre could be practised safely above 1000 ft above ground level. Such a manoeuvre at low altitude is not described or recommended in the aircraft flight manual.
