## Safety of seafarers

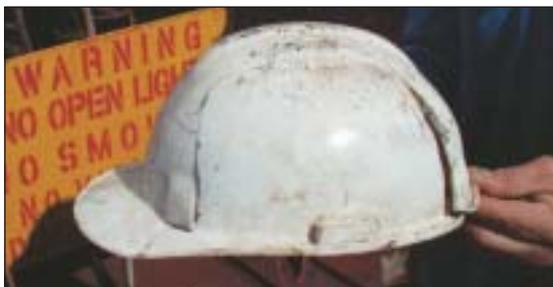
A seaman was killed and two other seamen were seriously injured when the lifeboat they were in fell 20 metres to the water after the wire falls parted. The limit switches did not operate and the falls parted when the davits came up to their stops with the winch motor running. Another fatality was only prevented by a crewmember's safety helmet. This was one of three similar accidents where lives were put at risk.

In each case, the local control for hoisting had failed to operate. The winch motors were then operated by manually depressing the contactor in starter panels situated in fan rooms or the funnel casing, from where the boats could not be seen. The effect of manually depressing the contactor was to bypass the limit switches, resulting in the winches continuing to run after the davits were 'home', and the falls parting.

**The risk of such accidents would be reduced by posting warning notices at the starter boxes for all lifeboat winches drawing attention to the hazard of operating the winch with the contactor, particularly if there are personnel in the boat.**

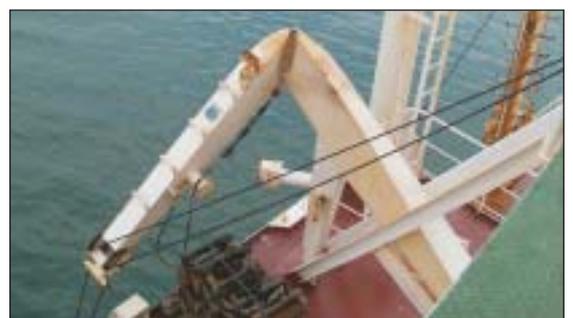
In the accidents described above, instead of determining why the boats could not be hoisted in the normal manner by using local or remote controls, an unsafe practice was followed, causing the accidents.

If, for operational reasons, it is necessary to recover a boat by operating a winch from its remote starter box, it is recommended that the following precautions are taken:

- The boat's crew are disembarked before hoisting starts and the boat is hoisted to embarkation deck level, or,
- The boat is initially hoisted to the embarkation deck where the crew are disembarked
- In either case, hoisting will have to be carried out with communications being checked to ensure that the recovery of the boat can be carefully monitored
- The lifeboat can then be turned in by manually winding in the falls.

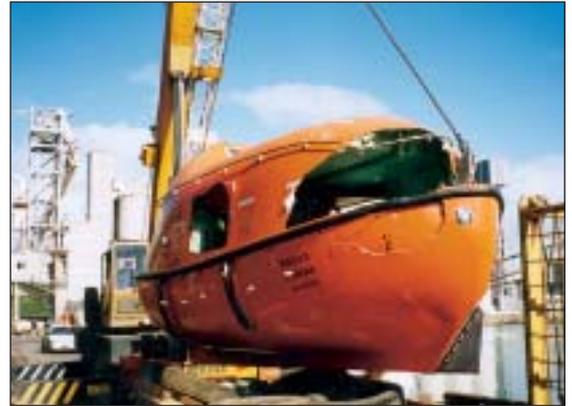
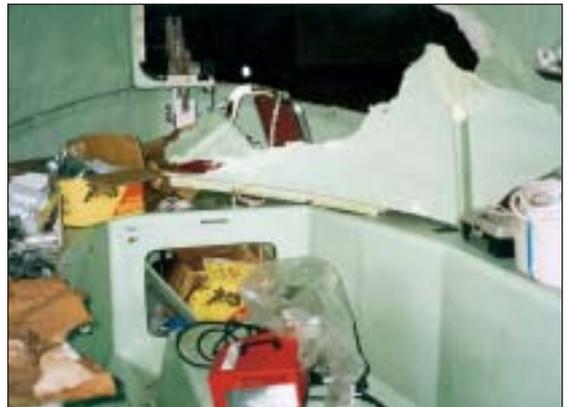
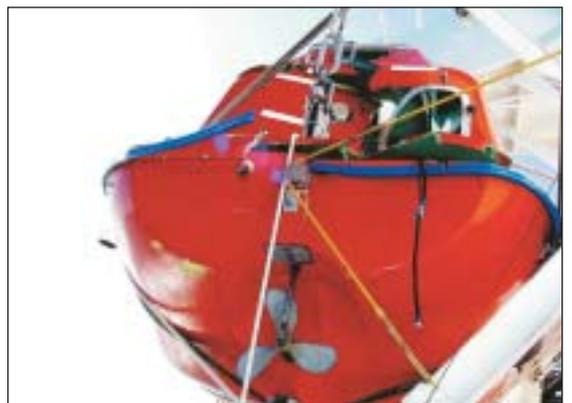
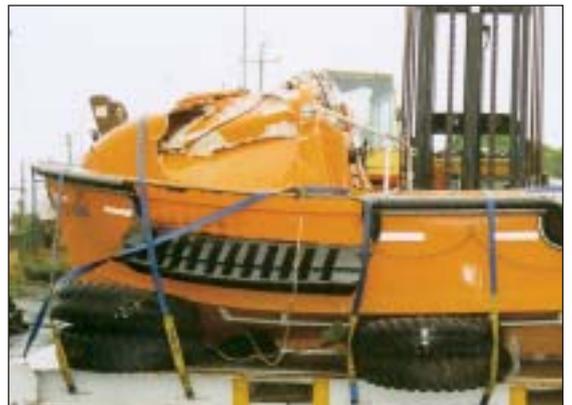
An accident occurred during a port state control inspection when a surveyor asked to see a lifeboat engine run ahead and astern. After some minutes with the engine running but the shaft in neutral, the boat detached from the falls and fell almost 20 metres to the water. Its crew were admitted to hospital with significant injuries, one of them with serious head and spinal injuries.

The Australian investigation into this incident determined that the lifeboat falls release mechanism had been armed and in a condition for instant, on load, release. It was considered likely that a crewmember had used the falls release lever, believing it to be the gear lever for ahead and astern movements of the engine.

- The boat was released by the operation of the release lever by one of the persons in the boat. The on-load release mechanism safety pin, preventing movement of the quadrant, was not in position and the release system was in the 'armed condition'.
- Although the boats were swung out at regular intervals and were in good working order, the vessel's crew were insufficiently practiced in the use of the release gear.
- No one in the boat understood how the on-load release mechanism operated.
- The languages used in the instruction manual and on notices inside the boats were not understood by the crew.
- Language difficulties between the crewmembers were a factor in the incident.
- The incident could have been prevented by the fitting of an operational interlock designed to ensure a two stage release of the boat.
