Incorrect configuration involving Airbus A320, VH-FNP

Newman Airport, Western Australia, 24 July 2013

ATSB Transport Safety Report
Aviation Occurrence Investigation
AO-2013-149
Final – 25 February 2014

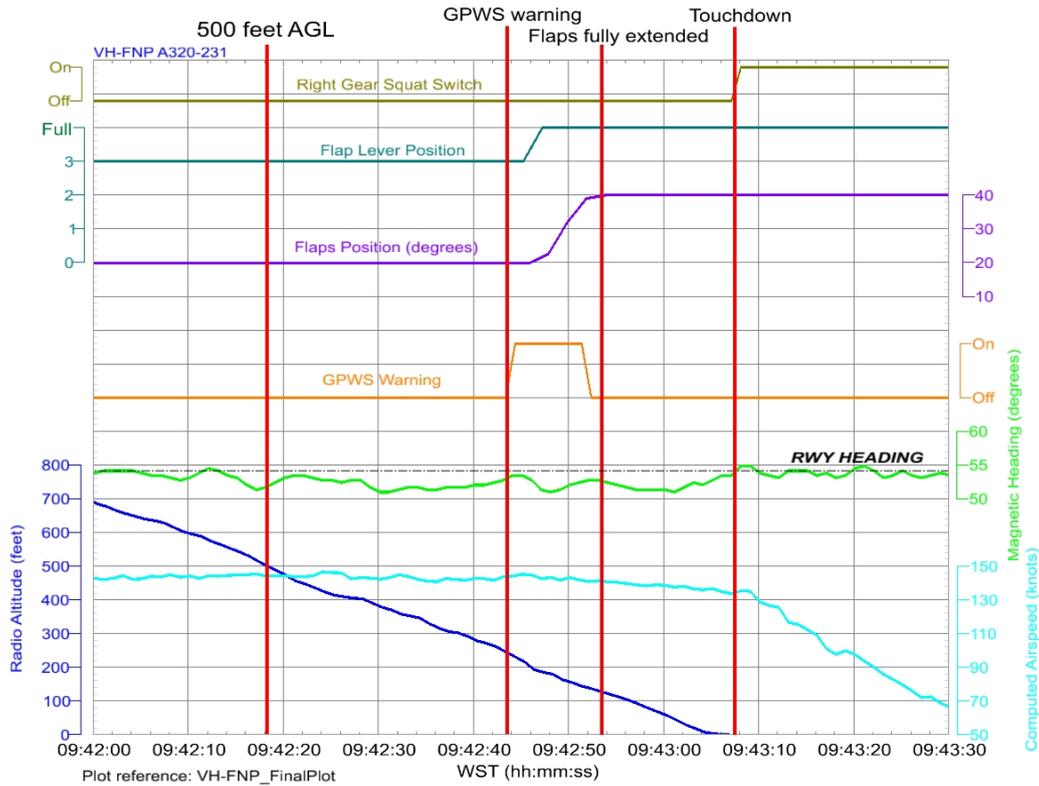
Figure 1: Summary of flight data

When on final approach, the crew reported everything was going to plan and as briefed. The aircraft was on the correct glidepath and on speed. By 500 ft AGL, the landing gear had been extended and 'Flap 3' was selected (Figure 1). As the visual approach had been programmed into the FMGS, the crew expected to receive the automatically generated callout of '500' (500 ft AGL), at which stage they would verify that the approach was stable and the aircraft was configured for landing. On this occasion, neither pilot could recall this callout occurring.

Shortly after, the crew received a ground proximity warning system (GPWS), 'TOO LOW FLAP' warning. The FMGS had been programmed for a 'flap full' landing, but at the time of the warning, Flap 3 was selected. The FO was focussing on the later part of the approach and assessed the aircraft to be at around 500 ft AGL. The FO called 'Flap Full - landing checklist'. At that stage, the captain was maintaining a visual lookout for other traffic and negotiating separation via the radio. With the exception of the final stage of flap, an assessment was made that the aircraft was within all the correct parameters, and it was determined that the safest course of action was to select 'Flap Full' and land. 'Flap Full' was selected, the GPWS warning silenced, and the aircraft landed safely at about 0943.

The aircraft was fitted with a flight data recorder (FDR) and following the incident, the data was downloaded and provided to the ATSB. The data showed the following (Figure 1):

- the aircraft was on the correct vertical and lateral path during the approach
- no large changes in pitch or roll were made
- thrust was stabilised
- vertical speed was not excessive

- the GPWS warning activated at 231 ft Radio Height
- Full flap was selected at 185 ft
- The flaps were fully extended at approximately 144 ft

- The company's standard go-around procedure is to be reviewed with regard to the requirement to maintain runway track
- A remedial training program was developed for the crew, which included human factors; simulator training; a simulator check; line training; and a line check.
