Loss of control involving a Bell 206B, VH-SMI

7 km NE of Horn Island, Queensland, 31 July 2013

ATSB Transport Safety Report
Aviation Occurrence Investigation
AO-2013-121
Final – 26 May 2014

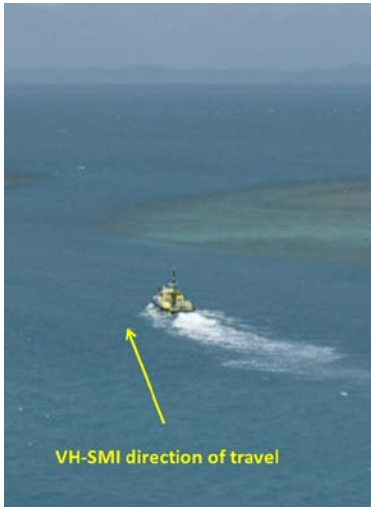
Figure 2: Approaching

After having completed four passes over the vessel, above 500 ft above sea level, the pilot positioned the helicopter for the next pass. Maintaining 200 ft, and with an airspeed of about 55 kt, the helicopter approached the vessel from behind and to the left (Figure 2). The vessel was travelling into wind.

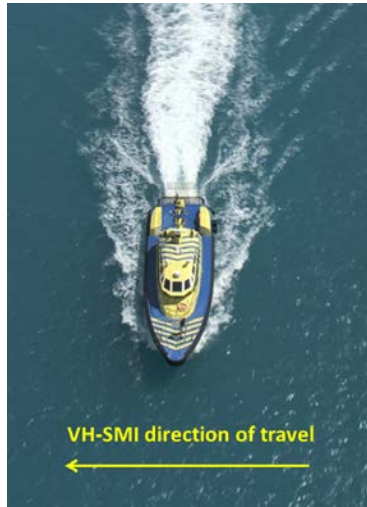
Figure 3: Passing in front

As the helicopter flew abeam the vessel, the pilot initiated a climb and selected about 95% engine torque and then commenced a right turn, to pass in front (Figure 3). The helicopter passed in front of the vessel at about 300-400 ft. At that time, the pilot was monitoring the view finder to ensure that the helicopter's skids did not impede the film shot. The pilot reported that the wind direction was then 280° relative to the helicopter.

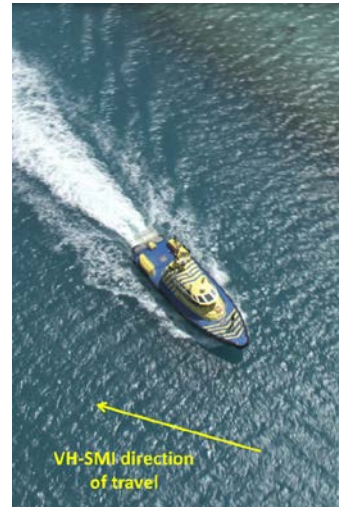
Figure 4: Prior to LTE

After having completed the film shot (Figure 4), when at about 450 ft, the helicopter entered an uncommanded yaw right by about 25-30° and started to experience a loss of tail rotor effectiveness (LTE). In response, the pilot attempted to manoeuvre the helicopter into wind by applying forward and left cyclic.¹ The pilot reported that the helicopter rotation stopped, but shortly after, it began to yaw right again. The pilot believed that he was not going to be able to recover from the situation.

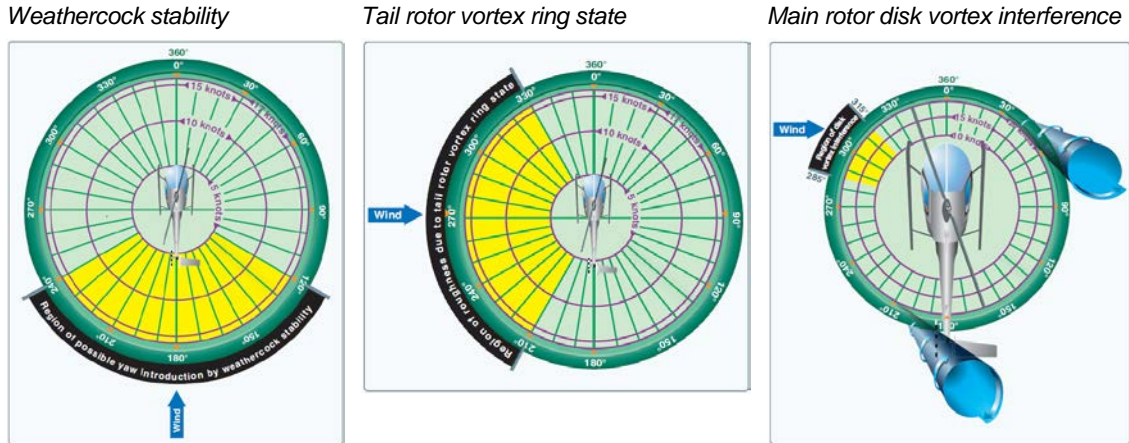
Figure 6: Relative wind azimuth regions

Any manoeuvre that required the pilot to operate in a high-power, low-air-speed situation with a left crosswind or tailwind, created an environment conducive to LTE. The susceptibility for LTE was also greater in right turns for US designed helicopters such as the Bell 206B, particularly during low airspeed flight where the pilot may not be able to stop the yaw. Flight and wind tunnel tests had identified four relative wind azimuth regions and aircraft characteristics that could, singularly or in combination, result in LTE (Bell Helicopter Information Letter 206-84-41) (Figure 6).

- *Weathercock stability (120° to 240°)*: the helicopter will attempt to weathercock its nose into the relative wind. The helicopter will then make an uncommanded turn to the right or left, depending on the wind direction.
- *Tail rotor vortex ring state (210° to 330°)*: the vortex ring state will cause tail rotor thrust variations, which result in yaw rates.

- *Main rotor disc vortex interference (285° to 315°)*: main rotor vortex passes the tail rotor, reducing the tail rotor angle of attack. This causes a reduction in thrust and a right yaw acceleration will commence.
- *Loss of translational lift (all azimuths)*: results in increased power demand and additional anti-torque requirements. If this occurs during a right turn, the turn will be accelerated as power is increased unless corrective action is taken.

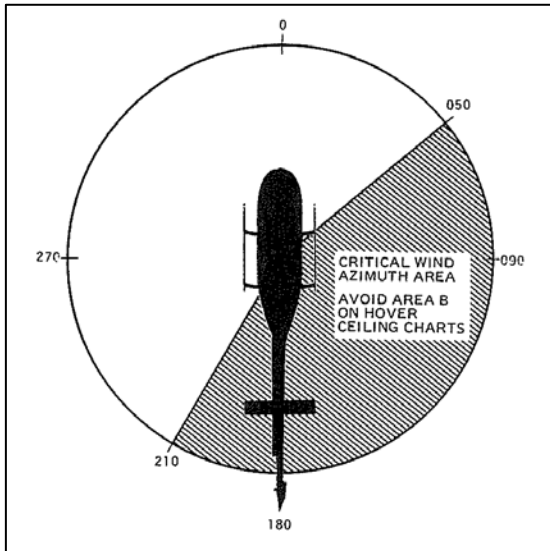
Figure 7: Critical relative wind azimuth area

The Bell Information Letter also emphasised that the helicopter could be operated in all of the above conditions if suitable attention was given to controlling the helicopter. However, if the pilot's attention was diverted and a right yaw rate commenced, the rate may increase unless appropriate corrective action was taken. It further noted that the above did not replace the critical relative wind azimuth chart located in the helicopter's flight manual (Figure 7).
