Runway excursion involving a Saab 340B, VH-ZRL

Taree Airport, New South Wales, 22 February 2013

ATSB Transport Safety Report
Aviation Occurrence Investigation
AO-2013-061
Final – 17 June 2014

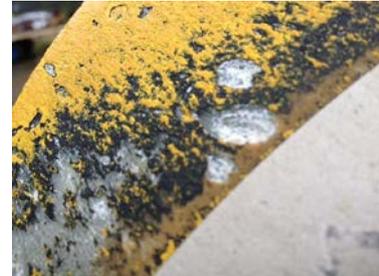
Propeller blade damage

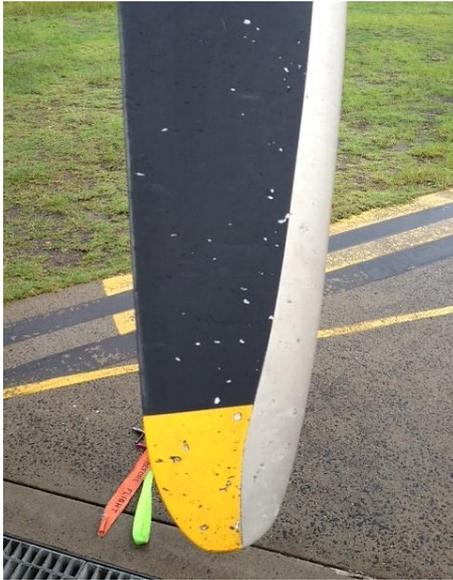
Figure 1: Propeller blade damage

The next day the flight to Grafton was conducted, with the required external inspections of the aircraft conducted by the FO. The aircraft then returned to Sydney, at which time maintenance personnel conducted an inspection of the aircraft and observed damage to the left propeller blades. All four blades had sustained stone damage predominantly on the back (reverse) of the blades (Figure 1). Individual blade damage repairs may have been carried out with the blades remaining in place; however, the four blades were all replaced in order to allow effective repair processes to be completed.

- He had conducted a thorough visual inspection of the left landing gear and top surface of the left propeller blades. When conducting his inspection, he stood facing the propellers and turned the blades in an anti-clockwise direction. This was suitable for sighting the front surface of the blades, but not the reverse side. He had also conducted a tactile inspection of the leading edge of the blades. He had got out of the habit of inspecting the surface of the reverse side of the blades and consequently did not see the damage.

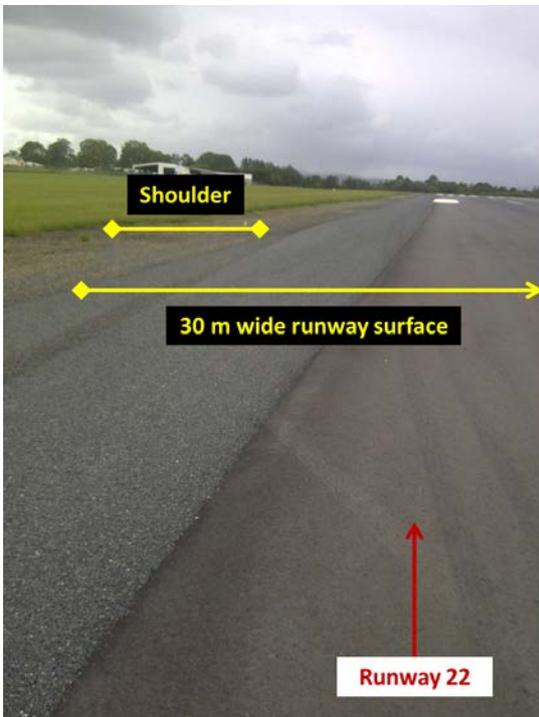
Figure 2: Runway surface

Runway 04/22 at Taree consisted of a 30 m wide runway with a 3-4m wide soil and gravel shoulder either side (Figure 2). A subsequent runway inspection during daylight hours determined that the aircraft had veered onto the runway shoulder (Figure 3).

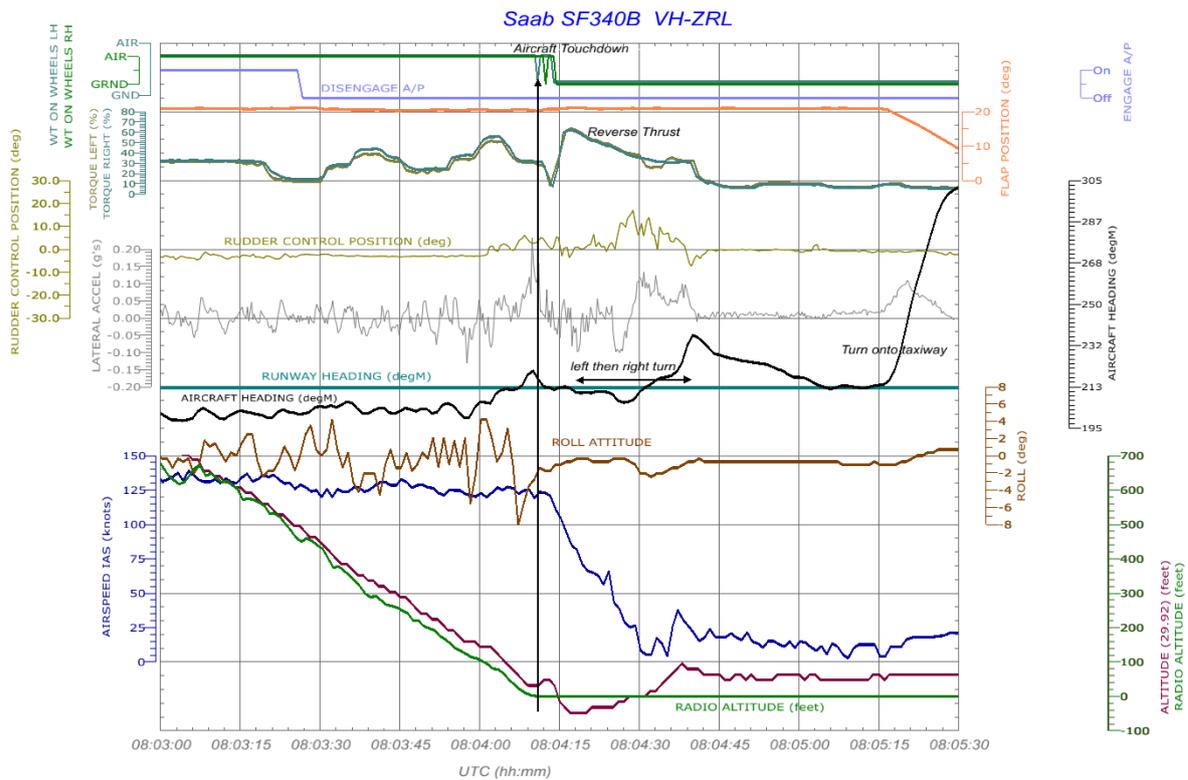
Figure 4: Summary of flight data

The aircraft was fitted with a flight data recorder (FDR) and following the incident, the data was downloaded and provided to the ATSB. The recorded data (Figure 4) showed that, during final approach, the aircraft's heading was less than the published runway heading, indicating that the aircraft was experiencing a crosswind from the left. When at about 800 ft, the calculated crosswind component was about 30 kts and decreased to about 13 kt when at about 100 ft.⁷ At 1904:08, just prior to touchdown, the aircraft rolled left by about 8° and right rudder was applied. The aircraft rolled back to the wings level position.

As the aircraft touched down the weight on wheels parameter changed state several times before indicating the aircraft was firmly on the ground. The recorded lateral acceleration indicated that the aircraft was subjected to a side loading toward the left at touchdown.

After touchdown, reverse thrust was selected. As the aircraft's airspeed reduced through about 65 kt, the heading began to swing to the left. Right rudder was applied and the aircraft then turned toward the right at 1904:29, at an airspeed of 25 kt. The recorded lateral acceleration indicated that the aircraft was subjected to a side loading during the turn and rolled to about 2.5° left wing down. The rate of turn reduced, coincident with the left engine torque being reduced (a reduction in reverse thrust) to a lower value than the right engine torque.

After 1904:38, the rate of turn increased, but the lateral acceleration and roll attitude decreased. The right turn stopped at 1904:41 and with an airspeed of 21 kt, a left turn began. The left turn continued until 1905:06 when a heading of 213° was established and maintained until 1905:18 when a right turn onto the taxiway was commenced.
