# Loss of control involving a Cirrus SR22, N802DK

near Katoomba, New South Wales, 10 May 2014

**ATSB Transport Safety Report**  
Aviation Occurrence Investigation  
AO-2014-083  
Final

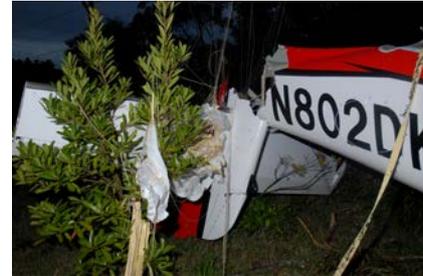
### Damage to N802DK

The aircraft was overhead high voltage powerlines and the passenger in the front seat asked the PIC whether there was any way to manoeuvre the aircraft to avoid them and was advised that there was not. The aircraft narrowly avoided the powerlines, collided with branches of a tree, and came to rest on a fence in the garden of a residential dwelling (Figure 1). The passenger in the front seat reported that he observed that the ignition and master switches and fuel selector were still 'ON' and selected them to 'OFF'. He reported that he had to shake the PIC as he appeared dazed, and told the PIC and the passenger to hurry up and open the door and exit the aircraft. The PIC reported that after exiting the aircraft he confirmed that no injuries had been sustained and spoke to National Search and Rescue personnel to confirm that the emergency beacon had been activated.

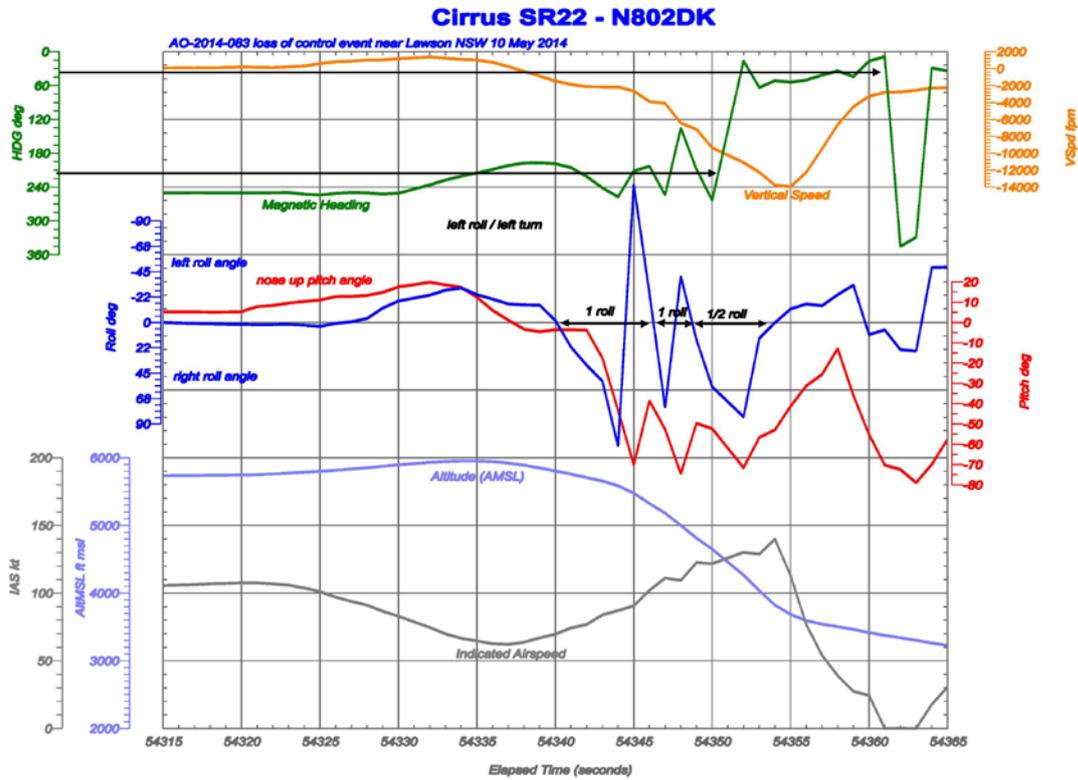
Figure 2: Roll and pitch data

At the commencement of the manoeuvre, when at about 5,800 ft AMSL, the aircraft nose pitched up to about 20°, and simultaneously entered a left turn with about 25° angle of bank (roll) (Figure 2). The maximum roll value in the turn was about 30° with a corresponding pitch angle of about 17°. The indicated airspeed reduced to about 62 kt. The right wing then dropped rapidly and the aircraft rolled to the right, the nose pitched down to about 70° and the aircraft commenced a nose low spin to the right. The first complete roll to the right took about 6 seconds and the second roll had a noticeably higher roll rate and took about 2.5 seconds. The roll rate then reduced, with the next 180° of roll taking about 5 seconds. The CAPS was deployed and the parachute inflated when the aircraft was about 1,000 ft above ground level. The aircraft continued to roll when the parachute inflated, and the aircraft nose pitched down about 80°. The maximum vertical speed reached about 14,000 feet per minute prior to the CAPS deployment.

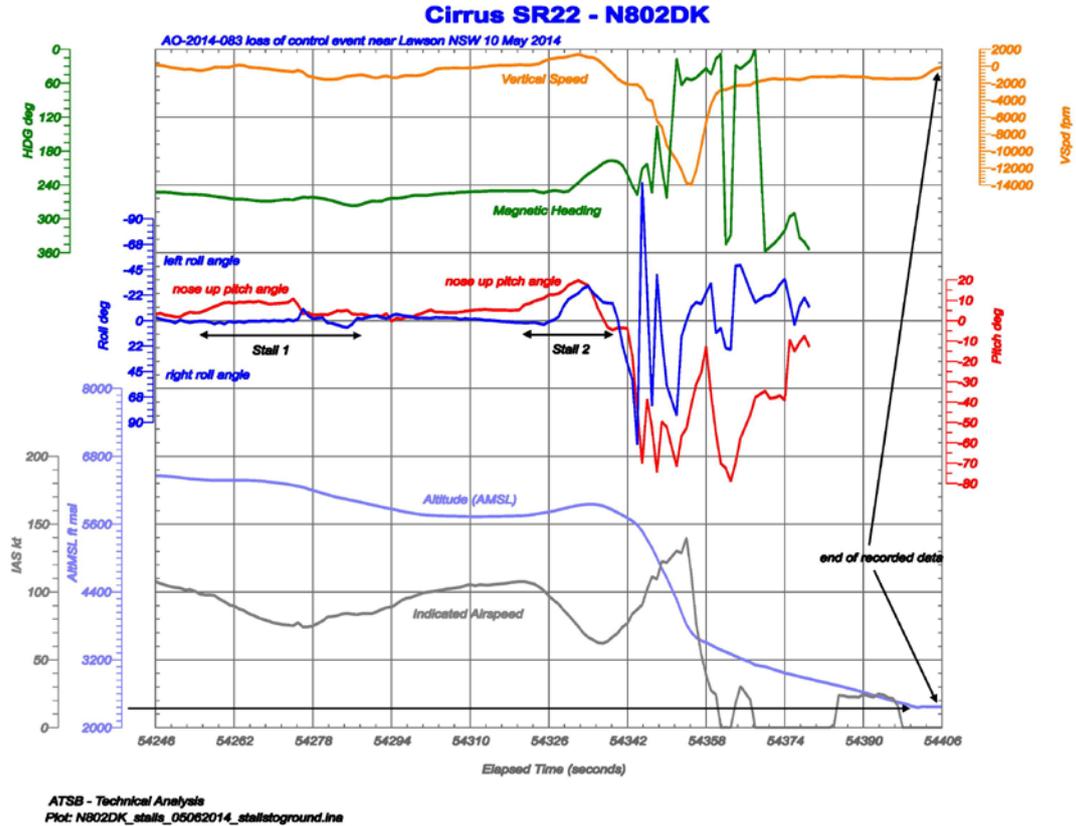
Figure 3: Flight data from N802DK

Figure 3 shows the flight data from the commencement of the first stall until the aircraft collided with the ground. The nose up pitch angle in the first stall reached a maximum of about 9°, and in the second stall about 20° was reached. The first stall developed over a period of about 25 seconds before recovery and the second was about 16 seconds prior to the aircraft nose dropping below the horizon. In the first stall, the airspeed reduced from 100 kt to 75 kt in about 25 seconds, and in the second stall the airspeed reduced from about 100 kt to 62 kt in about 12 seconds.

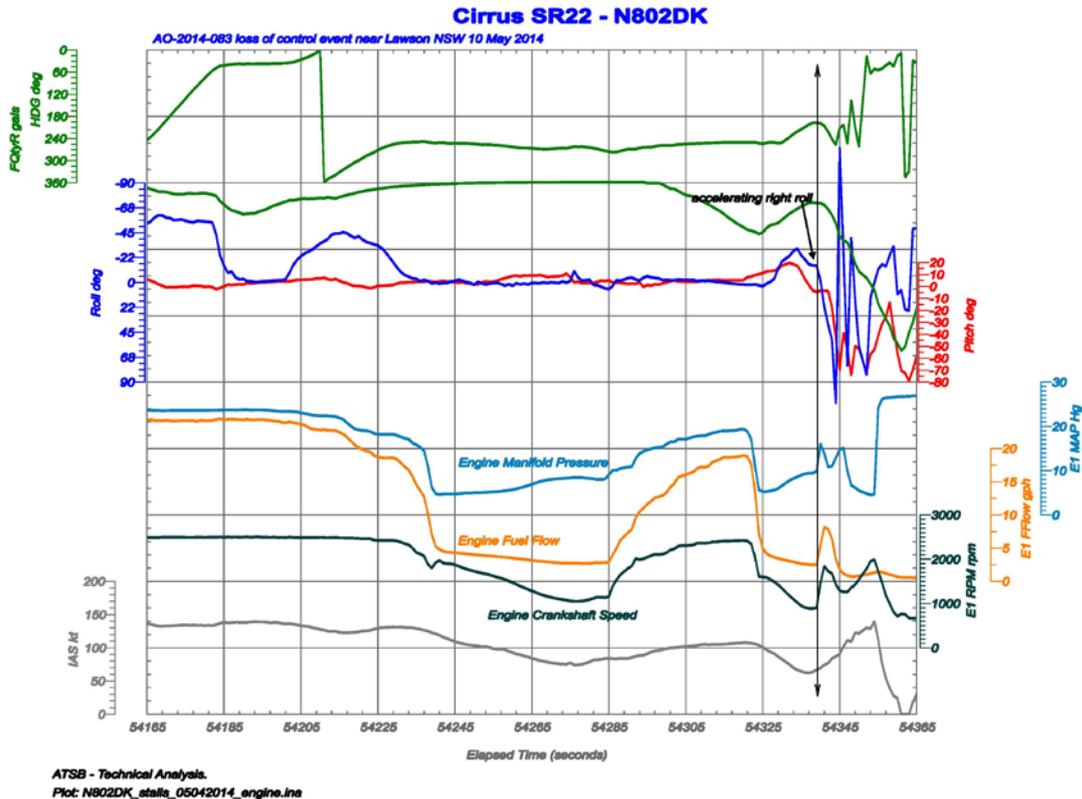
Figure 4: Flight data depicting engine settings

Figure 4 depicts the engine parameters during the steep turn, the wings-level stall and the subsequent stall, spin and CAPS deployment. The manifold pressure, fuel flow and crankshaft speed (rpm) were reduced prior to commencement of the manoeuvre. These then increased in a consistent manner at the incipient spin stage. The rpm increased momentarily prior to the engine shutdown while the manifold pressure was low. This may have been due to increasing airspeed, low nose attitude and high rate of descent.
