Operational-Warning device – Alice Springs Airport – 18 September 2008

Abstract

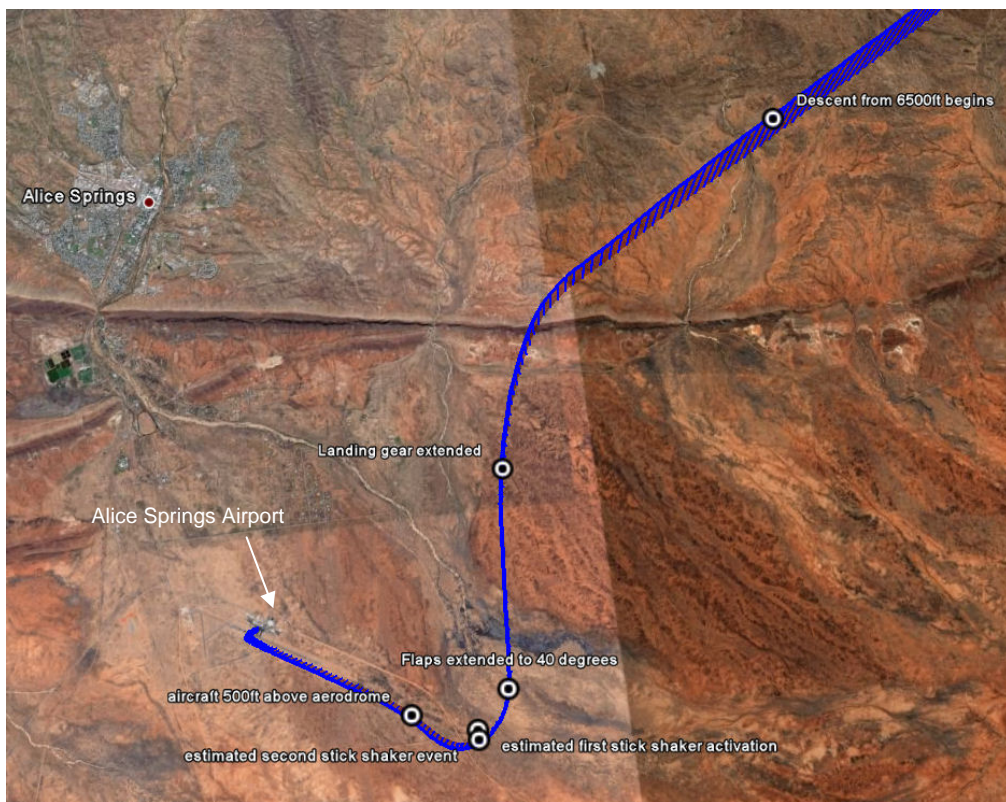
Figure 1: Aircraft final approach path

On 18 September 2008, a Boeing Company 717-200 (717) aircraft, registered VH-NXE (NXE), was being operated on a scheduled passenger service from Cairns, Qld, to Alice Springs, NT, with six crew and 70 passengers. During a visual approach to runway 30 at Alice Springs Airport, the pilot in command (PIC) reported that the aircraft stick shaker momentarily activated on two occasions during the final turn to the runway. (Figure 1)

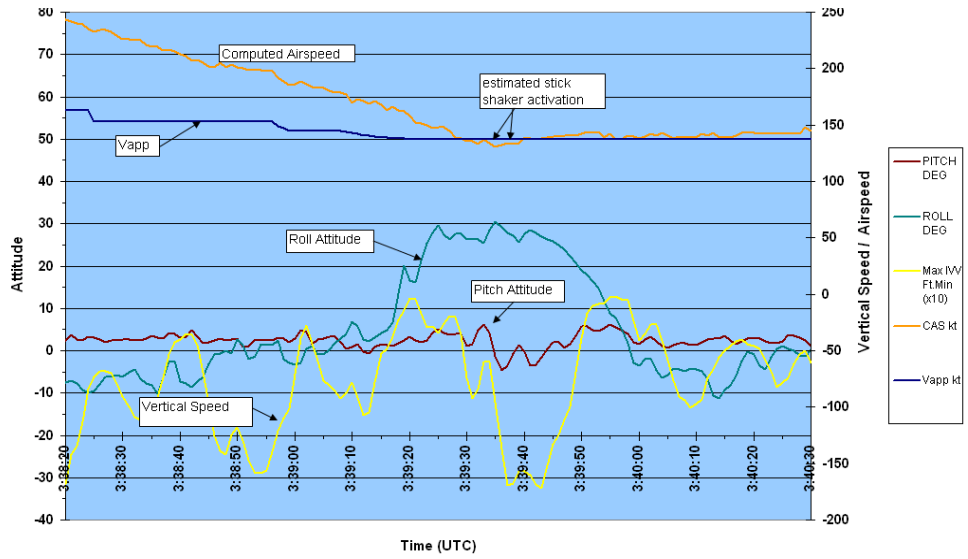
Figure 2: FDR airdspeed and stall warning

During the right turn to position the aircraft onto the final leg of the approach, the QAR indicated the computed airspeed was below the calculated approach speed for approximately seven seconds to a maximum value of approximately six kts (Figure 2). It was during this time, at 1309:32 when, at a bank angle of 30 degrees, that the stick shaker³ activated momentarily. In response to this warning, the handling pilot moved the thrust levers forward and reduced the back pressure on the control column. It was at this time the handling pilot identified the autothrottle was not engaged and re-engaged it.

Five seconds after the first stick shaker activation, the stick shaker momentarily activated again. The handling pilot again reduced the back pressure on the control column and the stick shaker stopped.

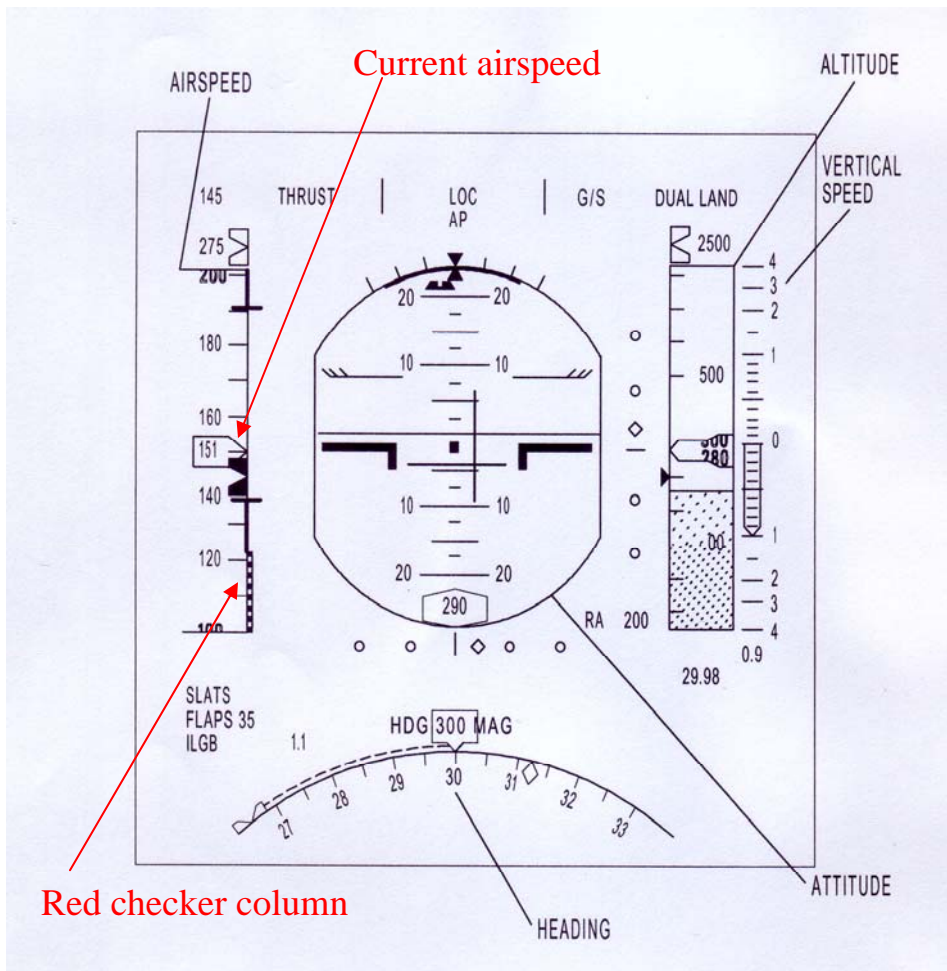
Figure 3: Pilots primary flight display

The pilot's primary flight display shows the red checker column that moves vertically on the left of the display and graphically displays the margin between the stick shaker activation speed and the current airspeed (Figure 3). When the top of the red checker column reaches the current airspeed indication, the stick shaker will activate. The margin between the current airspeed and the stick shaker speed is dynamic and is continuously displayed throughout the flight and while manoeuvring to land.
