Loss of control during landing, involving a Diamond DA40, VH-CGT

Bankstown Airport, New South Wales, 16 May 2014

ATSB Transport Safety Report
Aviation Occurrence Investigation
AO-2014-090
Final – 15 October 2014

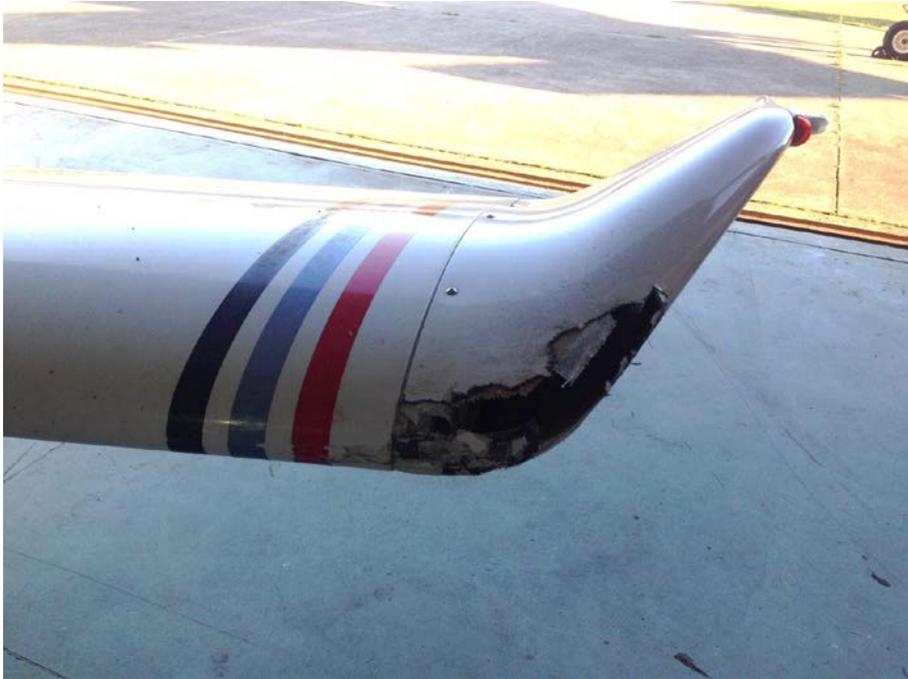
Figure 1: Left wingtip damage

Within seconds, the aircraft rolled rapidly to the left and stalled, resulting in the left wingtip striking the ground (Figure 1). The aircraft then turned further left through about 100 degrees, and the wings levelled. It continued in this direction, crossing over taxiway Bravo, then through a wire perimeter fence, coming to rest about 25 m later, in the long grass of an open paddock (Figure 2).
