# Wheels-up landing involving a Cessna 210, VH-JGA

Cairns Airport, Queensland on 11 November 2014

**ATSB Transport Safety Report**  
Aviation Occurrence Investigation  
AO-2014-178  
Final – 10 June 2015

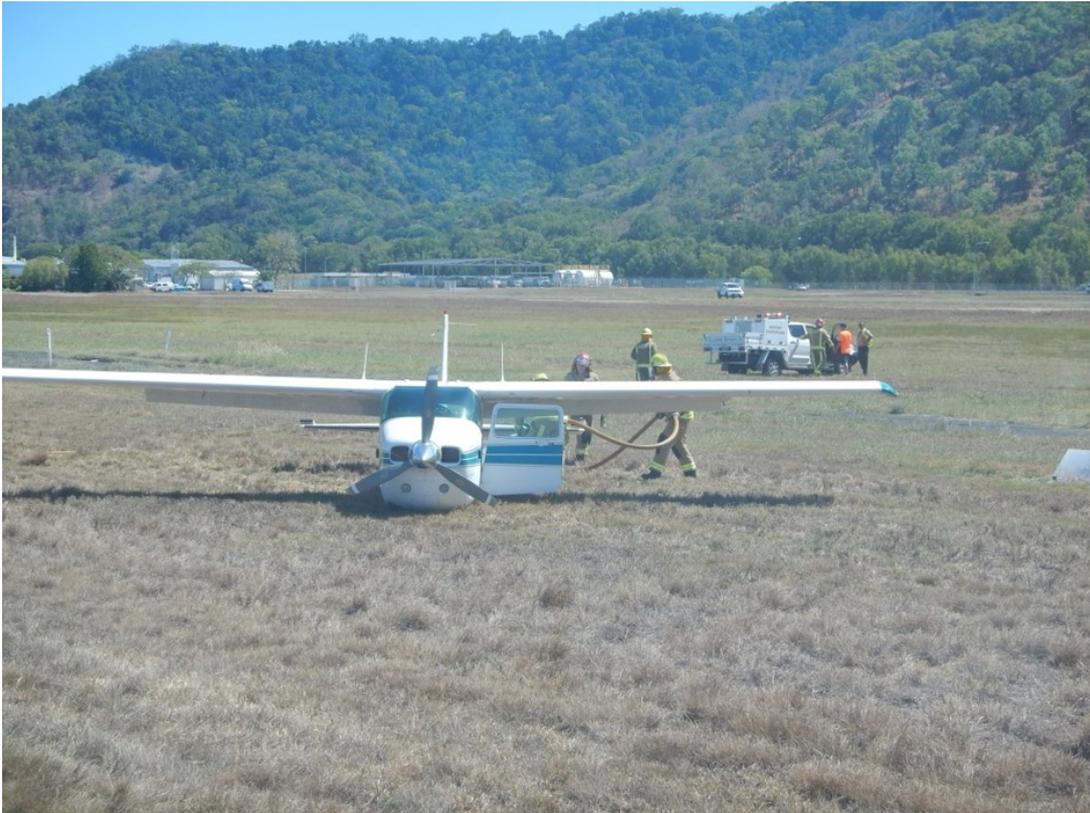
The pilot of JGA conducted two practice approaches to assess the aircraft configuration and landing area before beginning the approach for a wheels-up landing. The pilot extended the flaps to help slow the aircraft and, after turning onto a long final, briefed the passengers for the landing and instructed them to take up the brace position. Just prior to touchdown, the pilot turned off the master switch and moved the engine mixture control to the cut-off position. At about 1416, the aircraft landed on the fuselage underside on the grass area abeam runway 33 and came to a stop. The pilot and four passengers were uninjured and the aircraft was substantially damaged (Figure 1).

**Figure 1: Damage to JGA**

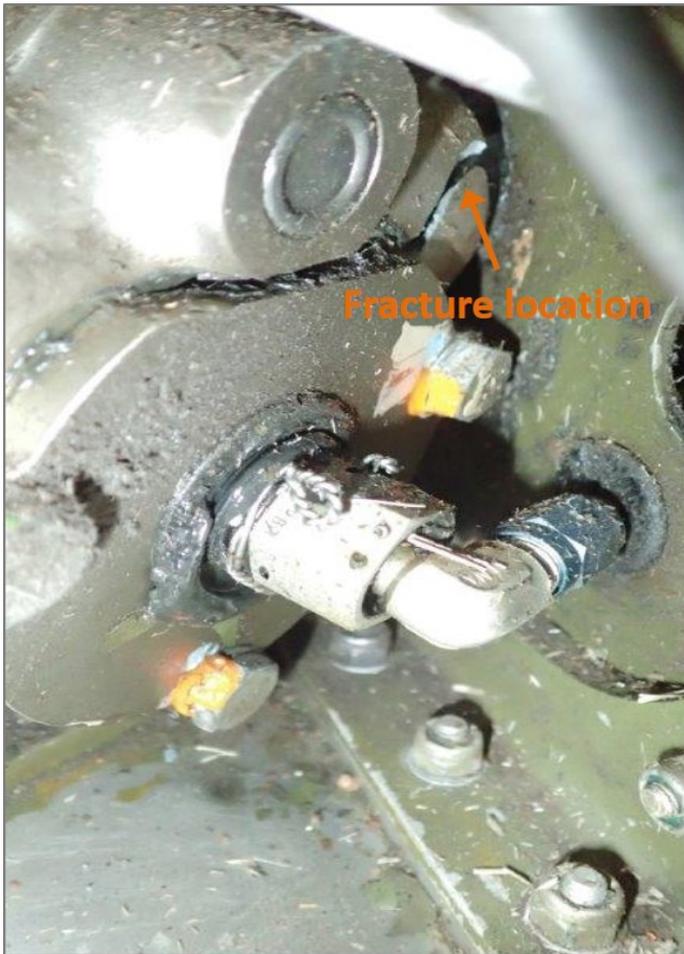
The operator conducted an investigation into the accident and determined that the housing of the left main landing gear had fractured (Figure 2), resulting in the gear not extending to the down and locked position. The operator reported that they conducted a visual inspection of the left and right main landing gear actuators for cracks and checked the tightness of the actuator mounting bolts at the periodic (100 hourly or 12-month) maintenance inspections with the actuator in-situ. The last inspection was conducted about 50 hours prior to the accident, with no defects found.

**Figure 2: JGA left main landing gear actuator showing the fractured housing**

Information provided to the operator by the aircraft maintenance organisation was that the actuator fractured in what appeared to be one clean break and not a crack that slowly progressed, and that type of crack could occur in a sudden overload situation during the take-off when the landing gear is selected up and the wheels contact the ground. The maintenance organisation also recommended that the Service Bulletin requirements be carried out on aircraft that have exceeded 5,000 airframe hours.

The operator's Cessna 210 aircraft fleet will undergo further examination to see if there is any evidence of other potential failures within the fleet.

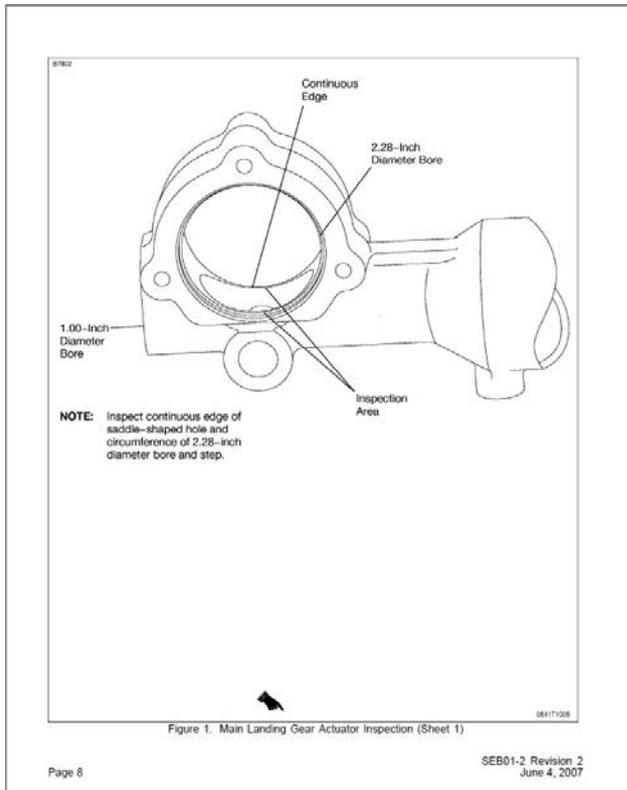
Cessna Service Bulletin SEB01-2 *Main Landing Gear Actuator Inspection* revision 2 dated 4 June 2007, required the inspection of the main landing gear actuators for the presence of cracks. Indicating that non-compliance with the service bulletin could result in failure of the main landing gear actuator. The service bulletin required the removal and disassembly of the main landing gear actuators and a fluorescent penetrant inspection of the actuator body to be carried out using black light and a magnifying glass to detect any cracks (Figure 3). The inspection was to be carried out initially every 3,000 hours total time in service within the next 100 hours operation and subsequent inspections every 500 hours total time in service thereafter.

**Figure 3: Cessna Service Bulletin SEB01-2 main landing gear actuator inspection area**

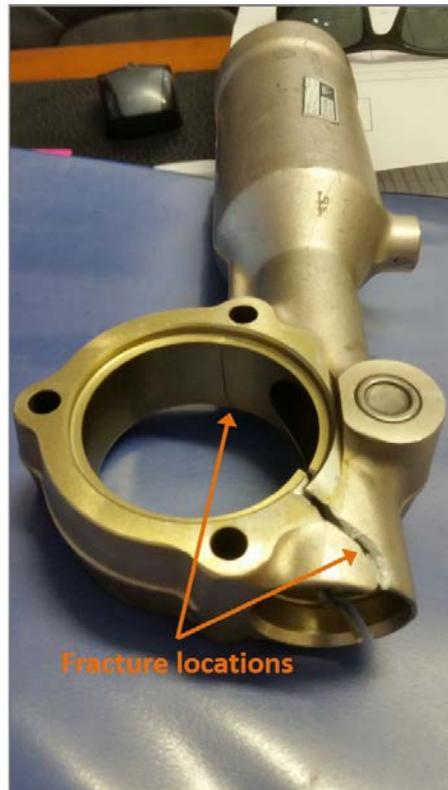
**Fracture located in JGA main landing gear actuator**
