Windscreen fogging and collision with terrain involving a Robinson R22, VH-RBT

11 km east of Boyup Brook ALA, Western Australia on 23 June 2015

ATSB Transport Safety Report
Aviation Occurrence Investigation
AO-2015-064
Final – 4 November 2015

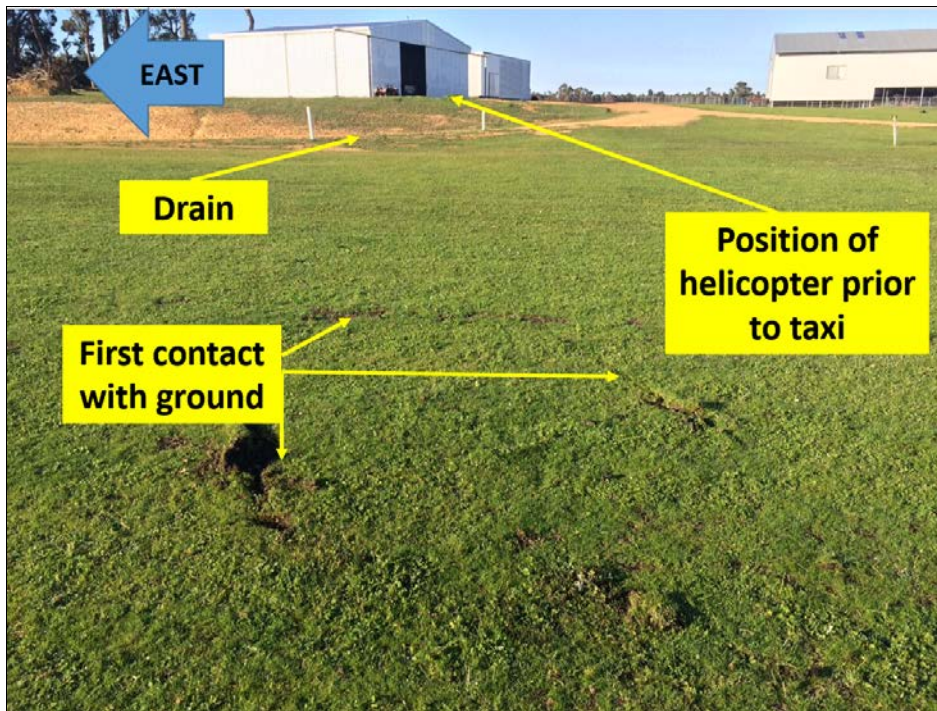
Prior to commencing the flight, the pilot re-checked the area meteorological forecast (ARFOR). The ARFOR indicated the probability of low cloud with fog, west of Boyup Brook ALA. The pilot reported that it was a cold and clear morning, with calm conditions. Although there was fog in a gully, about 200-300 m down the slope from the hangar, the general area and intended flight path were completely clear (Figure 1).

Figure 1: Marks where the helicopter tail and skid struck the ground. The drain the pilot planned to clear prior to transitioning to forward flight and hangar are in the background

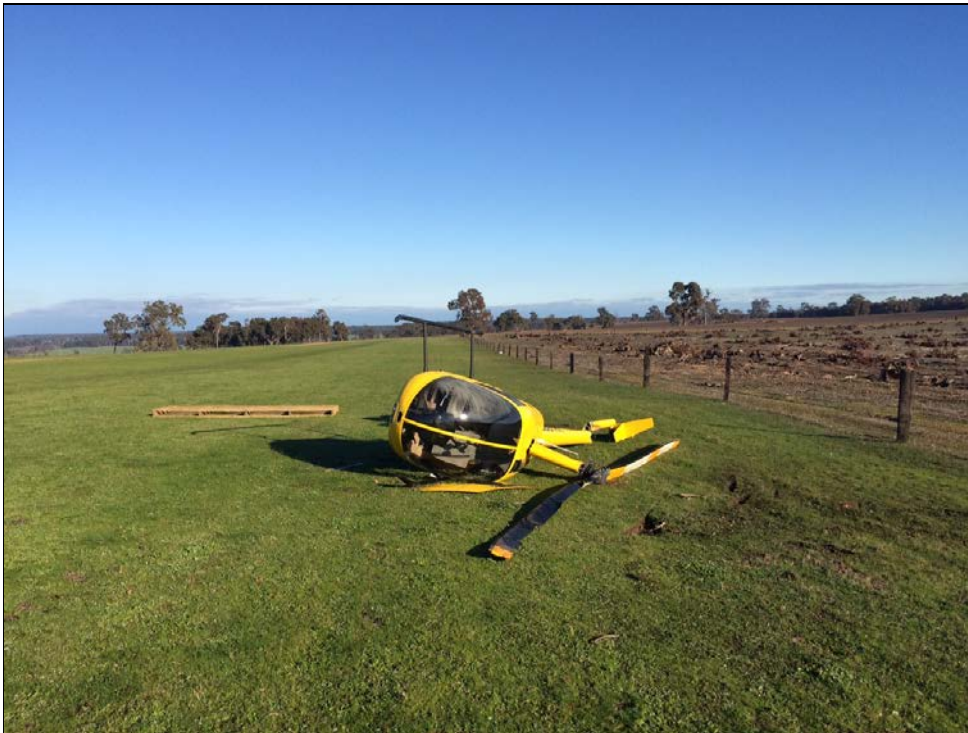
Now about 30-40 ft above the ground, the pilot elected to put the helicopter back on the ground. Manoeuvring slightly left to avoid the assumed position of the drain, the pilot unexpectedly felt the tail and rear skids of the helicopter strike the ground. The pilot stated this was a heavy collision, and resulted in the helicopter bouncing back into the air. The pilot applied some collective and the helicopter bounced again then yawed rapidly to the right. The pilot applied full left pedal in an attempt to prevent the helicopter from entering a spin, however the yaw continued, so the pilot rapidly reduced the throttle to idle. As the yaw decreased, the helicopter fell onto its left side (Figure 2).

Figure 2: VH-RBT at rest on the left side. Note the broken tail boom and rotor blades

The pilot was uninjured; however the passenger sustained minor injuries. The helicopter was substantially damaged.

A cold windshield that is exposed to slightly warmer or moist air can 'fog up'. It is likely that the helicopter moved between different temperature layers as it moved forward and up, and this may have led to a combination of temperatures suitable to allow fog.

The use of heaters, demisters (if fitted) and air vents should always be operated as per the manufacturer's recommendations.
