# Collisions with kangaroos involving a Fairchild SA227 (Metroliner) VH-HPE, at Thangool Airport and a King Air B200, VH-FDB

Thangool Airport, Queensland, 1 September 2015

Barcardine Airport, Queensland, 2 September 2015

**ATSB Transport Safety Report**  
Aviation Occurrence Investigation  
AO-2015-102  
Final 22 – December 2015

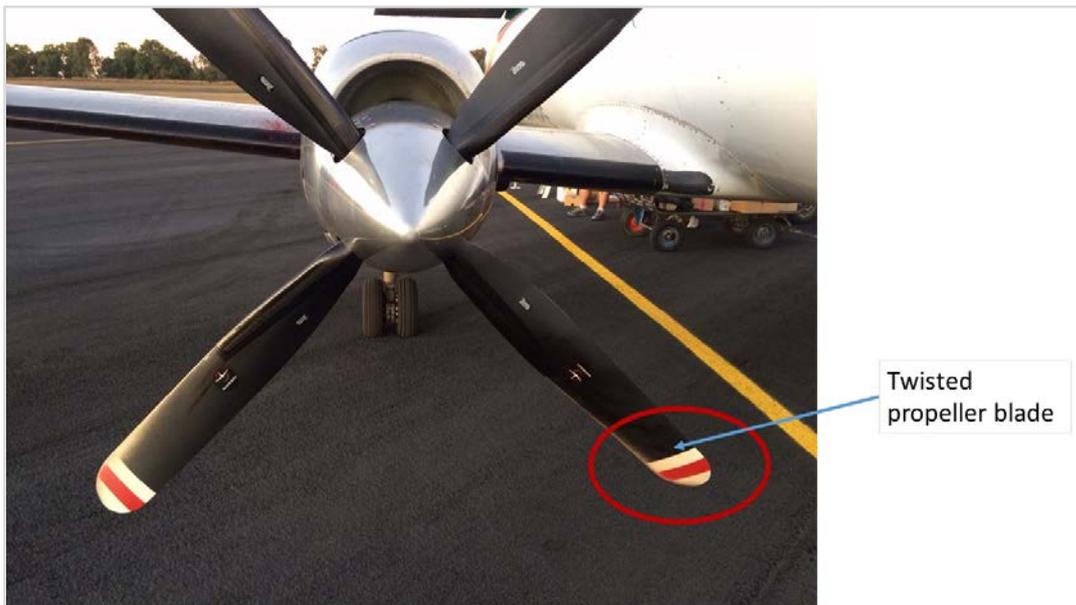
**Figure 1: Damage to propeller blade on VH-HPE**

Shortly after touchdown, and with all landing gear wheels in contact with the ground, the pilot saw the glimpse of an animal flash from left to right in front of the aircraft. At the time, the aircraft was travelling at about 80 kt. The right propeller then struck the animal, later identified as a small kangaroo. The pilot reported that following the large bang associated with the propeller striking the animal, there was a lot of vibration throughout the aircraft, but no abnormal engine indications. The pilot continued the landing roll, and used ground idle rather than reverse thrust to slow the aircraft.

The pilot taxied the aircraft to the parking bay, shut down the engines, then carried out an external inspection and found that one of the propeller blades attached to the right engine was twisted (Figure 1). The pilot was not injured.

Following the incident, the operator replaced the right engine and propeller and arranged for the original engine to be further assessed by engineering staff.

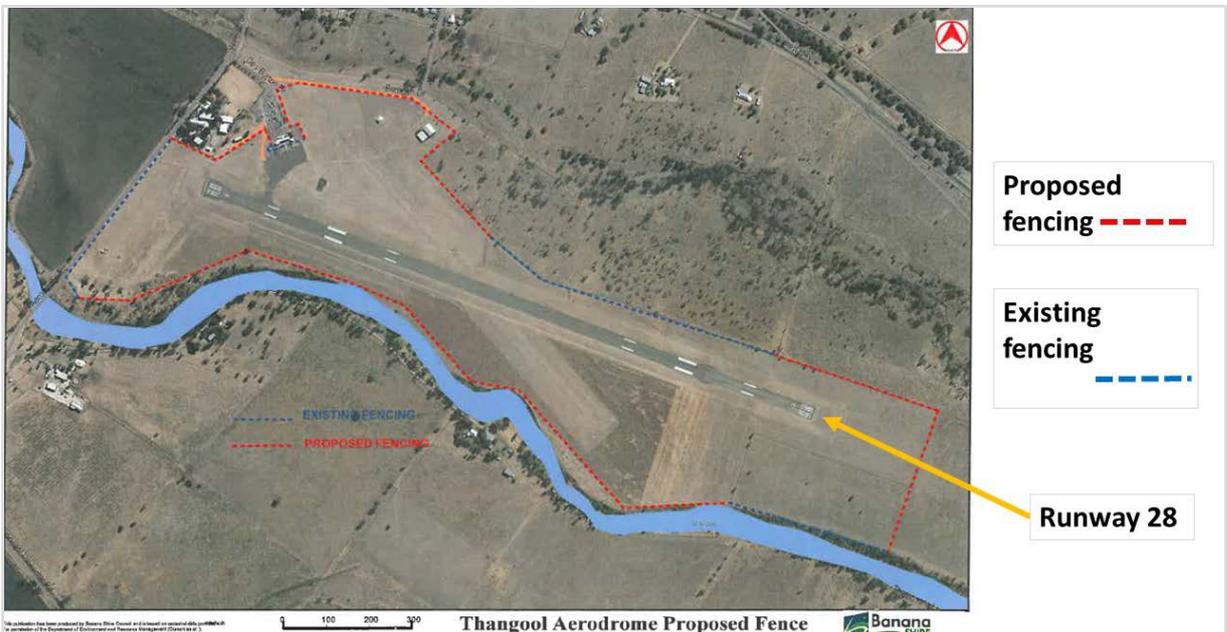
**Figure 2: Thangool airport with current and proposed fencing marked**

Sections of the Thangool Airport had wildlife protective fencing however, it is not fully fenced. At the time of publication, the Banana Shire Council, who own and operate the airport, had a funding application lodged with the Australian Government’s Regional Aviation Access Programme to enable the remainder of the airport fencing to be completed (Figure 2).

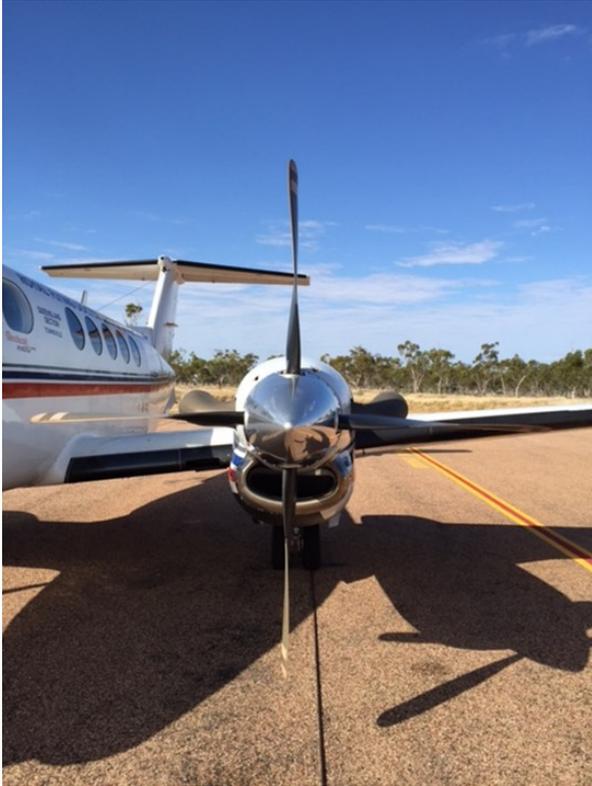
**Figure 3: VH-FDB showing twisted propeller blades**

On 2 September 2015, another kangaroo strike was reported to the ATSB (ATSB occurrence number 201503915). In this occurrence, a Raytheon B200 aircraft, VH-FDB, was on a medical retrieval mission from Townsville to Barcaldine Airport, Queensland. As the aircraft touched down in the early hours of the morning, at about 0141 EST the pilot caught a last moment glimpse of the animal before the aircraft struck a small kangaroo. The pilot reported that engine indications were normal, with no noticeable vibration as they completed the landing roll and then shut down the left engine while on the runway. They then taxied clear of the runway using the remaining engine. The strike caused damage to the three propeller blades attached to the left engine and disabled the aircraft (Figure 3)

The operator/crew had not requested a “roo inspection” prior to the landing. They have also advised the ATSB that apart from the propeller damage, the left engine power module may also need replacing.

The operator is amending their internal procedures, to automatically request a strip inspection for animals at any airport in the ERSA where an animal hazard is listed. This new procedure will also extend to requesting a strip inspection at any aeroplane landing area (ALA) when deemed appropriate.
