Separation issue involving a de Havilland DH-82A (Tiger Moth), VH-BJE and a Robinson R44, VH-HOQ

at Redcliffe (ALA), Queensland, on 7 November 2015

ATSB Transport Safety Report
Aviation Occurrence Investigation
AO-2015-130
Final – 13 April 2016

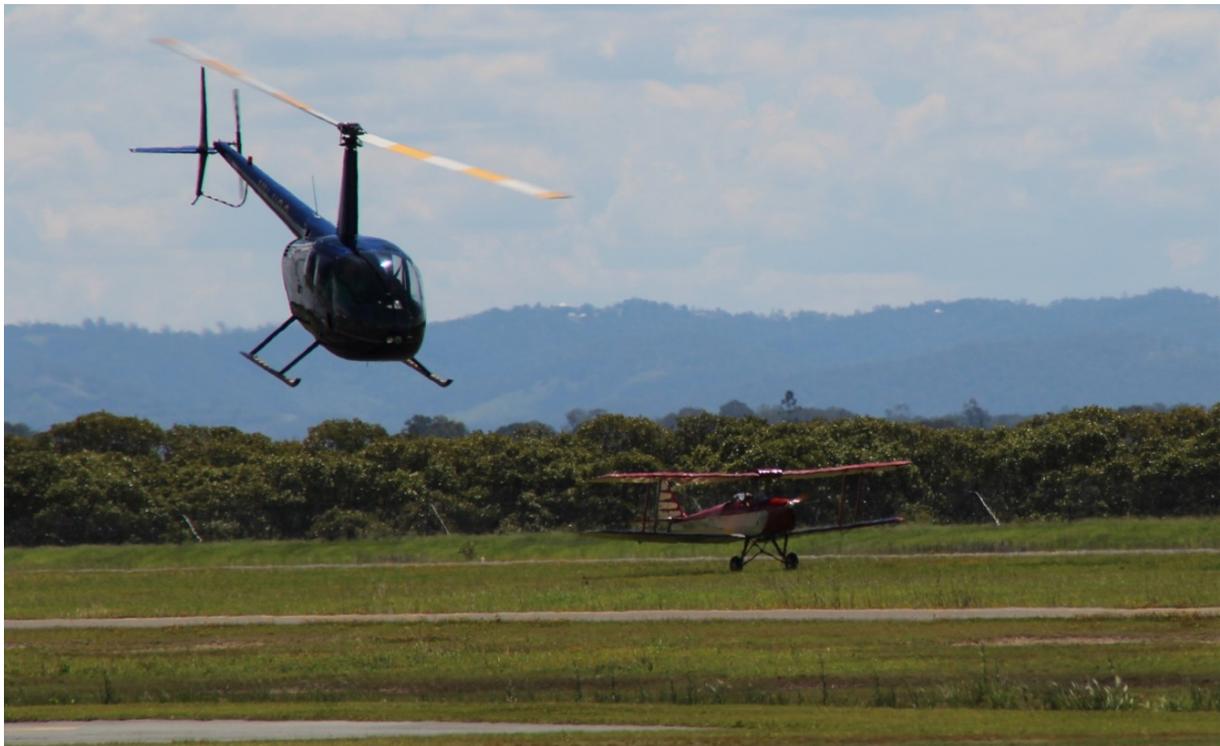
Figure 2: BJE during the take-off run just prior to HOQ conducting the left turn

The pilot of BJE lined up for departure on the grass beside the runway, because the aircraft was fitted with a tail skid, not a tail wheel. The grass area for BJE's take off was within the runway strip to the side of the runway closest to the taxiway. BJE commenced the take-off run and, shortly after, the pilot noticed HOQ flying on a parallel track to BJE (Figure 2). The helicopter was to the right, slightly ahead and above BJE, and in close proximity.

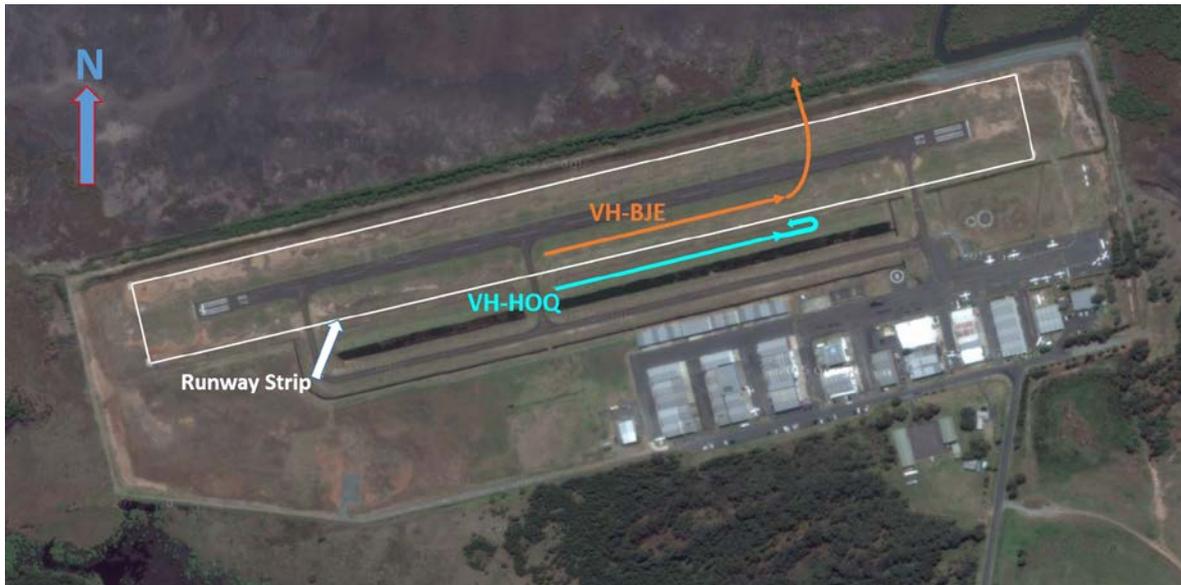
Figure 3: Redcliffe aerodrome showing the runway strip (white). The take-off run and left turn of BJE is indicated in orange. The track of HOQ when conducting the engine failures during taxi and the reversal turn is indicated in blue.

Shortly after becoming airborne from the grass runway, at about 50 to 60 ft above ground level (AGL), the pilot of BJE saw the helicopter commence a left turn towards the runway. Thinking that there was going to be a collision, the pilot of BJE took avoiding action by conducting a hard left turn, with a high angle of bank, at low altitude. The approximate tracks of the aircraft are depicted in Figure 3.

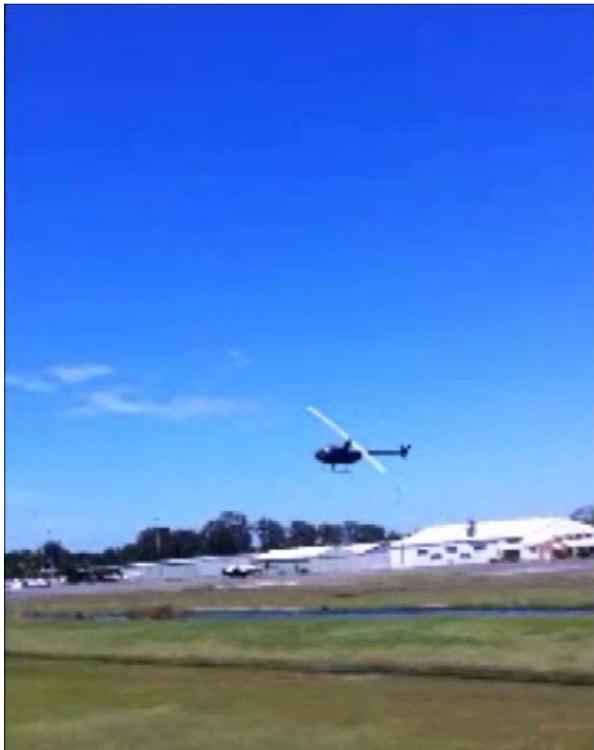
Figure 4: View from the Tiger Moth when the helicopter was approximately half way through the reversal turn

The instructor in HOQ was executing a reversal turn in order to reposition the helicopter for further training (Figure 4). The manoeuvre involved a 180-degree left turn, to reverse the direction of flight, with an increase in height to about 50-60ft and a bank angle of about 50°. The turn and track back down the grassed area would keep the helicopter outside the runway strip and clear of BJE. However, as the instructor had not advised their intentions on the CTAF, the pilot of BJE was unaware that the helicopter was going to remain clear of the aircraft.

Both pilots were monitoring the CTAF and the pilot of BJE had transmitted their intentions correctly. However, as the instructor of HOQ did not advise that they were going to conduct the reversal turn, the pilot of BJE did not know that the helicopter would remain outside the runway strip. The avoiding action taken by the pilot of BJE in this case may have been avoided if the helicopter pilot had communicated their intentions.

Pilots are encouraged to 'err on the side of caution' when considering when to make broadcasts on CTAF, particularly when the aircraft operations are likely to be in close proximity to other aircraft.
