Flight crew incapacitation involving a SOCATA TBM 700, VH-YZZ

at Lake Macquarie Airport, New South Wales, 15 December 2015

ATSB Transport Safety Report
Aviation Occurrence Investigation
AO-2105-145
Final – 13 April 2016

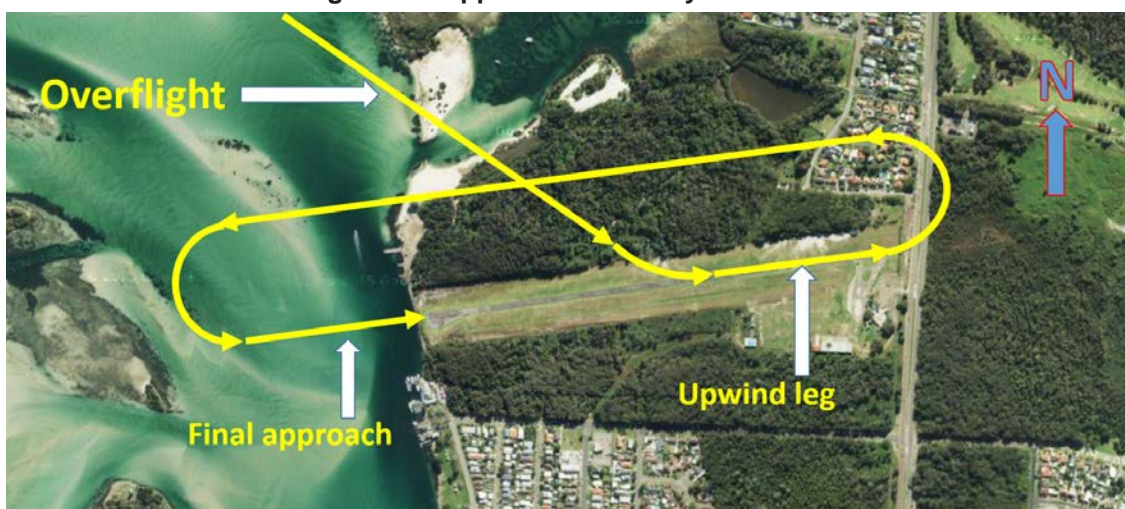
Having not previously landed at Lake Macquarie, the pilot overflew the aerodrome, at approximately 1,500 ft above ground level, to confirm the airfield layout. After the overflight, the pilot joined the upwind leg and commenced a left circuit for runway 07 (Figure 1). The aircraft was configured for landing during this time and, when on final, the approach speed was set to 80 kt.

Figure 1: Indicative flight path of YZZ overflying Lake Macquarie Airport prior to joining the downwind and final legs of the approach to runway 07

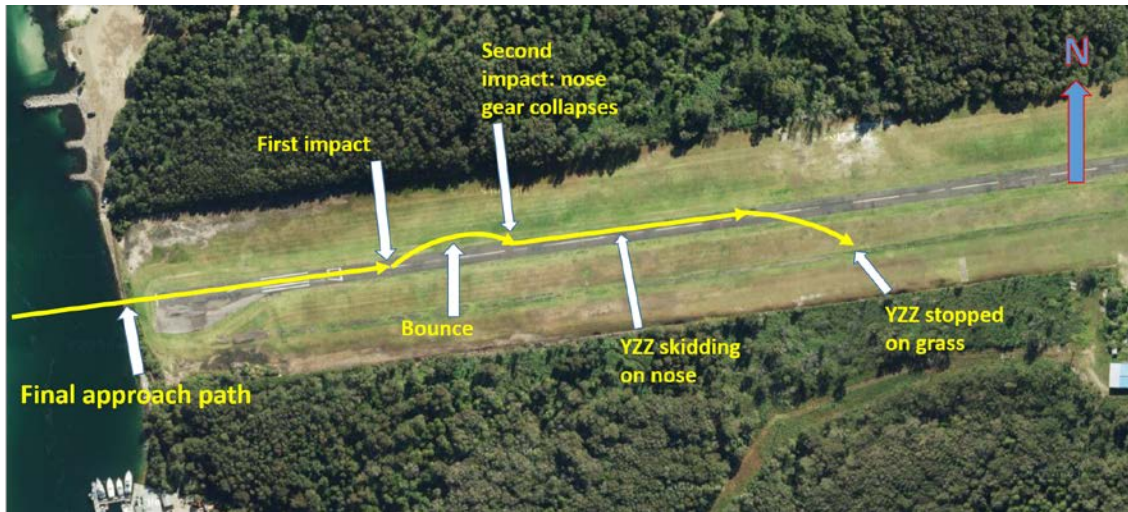
When YZZ was on short final, the pilot began to feel ‘woozy’ and, shortly after, lost consciousness. Closed circuit television footage showed the aircraft descended onto the runway and bounced before impacting the runway in a nose-low attitude to the left of runway centreline. The nose-low impact collapsed the nose gear and caused the forward section of the aircraft to strike the runway, bending all four propeller blades. It was at this time that the pilot regained consciousness, approximately 5 to 10 seconds after losing consciousness. The aircraft then skidded on the runway before veering to the right, and onto the grass (Figure 2). The aircraft eventually stopped on the grass area next to the runway (Figure 3).

Figure 2: Final approach path of YZZ to runway 07 with the approximate positions the aircraft first impacted the runway, bounced, the second impact and the approximate path YZZ skidded along, and across, the runway before coming to a stop on the grass

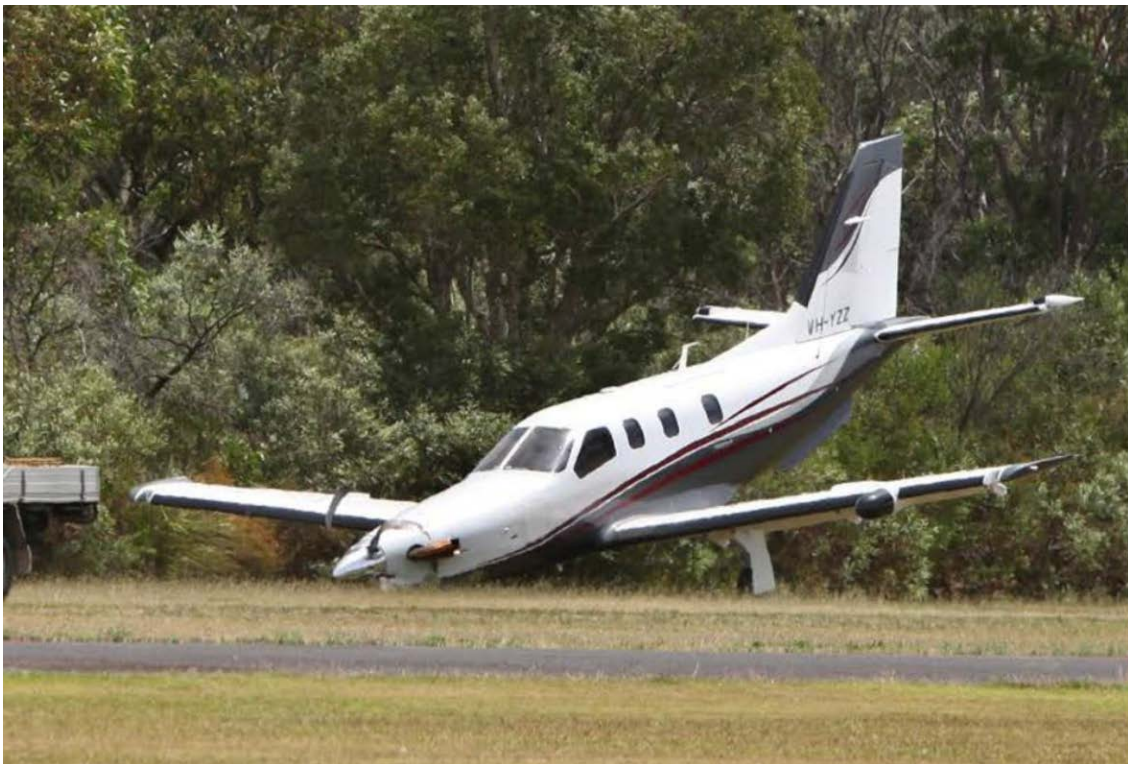
Figure 3: YZZ post-accident showing the damage to the forward section of the aircraft as a result of the nose gear collapse and skidding on the ground

After YZZ had come to a stop, the pilot and the passenger detected a burning smell and made an emergency egress from the aircraft. Once they were safely clear of the aircraft, the pilot saw that there was no fire and that the smell was from the nose gear being jammed under the fuselage and skidding on the runway surface. The pilot then re-entered the aircraft and shut down the engine to ensure that the risk of fire was eliminated. Neither the pilot nor the passenger were injured in the accident, however the aircraft was substantially damaged.
