Foreign object damage involving a Eurocopter AS365 N3 Dauphin, VH-WPX

Jandakot Airport, Western Australia, 3 November 2015

ATSB Transport Safety Report
Aviation Occurrence Investigation
AO-2015-127
Final – 27 May 2016

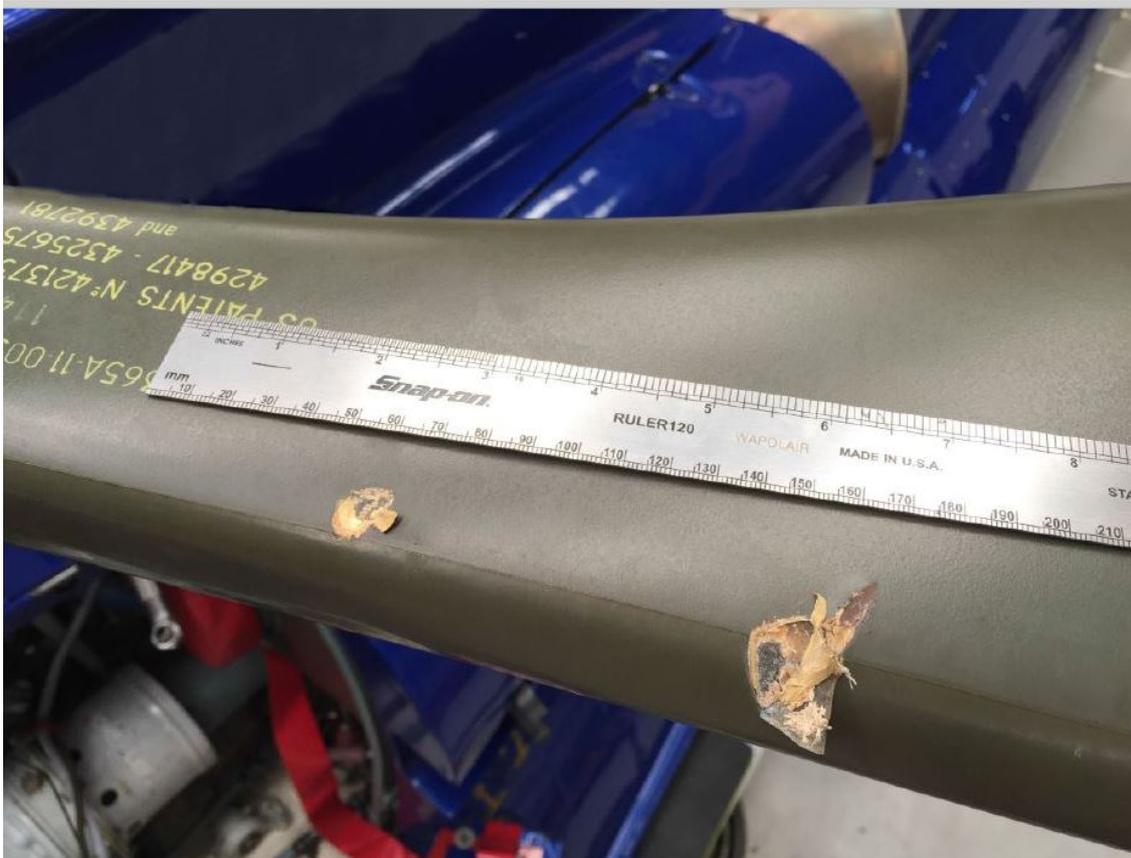
During the post-flight inspection following this test flight, one of two Licenced Aircraft Maintenance Engineers (LAMEs) involved in the test flight, noticed two large gouges to the leading edge of one of the main rotor blades (Figure 1).

A spanner that had been used during the third track and balance related adjustments could not be located. It was later located on an adjacent taxiway about 43 m from the hangar. Due to the scuff marks and scratches found on the spanner, it was determined that it had been left in the rotor head area and was likely ejected during the aircraft start up.

Figure 1: Damage to leading edge of a main rotor blade on VH-WPX

The operator will incorporate the tool control procedure into the MOM. This procedure requires that all tools used during any aircraft maintenance are returned to the tool storage location prior to any of the company aircraft being started.

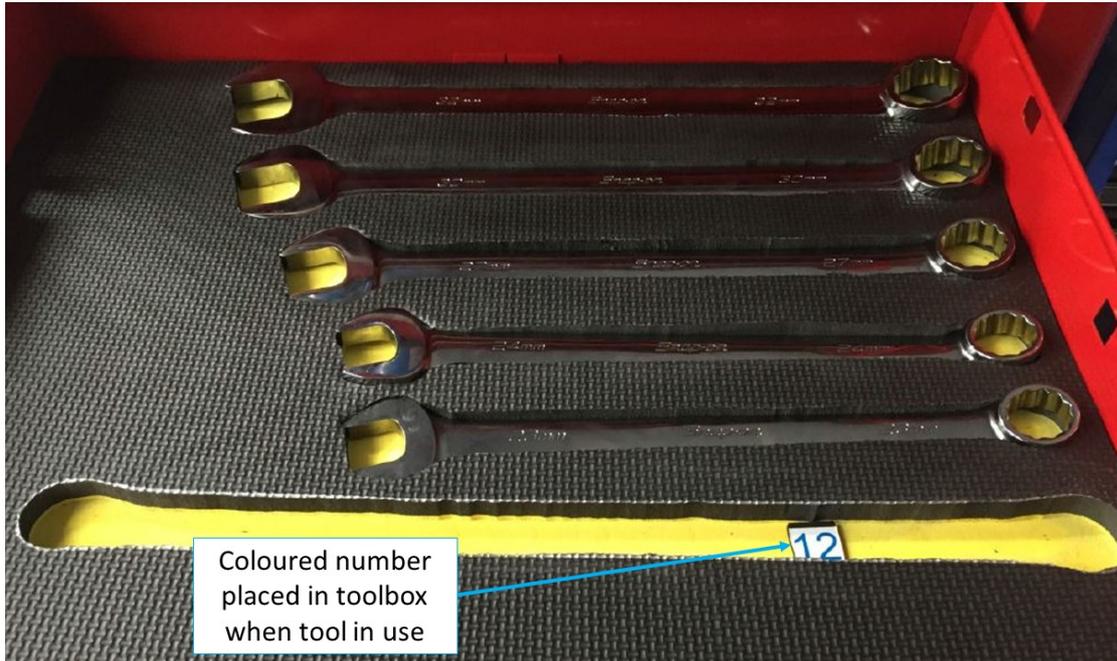
The tool control practice in place, prior to this incident, required that that each tool removed from the toolbox be tagged out by the person removing the tool. Each engineer was assigned a series of numbered tags of a certain colour, and the tag was placed into the 'empty' location (cut out) of the tool being used (Figure 2). A review of both the toolbox and the engineer's assigned tags would quickly identify if any tools were still in use.

Figure 2: Tool control procedure showing coloured number replacing tool in use by the engineer assigned the blue coloured tags

A tool control procedure was in place at the time of the incident, however, the procedure had not been documented in the MOM. Additionally, there was no documented procedure requiring the tools to be returned to the toolbox prior to the aircraft being started.
