Wirestrike involving Kavanagh G-450 balloon, VH-RUW

Mareeba, Queensland, 7 February 2016

ATSB Transport Safety Report
Aviation Occurrence Investigation
AO-2016-008
Final – 27 May 2016

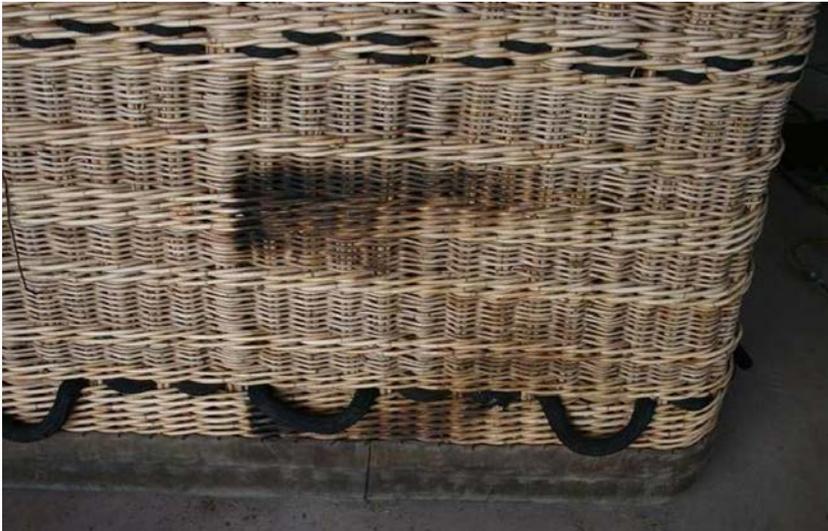
Figure 1: Scorch marks on wicker basket

The pilot checked that the passengers were all ok and still in the landing position, and checked that there was no evidence of fire. Due to the amount of heat in the balloon, the balloon was climbing. The pilot then conducted a normal controlled descent and landing into a paddock about 500 m beyond the original planned landing site. The balloon landed without further incident and no one was injured. The wicker basket sustained scorching (Figure 1) and a stainless steel cable fixed to the underside of the basket sustained arc damage.

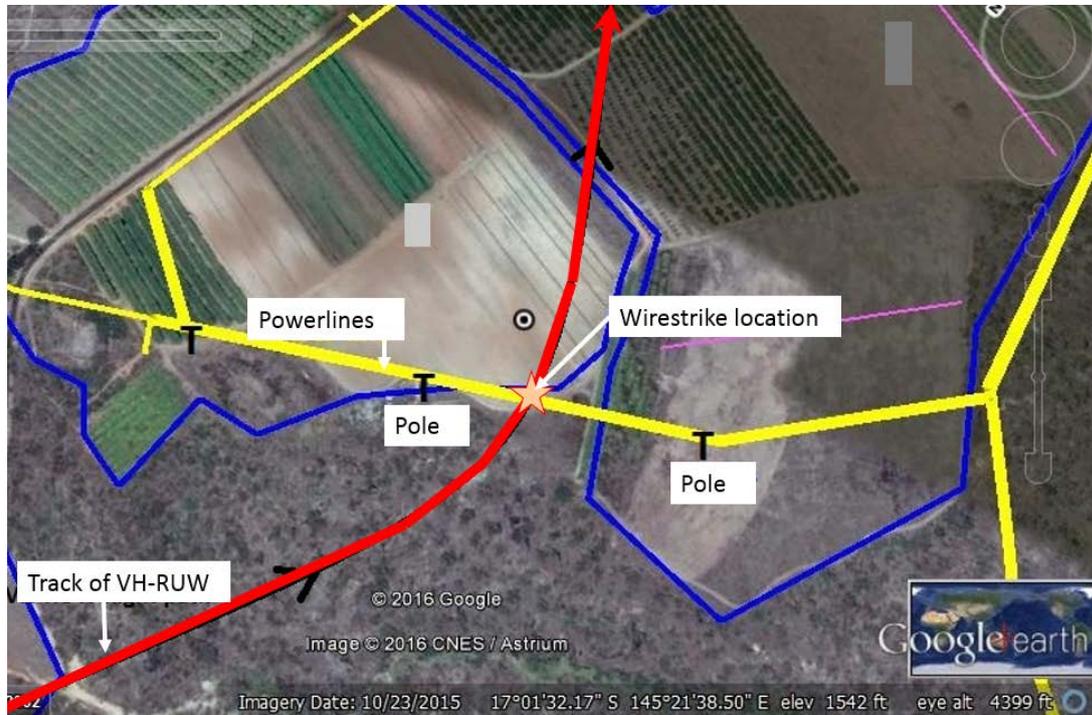
Figure 2: Balloon track and location of powerlines

The balloon's track crossed the powerlines at an angle (Figure 2). As the balloon approached the wires, the pilot lost sight of the pole to the left and used the pole on the right to gauge their height. However, the left pole was situated on a hill and higher than the right pole, and the wires sloped

upwards from the right pole to the left. The pilot’s assessment of sufficient height was based on the lower pole; consequently, the left side of the basket struck the wires to the high side.

The powerlines were difficult to see as the area was heavily vegetated. The sun was to the right of the balloon and did not affect the pilot’s vision of the wires.

The operator will circulate a copy of their investigation report and findings to all company pilots. Pilots are reminded to consider the possibility of sloping powerlines and apply an appropriate clearance margin when overflying them.
