Smoke event involving Airbus A380, VH-OQD

1,500 km WSW of Dallas-Fort Worth, Texas, United States, 16 May 2016

ATSB Transport Safety Report
Aviation Occurrence Investigation
AO-2016-051
Final – 25 August 2016

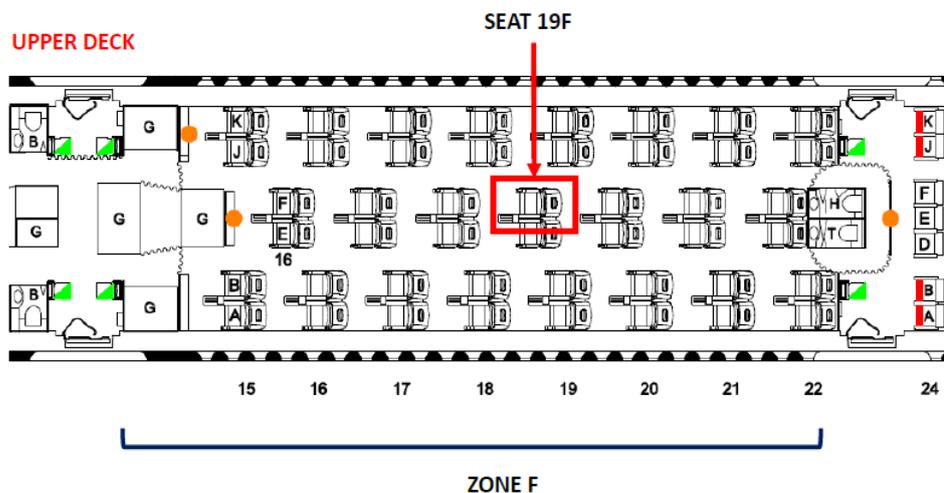
The cabin crew located the source of the smoke at seat 19F, in Zone F, on the upper deck (Figure 1). The crew removed the seat cushions and covers from seat 19F while the CSM turned off the power to the centre column of the seats. When the seat was further dismantled, the crew found a crushed personal electronic device (PED) wedged tightly in the seat mechanism. The cabin crew assessed that the crushed PED contained a lithium battery.

Figure 1: Cabin diagram showing the seat from where the smoke emanated

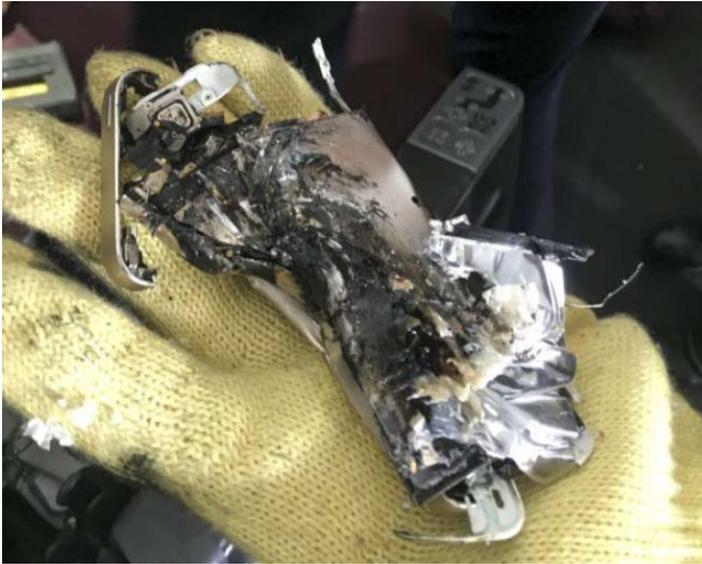
By that time, the PED was no longer emitting smoke, however, a strong acrid smell remained in the cabin. The crew then manoeuvred the seat and freed the PED (Figure 2). The crew placed the PED in a jug of water, which was then put in a metal box and monitored for the remainder of the flight.

Figure 2: Crushed PED after removal from seat
