VFR into IMC involving Cessna 172, VH-EOV

near Gold Coast Airport, Queensland, 19 March 2016

ATSB Transport Safety Report
Aviation Occurrence Investigation
AO-2016-024
Final – 28 September 2016

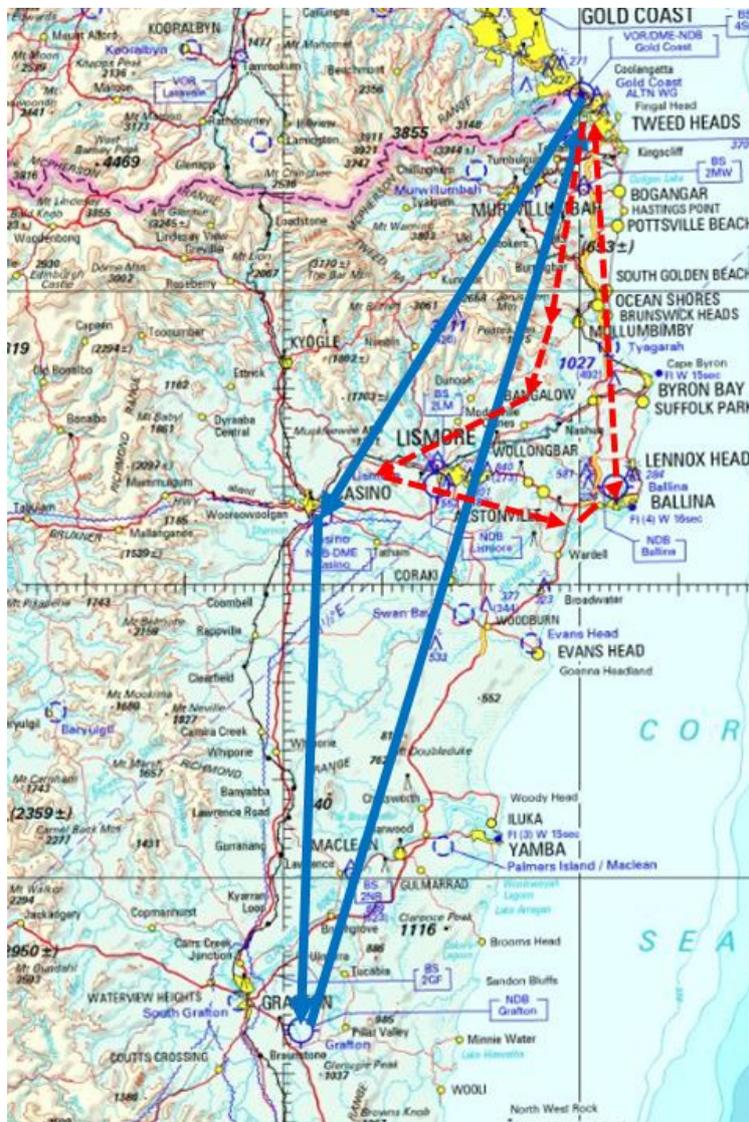
On 19 March 2016, a student pilot prepared for their first solo navigation training exercise in Cessna 172, registered VH-EOV (EOV). The flight was planned from the Gold Coast Airport, Queensland (Qld), overhead Casino, and onto Grafton Airport, New South Wales (NSW). The return leg plan was from Grafton Airport direct to the Gold Coast Airport (Figure 1 blue lines).

Figure 1: Flight planned track (blue), approximate track flow (red)

As EOV tracked north along the coast toward the Gold Coast (red line in Figure 1), the Centre controller advised the pilot of a conflicting aircraft tracking southbound. The pilot acknowledged this call and advised they were looking for this traffic. The two aircraft passed without incident. The pilot then continued to the Gold Coast and landed without incident.

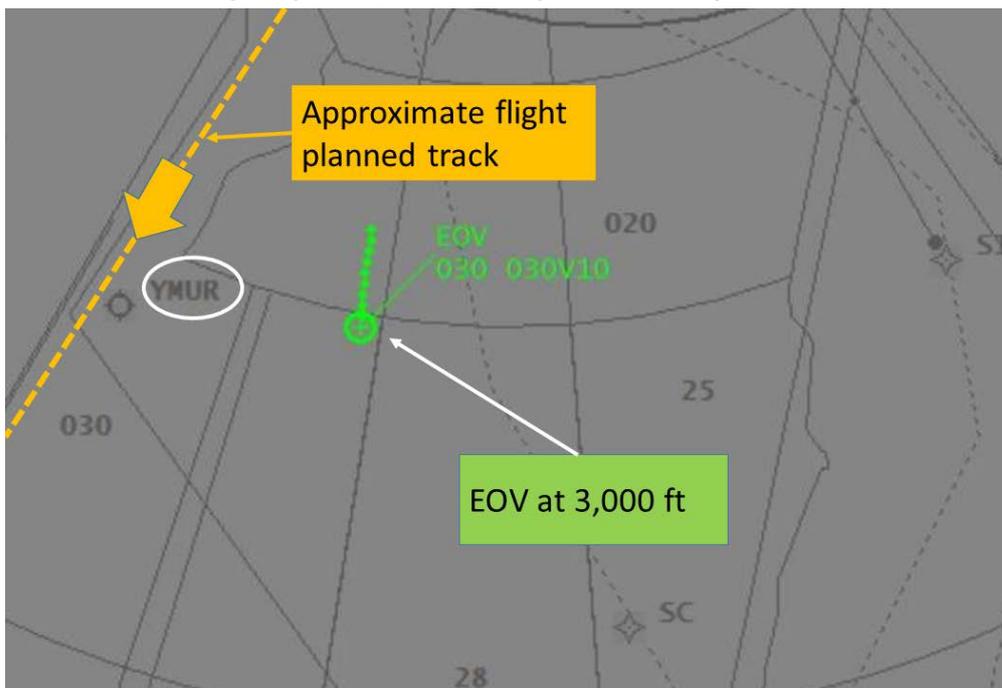
Part way through the right turn, the pilot unintentionally stopped the turn and started to track in a southerly direction, instead of south-westerly toward Casino. Noting that the aircraft was not tracking as expected, the Tower controller asked the pilot to confirm their current heading. The pilot asked the controller to 'standby'. With no further response from the pilot, the controller then instructed them to turn right onto a heading of 250°. However, the pilot continued to track about 40° left of track (Figure 2). To assist the pilot, the controller advised them of their current position, cleared the aircraft from that position direct to Casino, and as per normal procedure, and instructed the pilot to change frequency to contact Brisbane Approach.

Figure 2: Flight planned track to Casino in yellow. EOV (green) tracking to the east of Murwillumbah Airport (YMUR, white circle) in a southerly direction
