# Engine power loss and forced landing involving Piper PA-28, VH-TAK

3 km NW of Bankstown Airport, New South Wales, 21 July 2016

**ATSB Transport Safety Report**  
Aviation Occurrence Investigation  
AO-2016-082  
Final – 14 October 2016

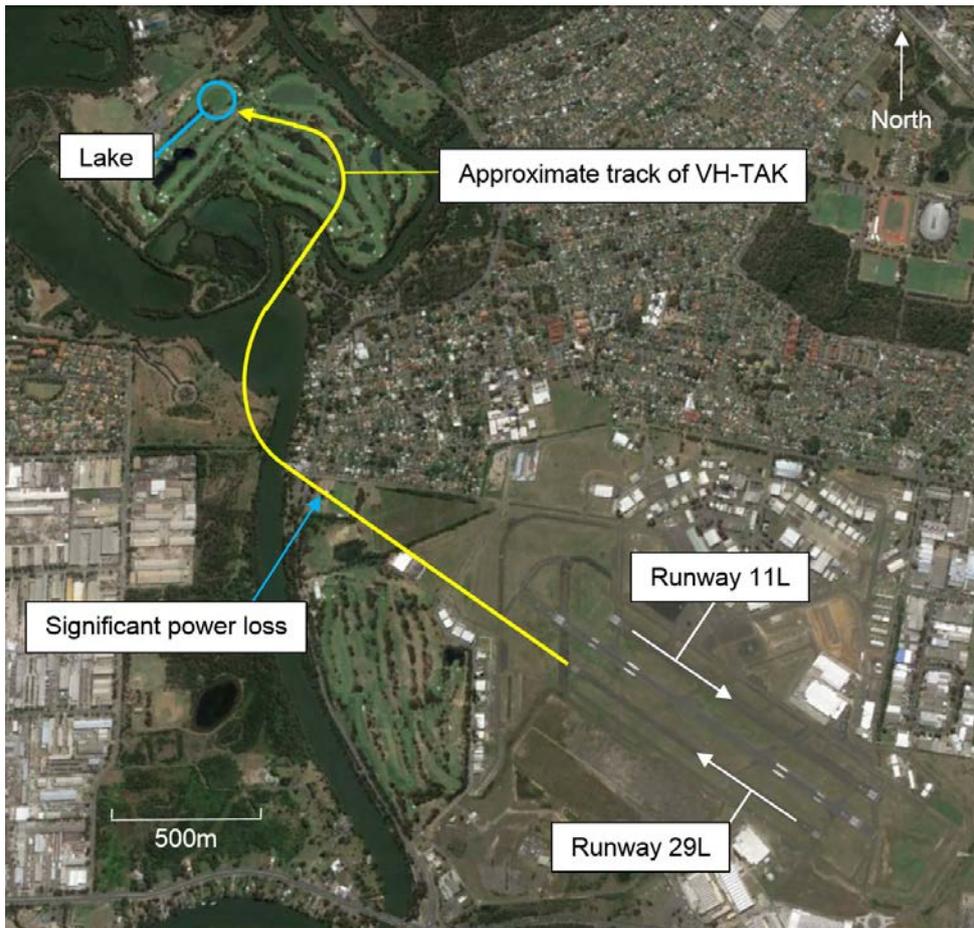
**Figure 1: Overview of accident flight**

As the aircraft climbed through about 300 ft above ground level (AGL), the pilot observed a slight loss of power produced by the engine. The pilot reported that at that time, the engine continued to run smoothly and TAK continued to climb. At a height of about 400 ft, the power loss increased (Figure 1), the engine was then producing about 1600 RPM<sup>1</sup> and the pilot reported that the engine was 'chugging'. The pilot made a right turn to attempt to return to Bankstown Airport to land on runway 11 Left (11L). The pilot broadcast a PAN<sup>2</sup> call and established TAK on a base leg for runway 11L.

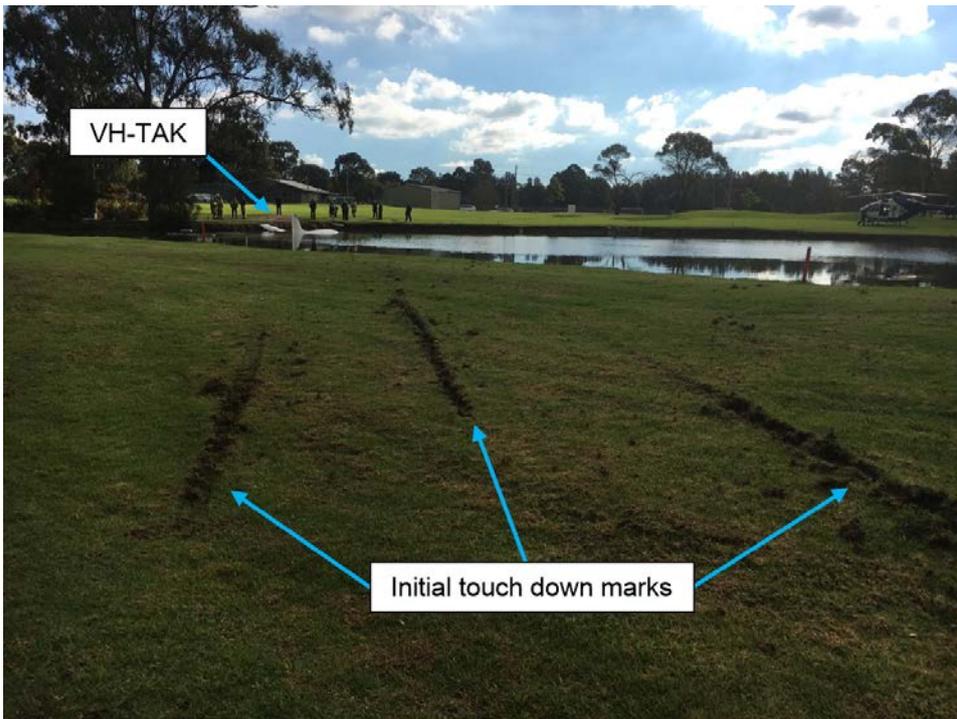
**Figure 2: Touch down point**

TAK landed on the up slope of a mound at the edge of a small lake and bounced back into the air (Figure 2). The pilot then attempted to fly the aircraft over the lake, but soon assessed that it did not have sufficient speed or height to clear the lake, and directed the occupants to brace for impact. TAK landed in the lake on the main wheels. The nose of the aircraft struck the water and submerged momentarily, before returning to the surface. After the aircraft stopped, the occupants immediately exited the aircraft through the door on the right side. They climbed over the fuselage and along the left wing to the edge of the lake (Figure 3). The pilot and occupants were uninjured and the aircraft was substantially damaged.
