Sling load incident involving Aerospatiale Industries AS350, VH-BII

Lake Disappointment, Western Australia, 23 May 2016

ATSB Transport Safety Report
Aviation Occurrence Investigation
AO-2016-096
Final – 22 November 2016

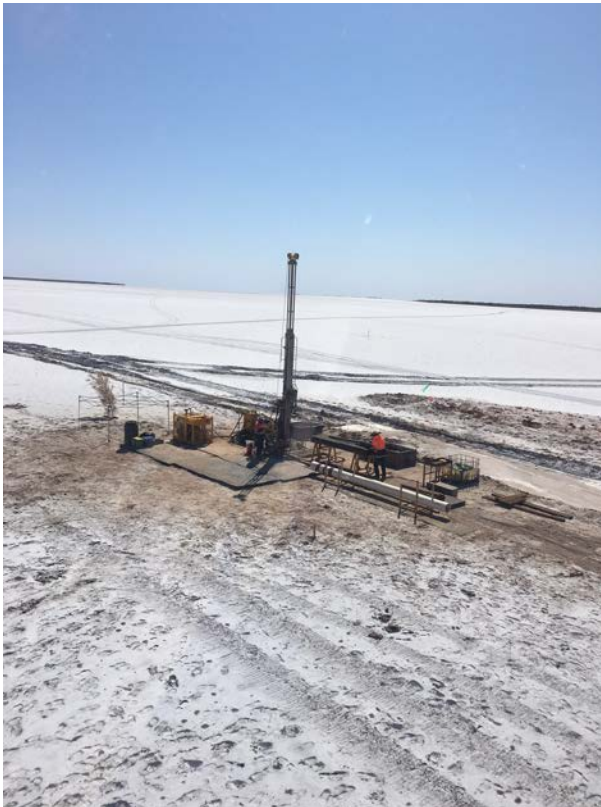
Figure 1: Drilling rig on Lake Disappointment

On 23 May 2016 at about 0600 Western Standard Time (WST), a team of ground and flight crew met to discuss the day's operations to move a drill rig and associated platform and equipment by helicopter to a new location at Lake Disappointment, Western Australia (Figure 1). The rig had been operating on a salt lake and the move involved two helicopters – an Aerospatiale Industries AS350 helicopter, registered VH-BII (BII), to move the rig and heavier equipment, and a smaller helicopter (Robinson R44) to move the smaller, lighter equipment and personnel.

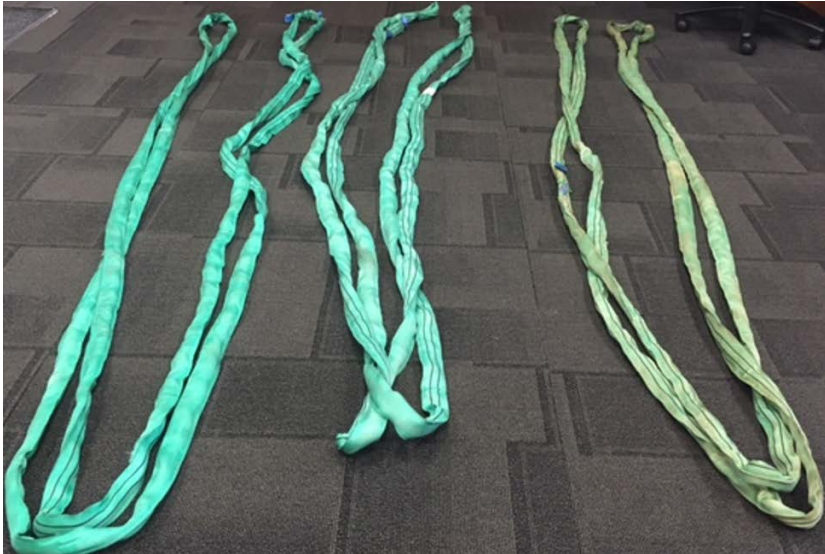
Figure 2: Loop slings

The pilot of BII suggested that the ground crew use tag lines for the operation. These would enable the ground crew to manoeuvre the loads as necessary while the load was off the ground slung under the helicopter. For tag lines, the pilot provided the ground crew with slings – 6 m loops (Figure 2), which they were to attach to the loads that were already encased in other slings ready for moving.

As they¹ stepped back, the offside had inadvertently stepped into the loop of the tag line. As the helicopter lifted the rig, the tag line went taut, and the offside's leg was ensnared in the loop. The offside was lifted off the ground by the leg and the helicopter began lifting the load. The load master radioed the pilot, and advised that the offside was hanging in the loop.

The offsider also commented that use of a sling as a tag line carries increased risk of ensarement. A single or unlooped line would be less hazardous.

- people carrying out slinging operations are to use more appropriate tag lines – 16 mm single strand synthetic rope²
- ground crew to undergo Dogging³ training
- helicopter pilot to visually confirm the load is not entangled prior to moving off
- job hazard analysis to incorporate the use of tag lines
- safe working procedures to take into account visual confirmation that the load is clear
- promotion of ‘take 5 culture’⁴ to address hazards as they are identified
- platform scales to weigh rig items have been provided, sling line certification has been conducted and routine condition inspections have been conducted
- UHF radios have been installed.
