Safety Advisory Notice

Number: MO-2015-005-SAN-005

Fatality highlights risks on open stern OSVs

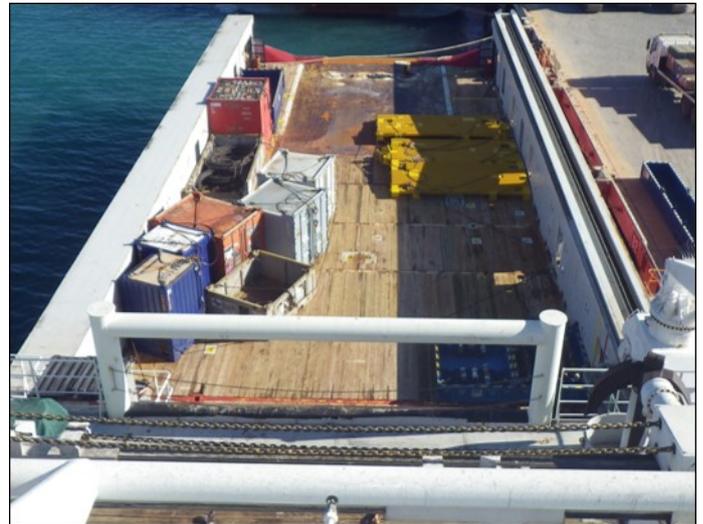
While securing the cargo, the crewmembers slackened the securing chain they had used to secure the containers on the starboard side to better secure the entire stow. Shortly after, two large waves came over *Skandi Pacific's* open stern, shifting the unsecured containers forward. One crewmember was trapped between the moving containers, chains and a skip and suffered fatal crush injuries.

Skandi Pacific's aft deck (Source: DOF Management)

However, the sequence of working exposed them to high risk if water was shipped on *Skandi Pacific's* aft deck. The crewmember attempting to fasten a securing chain forward of the two unsecured mini-containers was in a position of danger when waves came over the vessel's open stern.

The Australian Transport Safety Bureau (ATSB) found that vessel's managers had not adequately assessed the risks associated with shipping seas over the vessel's stern while securing cargo on this type of vessel (the OSV had an open stern). Further, there were no clearly defined limits for excessive water on deck that necessitated stopping operations, leaving individuals to make difficult, and necessarily subjective, decisions about whether or not to stop work.

MO-2015-005-SAN-005: The Australian Transport Safety Bureau advises the masters, owners and operators of all offshore support vessels to ensure that the risks associated with working on the aft deck of vessels with open sterns are adequately assessed.
