Engine malfunction and in-flight shutdown involving Boeing 777 A6-EGA

650 km NW of Adelaide, South Australia, 7 September 2016

ATSB Transport Safety Report
Aviation Occurrence Investigation
AO-2016-113
Final – 17 January 2017

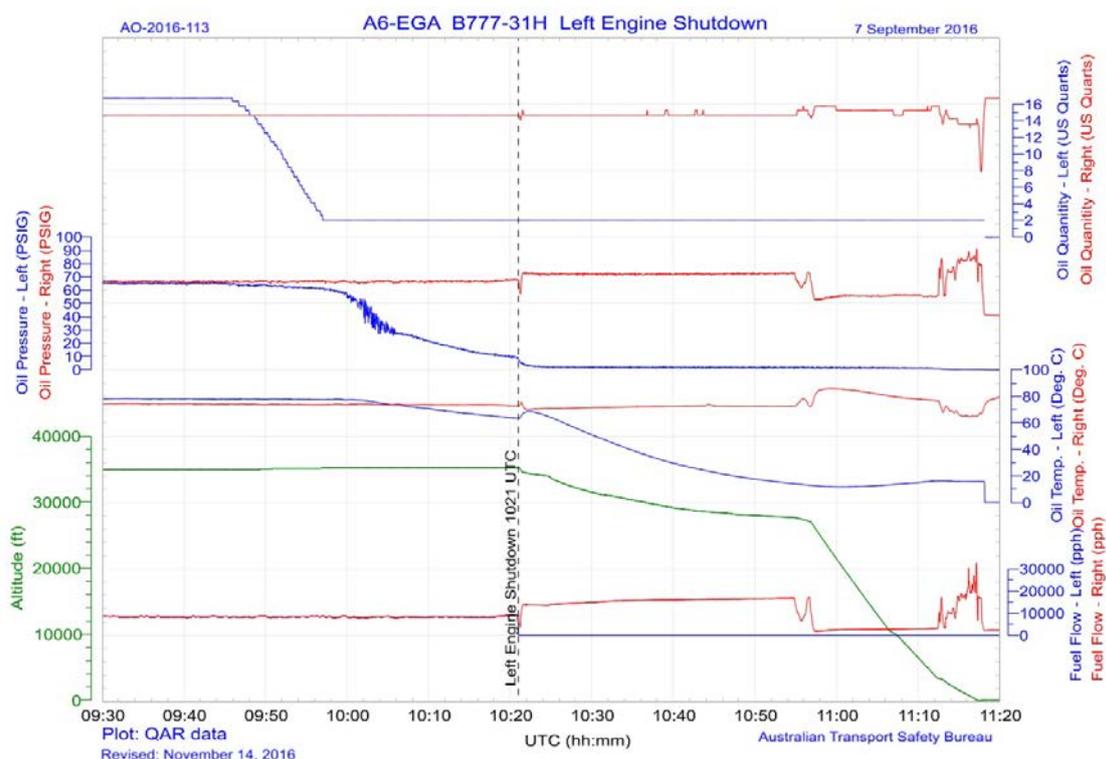
Figure 1: Flight data plot including oil pressure and engine shutdown

At about 1916 Central Standard Time (CST), the left engine oil quantity started to decrease from 16.4 quarts, stabilising at 2 quarts at 1927, when the aircraft was about 650 km north-west of Adelaide, South Australia, and at flight level (FL) 353.¹ The flight crew contacted company engineering and operations staff and advised them of the situation.

The flight crew received a left engine low oil engine-indicating and crew-alerting system (EICAS) message and conducted the associated non-normal checklist. At about 1951, the flight crew shut the left engine down (Figure 1).

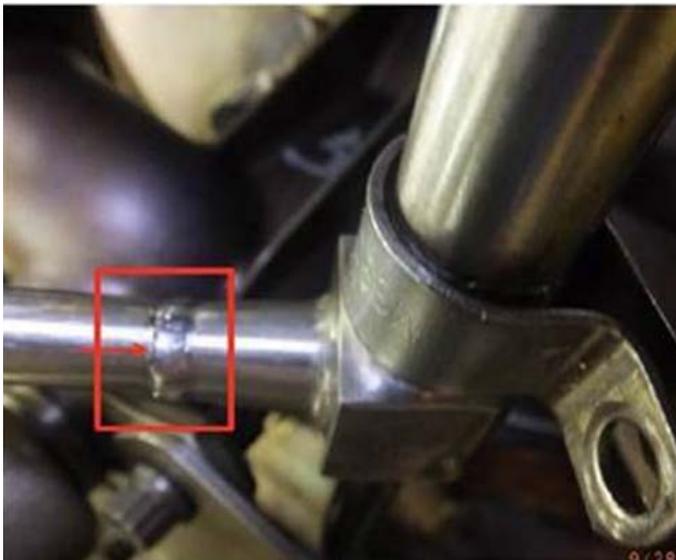
Figure 2: Fractured oil supply line

A subsequent engineering inspection found the left oil supply line to bearings numbers 4 and 5 had fractured and the associated clamp was broken (Figure 2).

The left oil supply line to bearings numbers 4 and 5 fractured, resulting in a loss of oil and oil pressure from the left engine. The flight crew received a left low oil pressure warning and followed the associated checklists, shut down the left engine and diverted the aircraft to Adelaide.

- The oil supply line to bearings 4 and 5 fractured at a welded joint and its support clamp was broken, resulting in an oil leak and therefore low oil pressure and quantity in the left engine.
- Following the receipt of a left low oil pressure warning, the flight crew completed the non-normal checklist, shut down the left engine and conducted a diversion to Adelaide.

The operator performed a fleet-wide inspection and found no leaks or cracks on any other engine.
