Runway undershoot involving Fairchild SA226, VH-SSV

Theodore ALA, Queensland, 23 November 2016

ATSB Transport Safety Report
Aviation Occurrence Investigation
AO-2016-163
Final – 24 March 2017

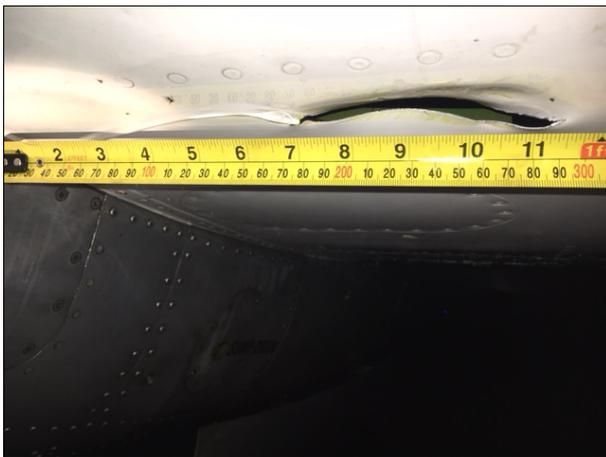
The landing was completed and after parking the aircraft on the apron, a passenger reported to the pilot that the right wing was leaking fuel. On inspection, the pilot found a puncture to the underside of the right wing, just outboard from the right engine nacelle, which had breached the fuel tank (Figure 1). They concluded it was probably the result of debris from the damaged runway light flicked up by the right main wheel tyre. There were no injuries and the aircraft received minor damage.

Figure 1: Damage to the underside of wing

The time of the incident was near the end of a hot day with light winds. The pilot did not report that any airspeed fluctuations occurred during the approach, but they experienced sink early on the final approach and again when the incident occurred. Therefore, the runway undershoot was probably the result of a low approach path, which combined with a downdraft from local convective activity to lead to an early touchdown. The early touchdown resulted in the collision with a runway light and subsequent damage to the aircraft wing.

- The pilot flew an approach path with a low runway threshold height, which combined with a downdraft from local convective activity on short final, resulting in a runway undershoot, collision with the runway light and damage to the aircraft wing.

Prior to further operations in this aircraft type, the incident pilot was retrained on the aircraft type, which involved the following:

- The pilot received a detailed briefing covering aircraft type performance.
- The pilot flew with the type specialist for re-training. These flights involved operations into different airports and runway environments.
- The pilot was returned to duty on charter operations under supervision, and then re-assessed prior to further line flying operations.

The company operations manual for the Fairchild SA226TC shall be amended to reference the factoring of landing distances as a company procedure.

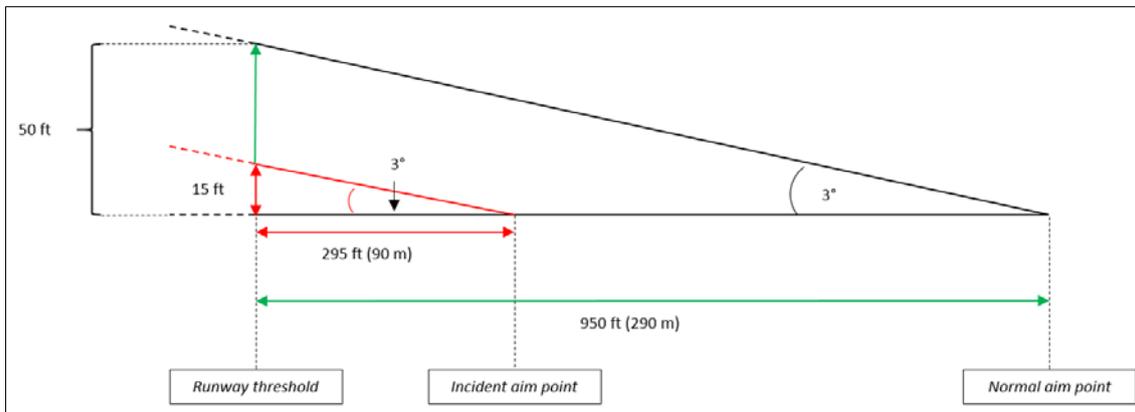
The landing distance required (LDR) begins at a height of 50 ft from over the runway threshold. The pilot reported flying a standard 3° approach path angle. However, a 3° approach path, with a threshold height of 50 ft is based on a landing aim point about 290 m from the runway threshold. Using the same approach path angle with an aim point 90 m from the runway threshold will reduce the threshold height to about 15 ft (Figure 2).

Figure 2: Runway threshold heights

The pilot's knowledge of the landing distance required and downslope of runway 17, led them to select the first row of runway lights as their aim point marker, while maintaining a 3° approach path profile. The use of this aim point resulted in the aircraft descending below 50 ft prior to reaching the runway threshold and therefore a low approach path on short final.
