Tail skid contact involving Boeing 777-312, 9V-SYG

Melbourne Airport, Victoria, 9 October 2016

ATSB Transport Safety Report
Aviation Occurrence Investigation
AO-2016-131
Final – 27 April 2017

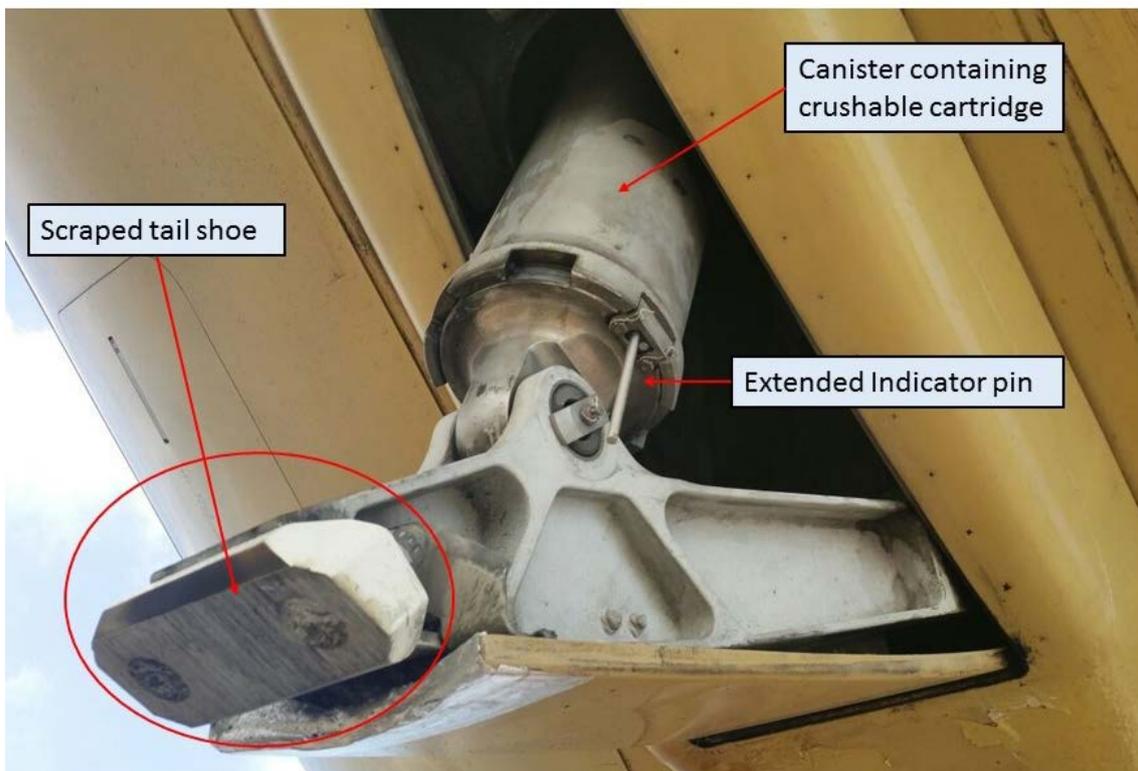
Figure 1: Damage to tail skid

Subsequently, an uneventful landing was carried out in Singapore. Engineers conducted a post-incident inspection of the aircraft and found no damage to the aircraft fuselage. Damage was evident to the tail skid system with indications of a scraped tail shoe, compression of the crushable cartridge and one indicator pin extended (Figure 1). This damage indicated that a moderate energy skid contact had occurred during take-off.

- The tail skid contact was a result of airspeed stagnation due to gusty atmospheric conditions which prolonged the time to lift-off, allowing the pitch attitude to exceed the tail skid contact attitude.
- The use of a higher take-off thrust setting would most likely have reduced the required runway length and minimised the aircraft exposure to gusty atmospheric conditions during rotation and lift-off.

As a result of this incident, the aircraft operator issued circulars to all company flight crew directing operation towards Boeing's recommendation of the use of higher thrust and rotation speed for take-off in gusty wind and strong crosswind conditions.

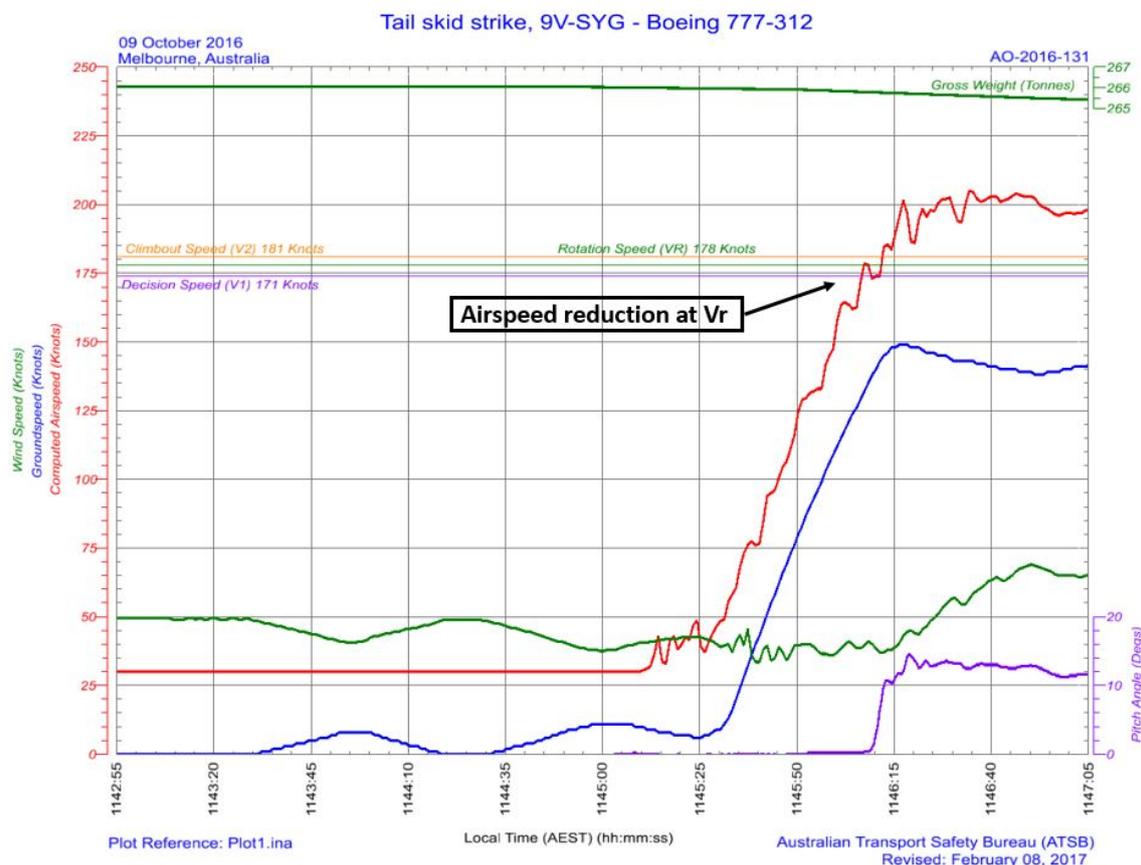
Figure 2: Flight data plot including computed airspeed, and rotation speed (Vr) and pitch attitude

initiated at a computed airspeed of 178 kt (at Vr) at approximately 0.5 degrees per second initially before increasing to approximately 3 to 4 degrees per second. As rotation was initiated, the headwind component decreased 12 kt, the computed airspeed stagnated and reduced to 173 kt (Figure 2). Lift-off occurred at a pitch attitude of 10.7 degrees. The tail skid contact attitude is 8.9 degrees.

After reaching rotation speed (Vr), the aircraft’s airspeed reduced by about 5 kt due to a reduction in headwind of about 12 kt.

The aircraft did not become airborne at the manufacture’s pitch attitude of 7 degrees, leading the PF to continue increasing the pitch attitude to 10.7 degrees where lift-off was achieved. This increased pitch attitude exceeded the 8.9 degrees attitude for where a tail strike will occur in the Boeing 777-300 aircraft.
