# Collision with terrain involving Air Tractor AT-401, VH-DDW

10 km NW of Mareeba Airport, Queensland, 21 January 2017

**ATSB Transport Safety Report**  
Aviation Occurrence Investigation  
AO-2017-009  
Final – 27 April 2017

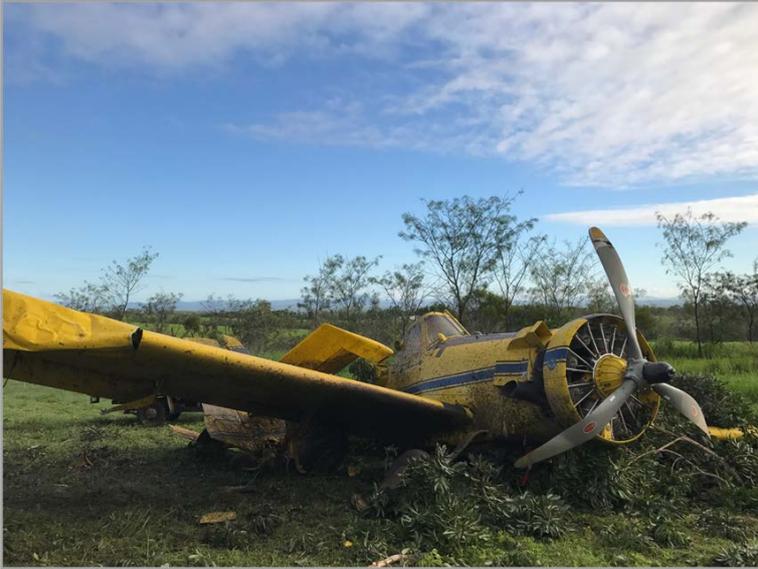
As the aircraft descended, the pilot sighted powerlines ahead and assessed that the aircraft would probably not make it over them. Therefore, the pilot descended to pass under the powerlines. The pilot again spoke to the loader driver briefly on the radio. The aircraft then collided with several lychee trees and a vehicle that was parked in an orchard. The aircraft came to rest upright and was substantially damaged. The pilot sustained a minor injury.

**Figure 2: Damage to VH-DDW**

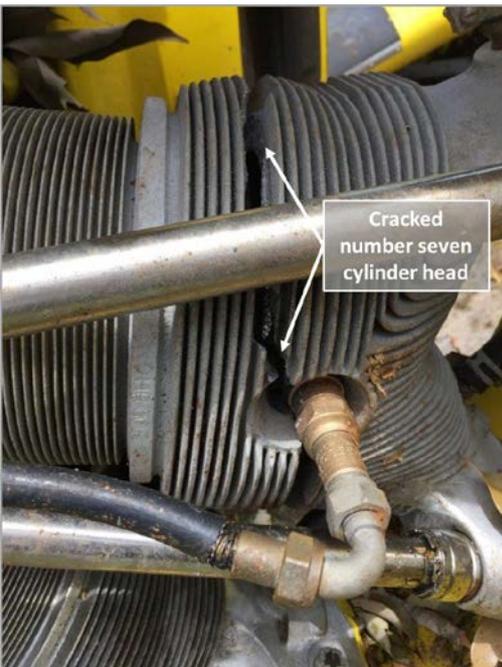
The aircraft was fitted with a Pratt and Whitney R-1340 radial engine that had 10,491 total hours and 478.1 hours since overhaul. The engine was inspected after the accident by a representative from an aircraft maintenance organisation and they determined that the number seven cylinder had failed (Figure 3). A crack was located around the circumference of the cylinder head, between the two spark plug holes. A recurring inspection of this area ([CASA airworthiness directive AD/PW-P/19](#)) was conducted about 91.9 hours prior to the accident at the periodic (100 hourly or 12-month) maintenance inspections.

**Figure 3: Engine cracked number seven cylinder**

A post-accident inspection revealed a cracked cylinder.

- The number seven cylinder cracked, resulting in a loss of power.
- The aircraft was operating at low level (below 200 ft AGL) in an area where there were limited options available to conduct a forced landing.
