# Near collision on ground involving Jetstar Airways Airbus A320, VH-VGJ and a dispatcher

Newcastle (Williamtown) Airport, New South Wales, 25 January 2017

**ATSB Transport Safety Report**  
Aviation Occurrence Investigation  
AO-2017-015  
Final – 24 May 2017

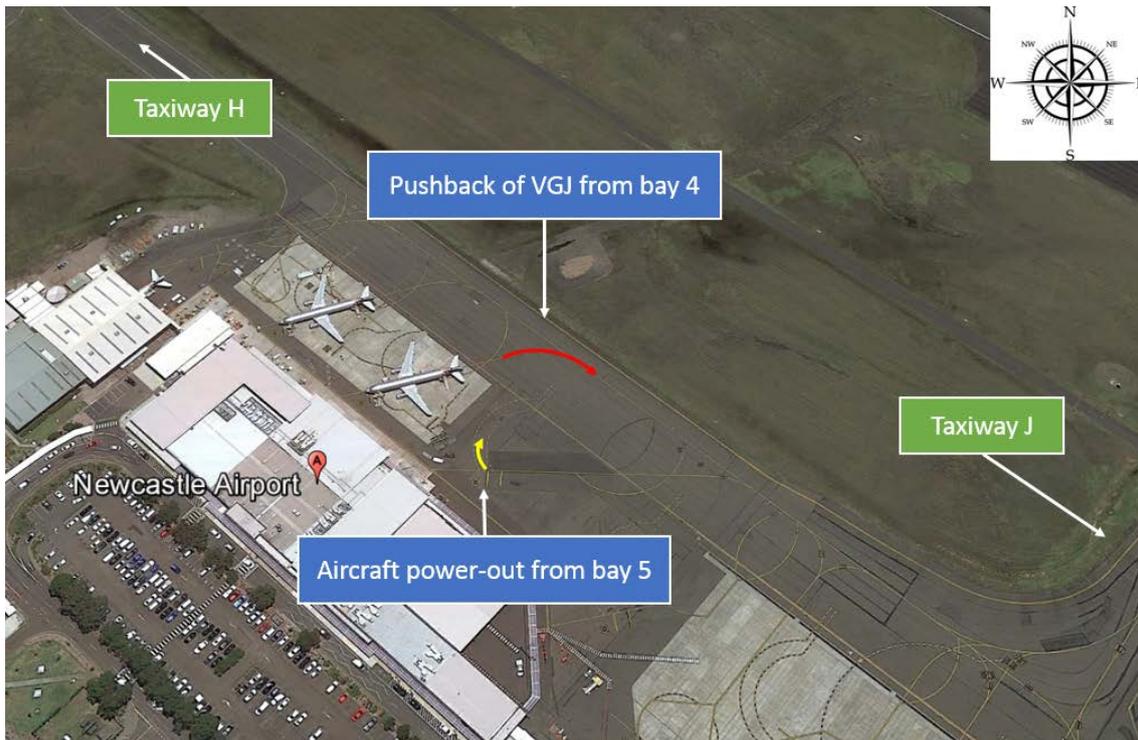
**Figure 1: Newcastle Airport apron**

The aircraft parked at bay 4 at the Newcastle Airport terminal for passenger disembarkation and boarding (Figure 1). Bay 4 was a 'pushback' bay, which means that when the aircraft is ready for departure, the aircraft is pushed backwards from the parking bay by a tug under the supervision of a dispatcher. Another operator's aircraft was parked on bay 5, to the left of VGJ. Bay 5 was a 'power-out' bay which means that on departure, aircraft taxi from the bay under their own power by turning sharply away from the terminal.

At about 1836 Eastern Daylight-savings Time (EDT), the crew of VGJ received a clearance from the surface movement controller to pushback, which placed VGJ to the right rear quarter of the aircraft parked on bay 5, and facing towards taxiway H (Figure 1). The dispatcher was walking beside the aircraft and was connected to the nose of VGJ by a headset for communications with the flight crew. The flight crew started the engines during the pushback in accordance with standard procedures. After the pushback was completed, the flight crew set the brakes, the tug disconnected and the dispatcher removed the nose wheel steering pin.<sup>2</sup> The flight crew then started their 'after start flows' (see: *After start flows*). After the tug disconnected from VGJ, the tug driver moved it to a position adjacent to the left wingtip of VGJ, facing towards the aircraft on bay 5.
