Birdstrike and inflight vibration involving Boeing 747-438 ER VH-OEH

near San Francisco International Airport, United States | 6 October 2016

ATSB Transport Safety Report
Aviation Occurrence Investigation
AO-2016-135
Final – 29 June 2017

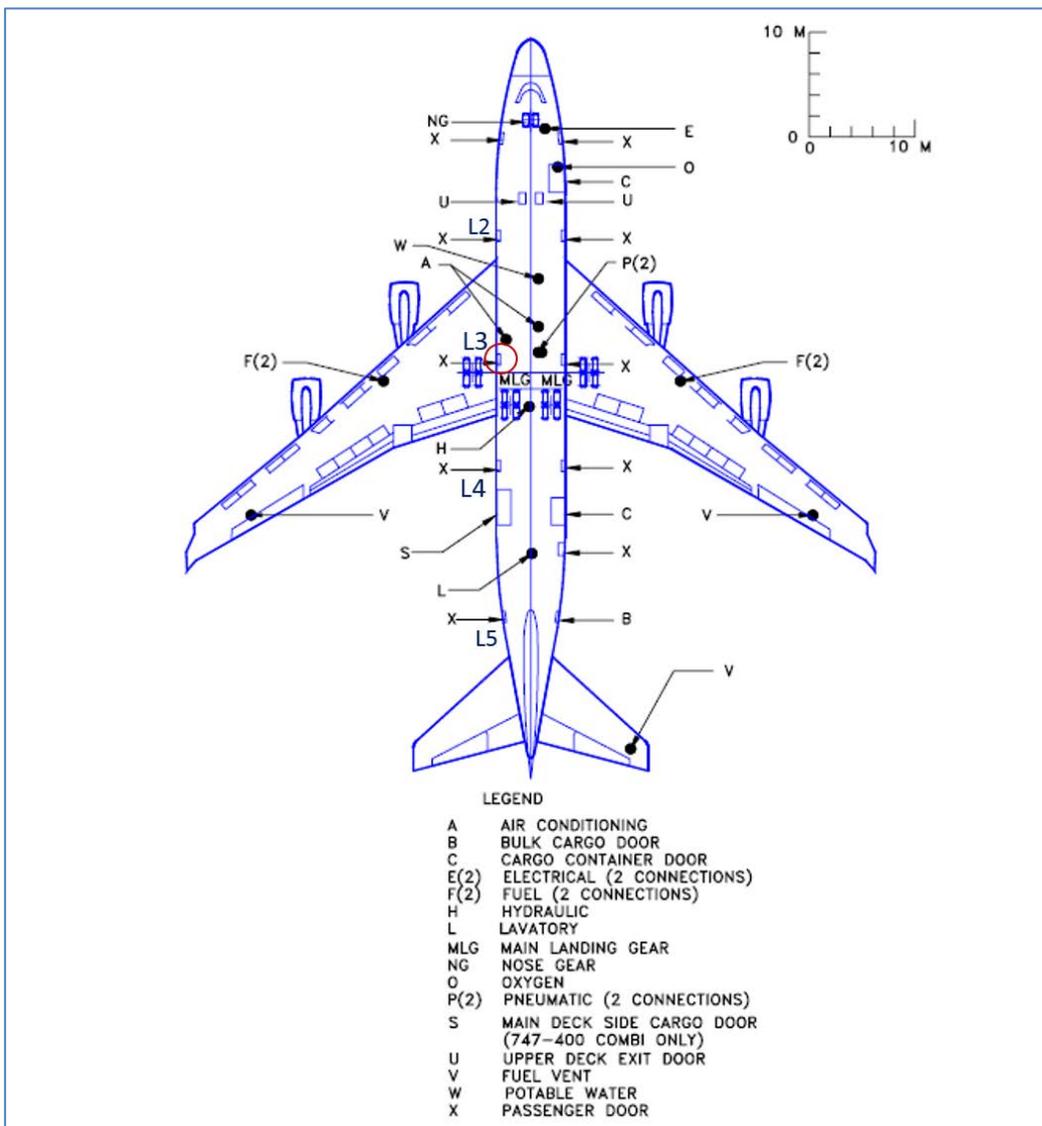
Figure 1: Aircraft schematic showing location of door L3 (circled red) and other services

Soon after take-off, the cabin services manager (CSM) was contacted via the aircraft interphone system by a cabin crew supervisor seated near door L3 (Figure 1). The supervisor advised the CSM that there was vibration and louder than normal cabin noise in their area. The CSM recalled that following receipt of that advice from the supervisor, they also became aware of the increased noise.

The second officer inspected several sections of the cabin in consultation with the CSM and other flight attendants. They concluded the magnitude of the vibration was largest near door L3 (rows 47-49, seats ABC) and that it was considerably noisier than normal. The CSM recalled that the second officer suspected the vibration may have been due to a landing gear door seal. Unlike other large passenger aircraft, VH-OEH did not have installed video cameras that permitted the crew to view external parts of the aircraft. In any event, the night conditions may have hampered visual examination of the landing gear area on this occasion. The second officer returned to the flight deck and briefed the other flight crew.

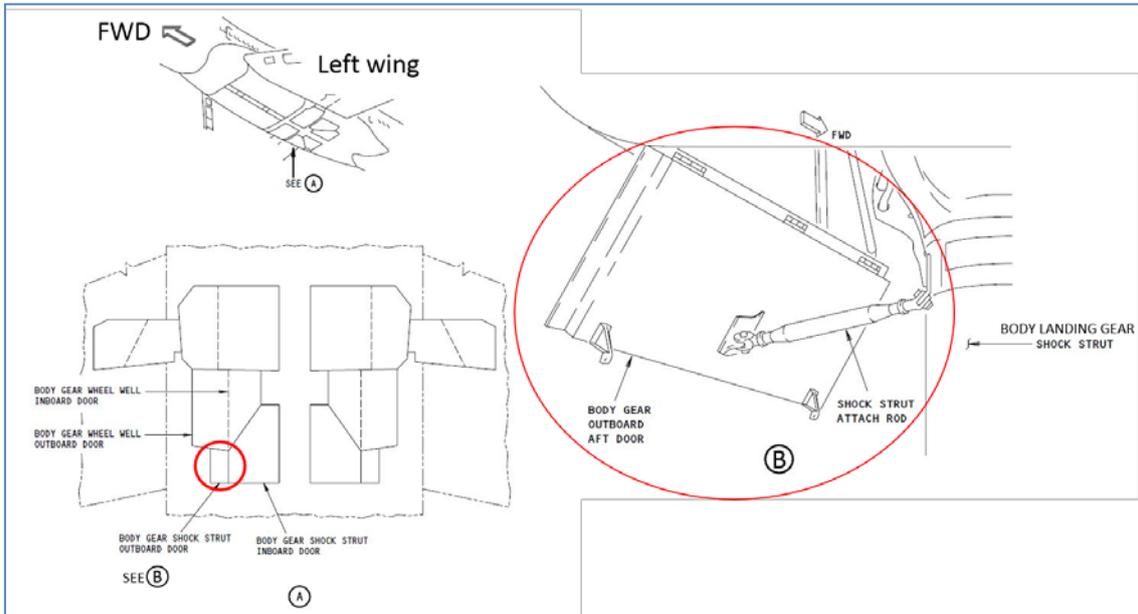
Figure 2 Main landing gear doors showing location of affected door and attach rod.

they observed that a rod, which normally attaches a small outboard landing gear door to the body landing gear shock strut (Figure 2), was sheared at the door attachment point as a result of a birdstrike.

The discovery of the sheared attach rod, evidence of a birdstrike, and the reported in-flight vibration, is consistent with the aircraft having sustained a birdstrike during the departure and while the landing gear was extended. Due to the sheared attach rod, the associated landing gear door would not have closed resulting in residual turbulence and vibration being generated in the area of door L3. The lack of an associated proximity sensor meant that the flight crew were unaware that the door was not closed.

- The noise and vibration experienced in the cabin was due to turbulent airflow associated with the un-closed landing gear door.
- The absence of cockpit indications and/or associated procedures to manage the observed vibration meant that the flight crew were required to use their professional judgement to assess its impact on the flight. The crew utilised available crew resources and maintenance expertise to troubleshoot and assess that the flight could safely continue to the destination airport.

Despite the door not being closed during the flight, there was no additional wear or damage. The attach rod was replaced and the aircraft returned to normal service, with no further vibration or noise reported.
