# Collision with terrain involving Yamaha RMAX

23 km W of Canberra, Australian Capital Territory, 6 April 2017

**ATSB Transport Safety Report**  
Aviation Occurrence Investigation  
AO-2017-043  
Final – 27 July 2017

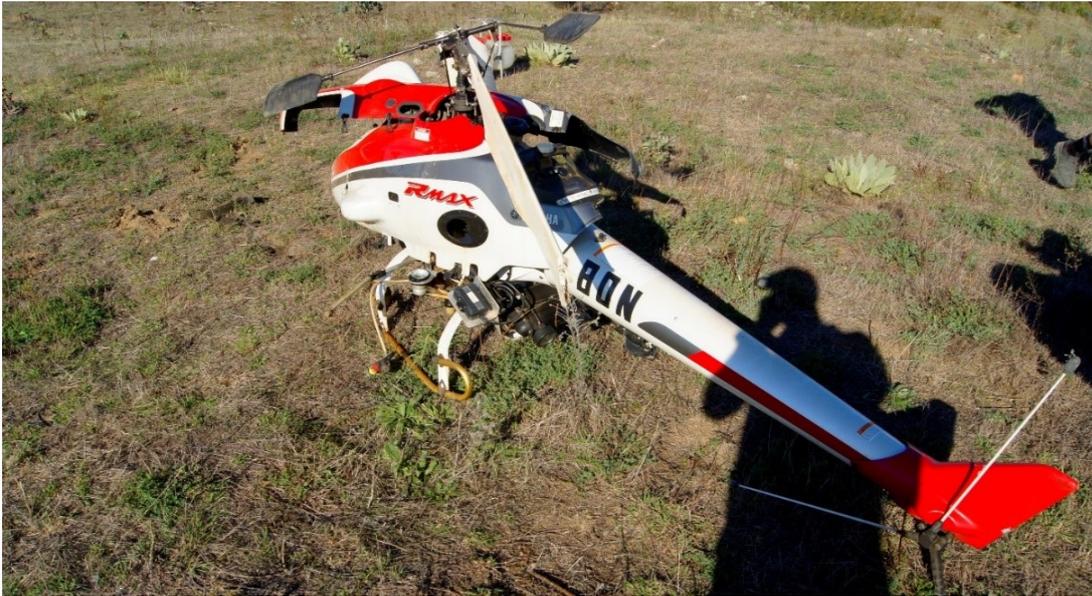
**Figure 2: Damage to the RMAX**

Subsequent inspection revealed that the tail rotor had separated from the aircraft and landed about 30 m from the rest of the aircraft.

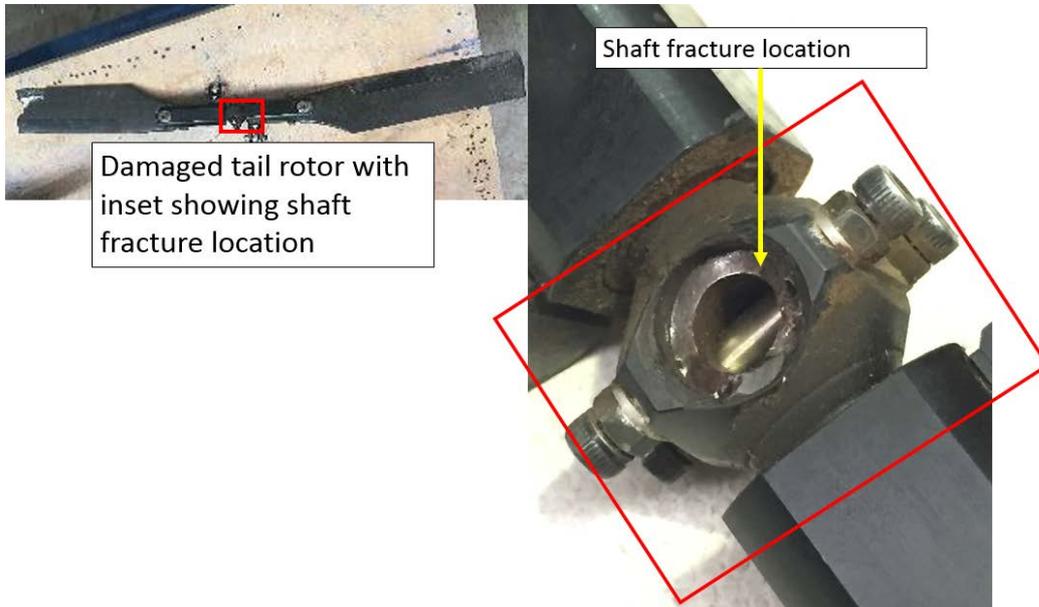
**Figure 3: Tail rotor showing fracture location**

The manufacturer found that the tail rotor shaft had fractured, resulting in the tail rotor detaching from the aircraft (Figure 3).

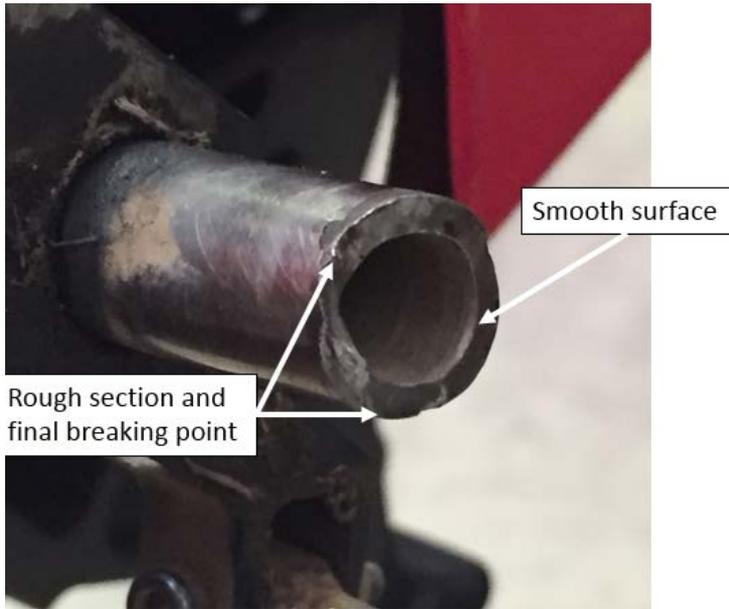
**Figure 4: Fractured tail rotor shaft**

The manufacturer assessed that the fracture had probably existed for some time, as one section of the fracture site was smooth, indicating a pre-existing fracture. Another section of the fracture was rough indicating the failure occurred during the accident flight (Figure 4). The tail rotor blade (Figure 3) probably struck the tail cover after the shaft failed, as this allowed excessive movement in the tail rotor head.

The manufacturer had conducted routine maintenance on the aircraft in October 2016. At that time, they found chips in the tail rotors and a broken antenna (fitted to the tail of the aircraft). The manufacturer replaced the antenna and tail rotor blades but was unable to determine how long the aircraft had been operating with the damage to the blades. Damage to the tail rotor blades may have caused an imbalance and extra load on the tail rotor shaft.

- Impact with a small branch at the time the blades sustained chip damage.
- Possibly flying with rotor blades out of balance after the first impact, for an unknown period.
- Other damage to the aircraft indicative of mishandling during transport, which may have resulted in stress fractures to the rotor shaft.

- The tail rotor drive shaft probably failed due to an existing fracture, resulting in the aircraft colliding with terrain.

Yamaha Motor Australia (YMA) is implementing an online form so that operators can send information and notification of incidents directly to Yamaha operations and maintenance departments.

YMA will modify operator’s manuals to better reflect handling standards.
