# Loss of separation assurance involving Robinson R44, VH-FOA, and Boeing 737, VH-XZP

Canberra Airport, Australian Capital Territory, 2 June 2017

**ATSB Transport Safety Report**  
Aviation Occurrence Investigation  
AO-2017-058  
Final - 15 March 2018

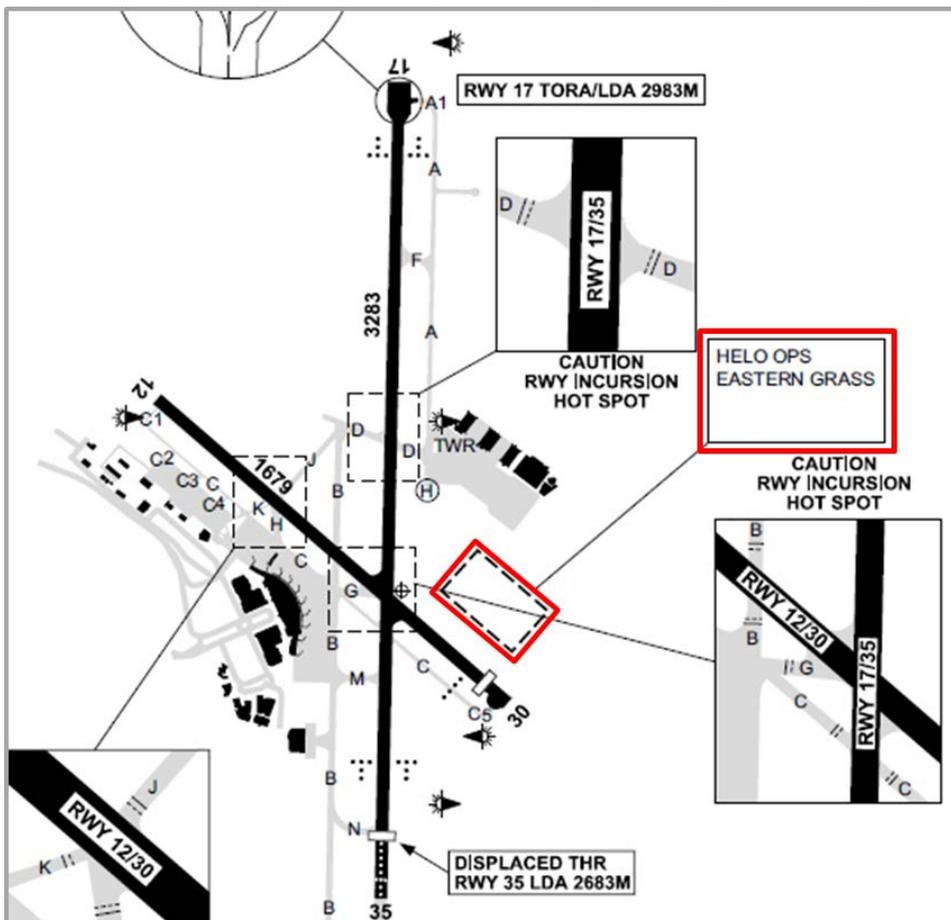
**Figure 1: Diagram of Canberra Airport showing eastern grass helicopter operations**

At about 0747 Eastern Standard Time<sup>1</sup> on 2 June 2017, a Robinson R44 II helicopter, registered VH-FOA (FOA) commenced taxiing at Canberra Airport, Australian Capital Territory. The helicopter was preparing for a training flight in the circuit area. A student pilot and instructor were on board the helicopter. The crew of FOA planned to conduct circuit operations on the eastern grass parallel to runway 12/30 (Figure 1).

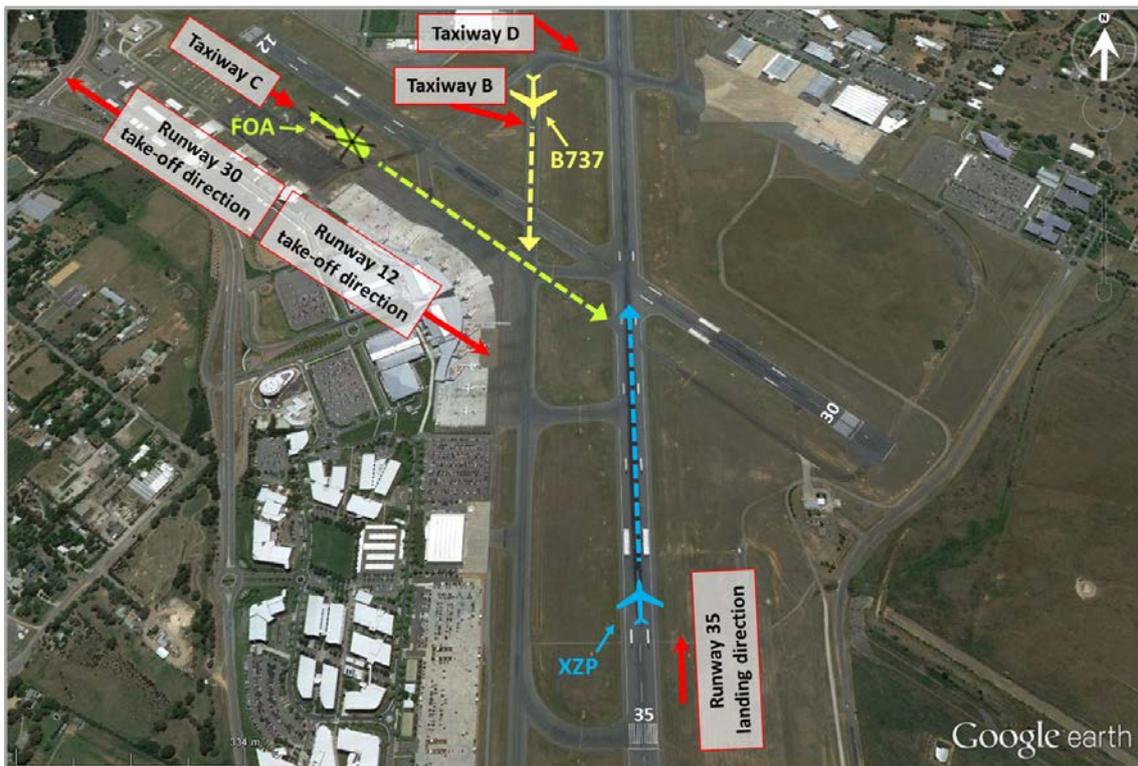
**Figure 2: Canberra Airport and projected routes of the aircraft involved in the incident**

The SMC issued a taxi clearance for FOA to taxi from the general aviation apron to taxiway C (Figure 2). The SMC also advised FOA’s crew to expect to depart from taxiway C in the runway 30 direction.

At about 0750, the ADC cleared a Boeing 737-838, registered VH-XZP (XZP), to land on runway 35 (Figure 2). The aircraft was a scheduled passenger flight from Melbourne, Victoria. At this time, FOA’s crew were on the surface movement control frequency, hence unaware of XZP’s landing clearance.

The ADC sighted FOA before issuing a take-off clearance to depart parallel to runway 12 and to maintain the runway heading. The student pilot read back this instruction to depart parallel to runway 12 and then realigned FOA in that take-off 12 direction (Figure 2). The student and instructor checked the airport windsocks – there was no downwind component in the take-off direction. Soon after, FOA began departing along taxiway C in the runway 12 direction.

Initially, the airport terminal buildings obscured the view that FOA’s crew had of the approach to runway 35 (see Figure 2). Once runway 35 came into view, and before crossing the runway, the crew looked to ensure there was no conflicting traffic. They then saw XZP touch down on the runway ahead of the helicopter.

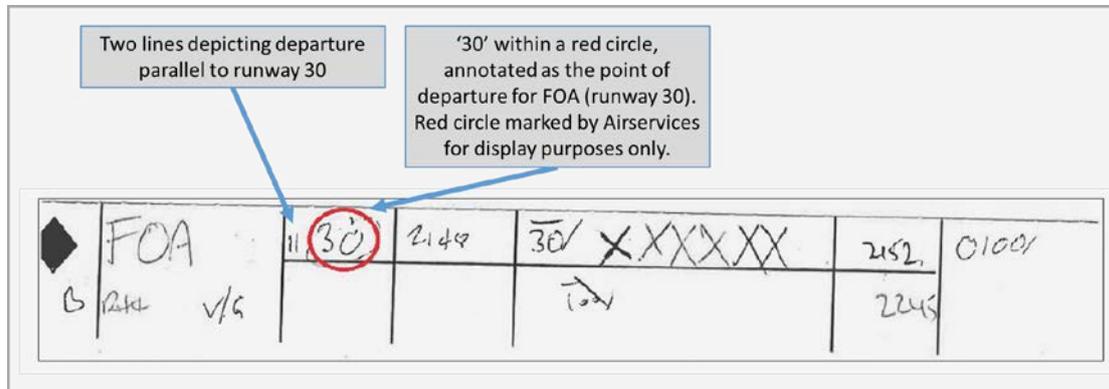
**Figure 3: Flight progress strip for FOA**

In the case of FOA, the departure location was recorded as two vertical lines followed by 30, indicating a departure parallel to runway 30 (Figure 3). As runway 30 was not the duty runway (which was runway 35) at the time, its designator was circled in red (see Figure 3).

When a controller’s instructions to an aircraft are acknowledged, the controller can use the progress strip to check the information is correct. The controller then may (but is not required to) annotate that on the progress strip next to the information. However, when the ADC issued FOA a take-off clearance, he did not refer to the progress strip or annotate it.

However, some existing risk controls could have allowed early detection of the error. The ADC's intended plan was indicated on the flight progress strip but he did not refer to the progress strip. The student pilot read back the take-off clearance issued but the ADC did not notice that the clearance issued was not what he had intended. As he was not annotating the strip as a matter of course either, he did not have another cue or memory prompt to avoid the error or detect the error once it had been made. While the ADC should have been visually observing FOA departing, he did not because he became focused on the coordination tasks.

This occurrence highlights the importance of air traffic controllers using system support tools effectively to manage the operational environment. The use of flight progress strips is intended to enhance the situational awareness of controllers. When fully utilised, these tools are an effective monitoring support tool. Flight progress strips also provide information to assist with the correct execution of the controller's plan and the early detection of any errors that may occur.
