Collision with water involving twin-engine EC135 helicopter, VH-ZGA

35 km north-west of Port Hedland, Western Australia, on 14 March 2018

ATSB Transport Safety Report
Aviation Occurrence Investigation
AO-2018-022
Preliminary – 3 May 2018

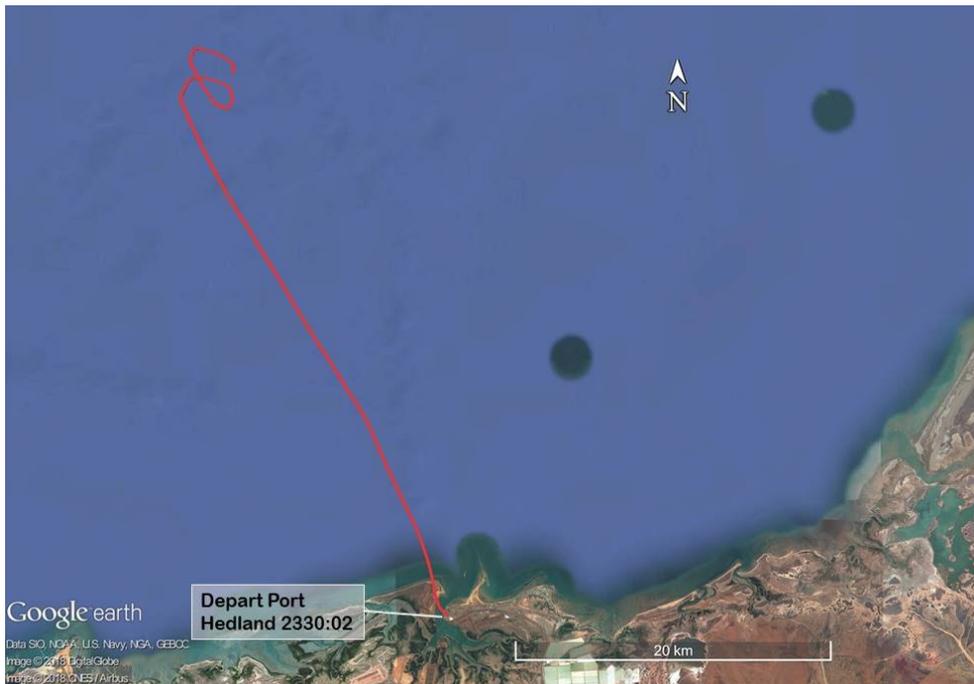
Figure 2: Ground track of the helicopter to collect the marine pilot

The recorded ground track of the helicopter outbound from the heliport and to the accident site is shown at Figure 2 and the final ground track in vicinity of the vessel can be seen in Figure 3.

The helicopter was fitted with Automatic Dependent Surveillance Broadcast (ADS-B) equipment. That equipment enabled air traffic services and other pilots to track aircraft without using conventional ground-based radar installations. The signals transmitted by the ADS-B equipment can also be received and recorded by other specialised ground-based receivers, such as those operated by flight tracking websites. Those receivers are situated at numerous locations around the world and feed data to centralised computer servers and accessed using internet browsers and other utilities. The image displays the server-recorded ADS-B ground track for the helicopter as it travelled to collect the marine pilot.

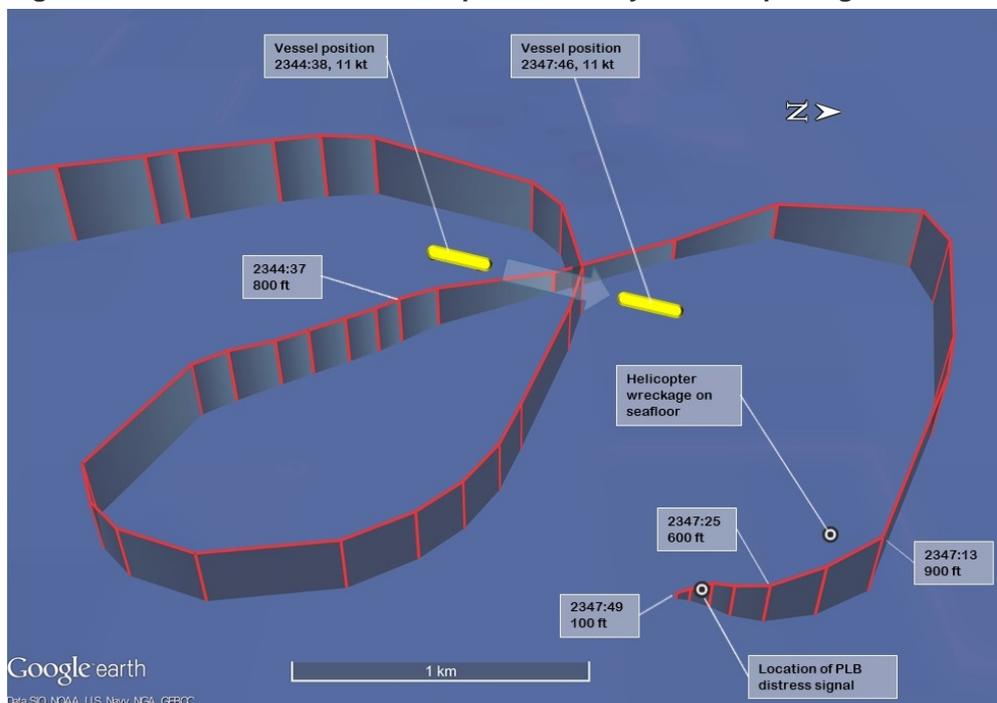
Figure 3: Ground track of the helicopter in vicinity of the departing bulk carrier

The image displays the helicopter's ADS-B ground track and pressure altitude (to the nearest 100 ft) while operating in vicinity of the departing bulk carrier. The positions of the distress signal from the PLB and the helicopter wreckage are also depicted. Note that the ADS-B data points are not at regular fixed-time intervals. The vessel location was broadcast by its automatic information system (AIS). Source: Background image GoogleEarth, overlaid with FlightRadar24 ADS-B data, AIS data from Pilbara Ports Authority and annotated by ATSB.

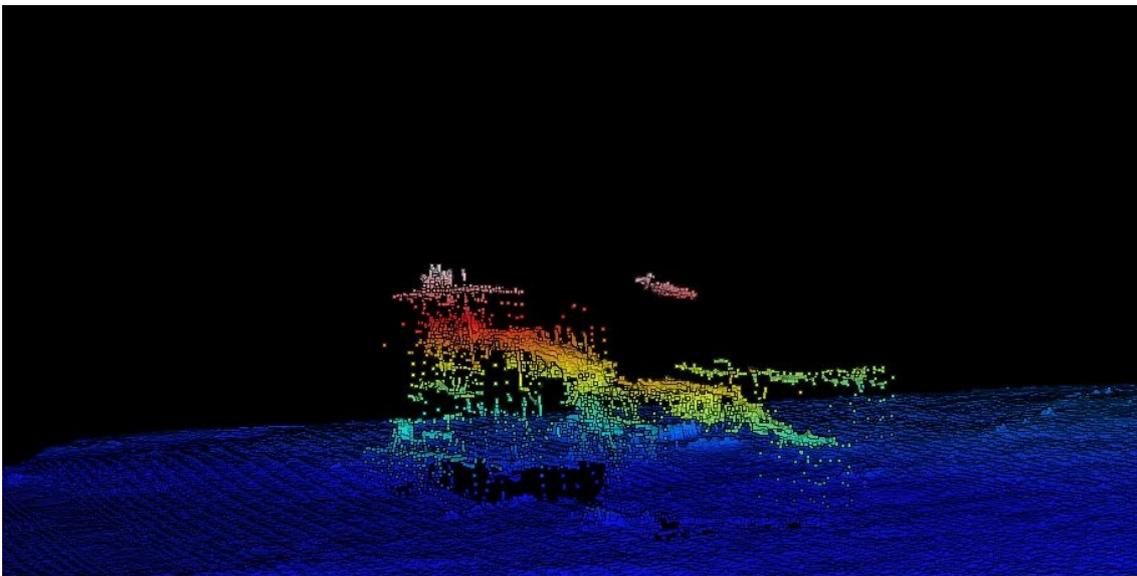
Figure 4: Sonar image of helicopter resting on the seabed, on its right side

A surface search for the missing pilot and wreckage was initiated and continued during the night and the next two days. A seabed sonar search of the area also commenced with a hydrographic survey vessel. The helicopter wreckage was identified on the seabed on 17 March 2018 (see Figure 4 and Figure 5). It was substantially intact and resting on its right side in about 20 m of water.

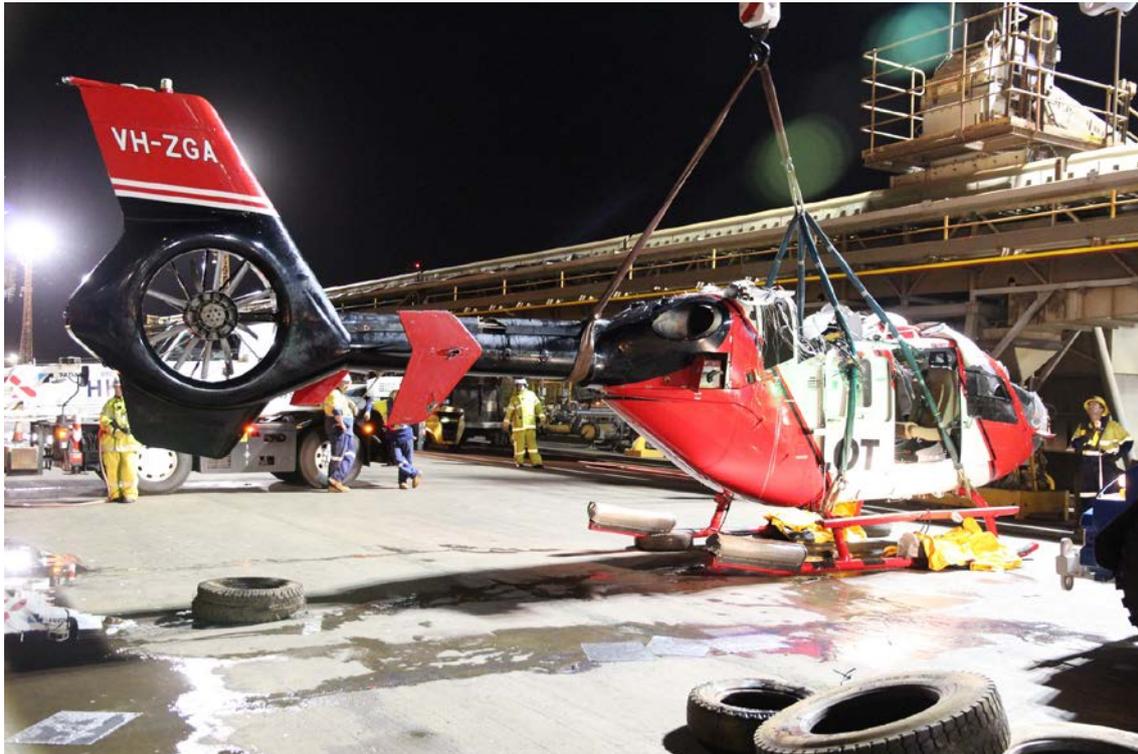
Figure 6: Helicopter wreckage being lifted onto the dock

The helicopter wreckage was recovered from the seabed during 18 and 19 March 2018 (Figure 6). The wreckage was moved into the secure storage area where it was examined by the ATSB.

The helicopter was substantially intact, although the hub of the main rotor and the main transmission had separated from the airframe during the recovery.

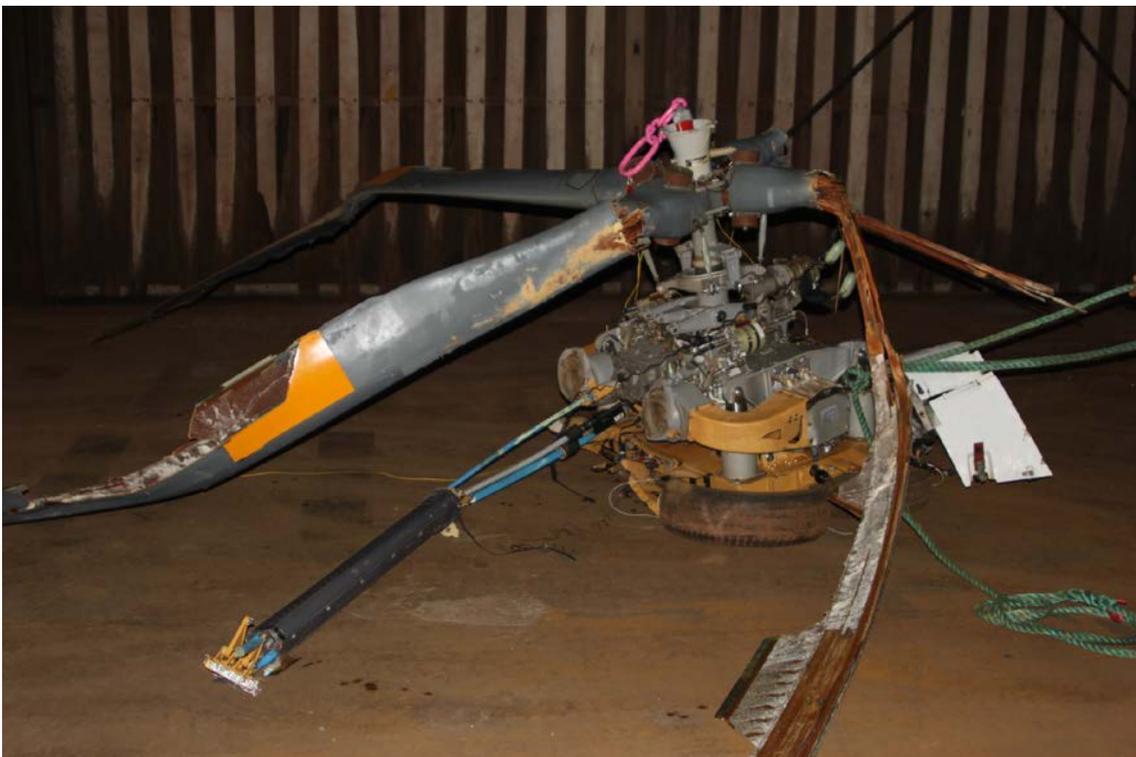
Figure 7: Main rotor blades and main transmission, showing damage in vicinity of the blade roots

Several of the main rotor blades had sustained significant damage near their blade roots during water impact and one of the blades of the main rotor had struck the helicopter tail boom. The flexible coupling of the main gearbox drive output shaft had sheared. The tail rotor blades of the Fenestron antitorque system exhibited evidence of rotational damage.

Figure 7 illustrates the separated main transmission and the damage to some of the helicopter's main rotor blades.
