Traffic conflict involving Cessna 208, VH-SJJ and Robinson R22, VH-MFH

Ballina Byron Gateway Airport, New South Wales, 19 September 2017

ATSB Transport Safety Report
Aviation Occurrence Investigation
AO-2017-097
Final – 5 September 2018

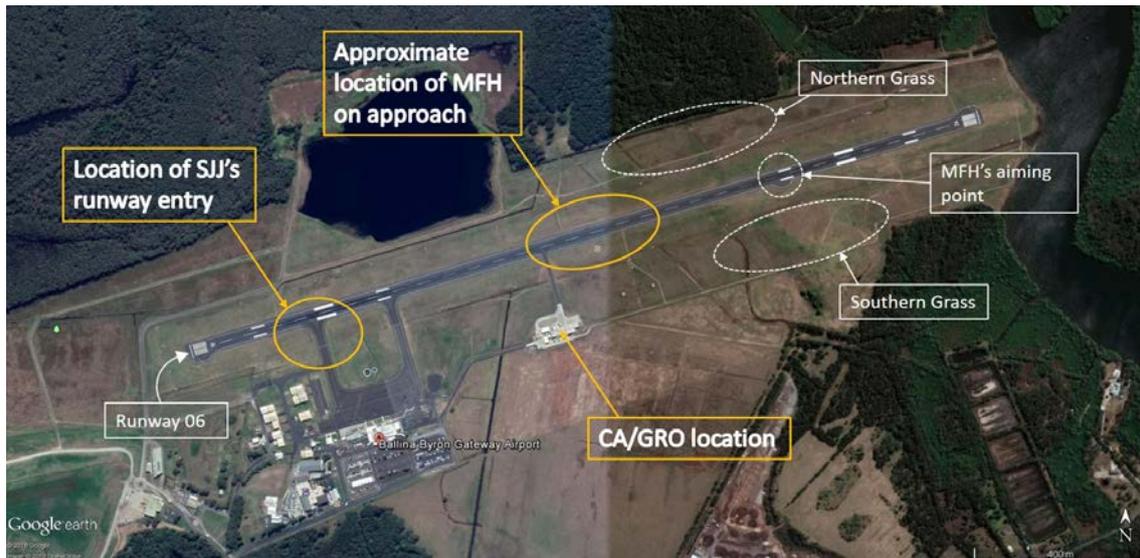
At about the same time, one of the R22s, registered VH-JKH (JKH), was operating clear of the runway strip in an area known as the southern grass (Figure 1). The other R22, registered VH-MFH (MFH), was being used for circuit training on runway 06 with approach and landing to a point about two thirds along the runway. At 1105, the instructor in MFH broadcast on the CTAF that they were on a left base for runway 06 to the runway.

At this time, MFH was on short final for runway 06 at approximately 200 ft above the runway and approaching a point that was about two thirds of the way along runway 06. The instructor realised that the C208 was departing and transmitted that MFH was 'runway 06 for the runway'. That call partly over-transmitted on the C208 pilot's response to the CA/GRO. The instructor took control of the helicopter and vacated the runway to the north followed by a call to advise their location at the 'northern grass.'

Figure 1: Approximate location of aircraft when the C208 pilot called entering and rolling
